Stream Condition Assessment Memorandum

To: Tonya L. Capparello, PE (Town Engineer, Town of Wilbraham)
FROM: Caitlin DeWolfe, EIT; Jamie Fitzpatrick, EIT; Dan Buttrick, PE (Tighe & Bond)
COPY: Andrea M. Lacasse, PE; Tracy J. Adamski, AICP (Tighe & Bond)
DATE: May 31, 2024 (Draft), June 13, 2024 (Final)

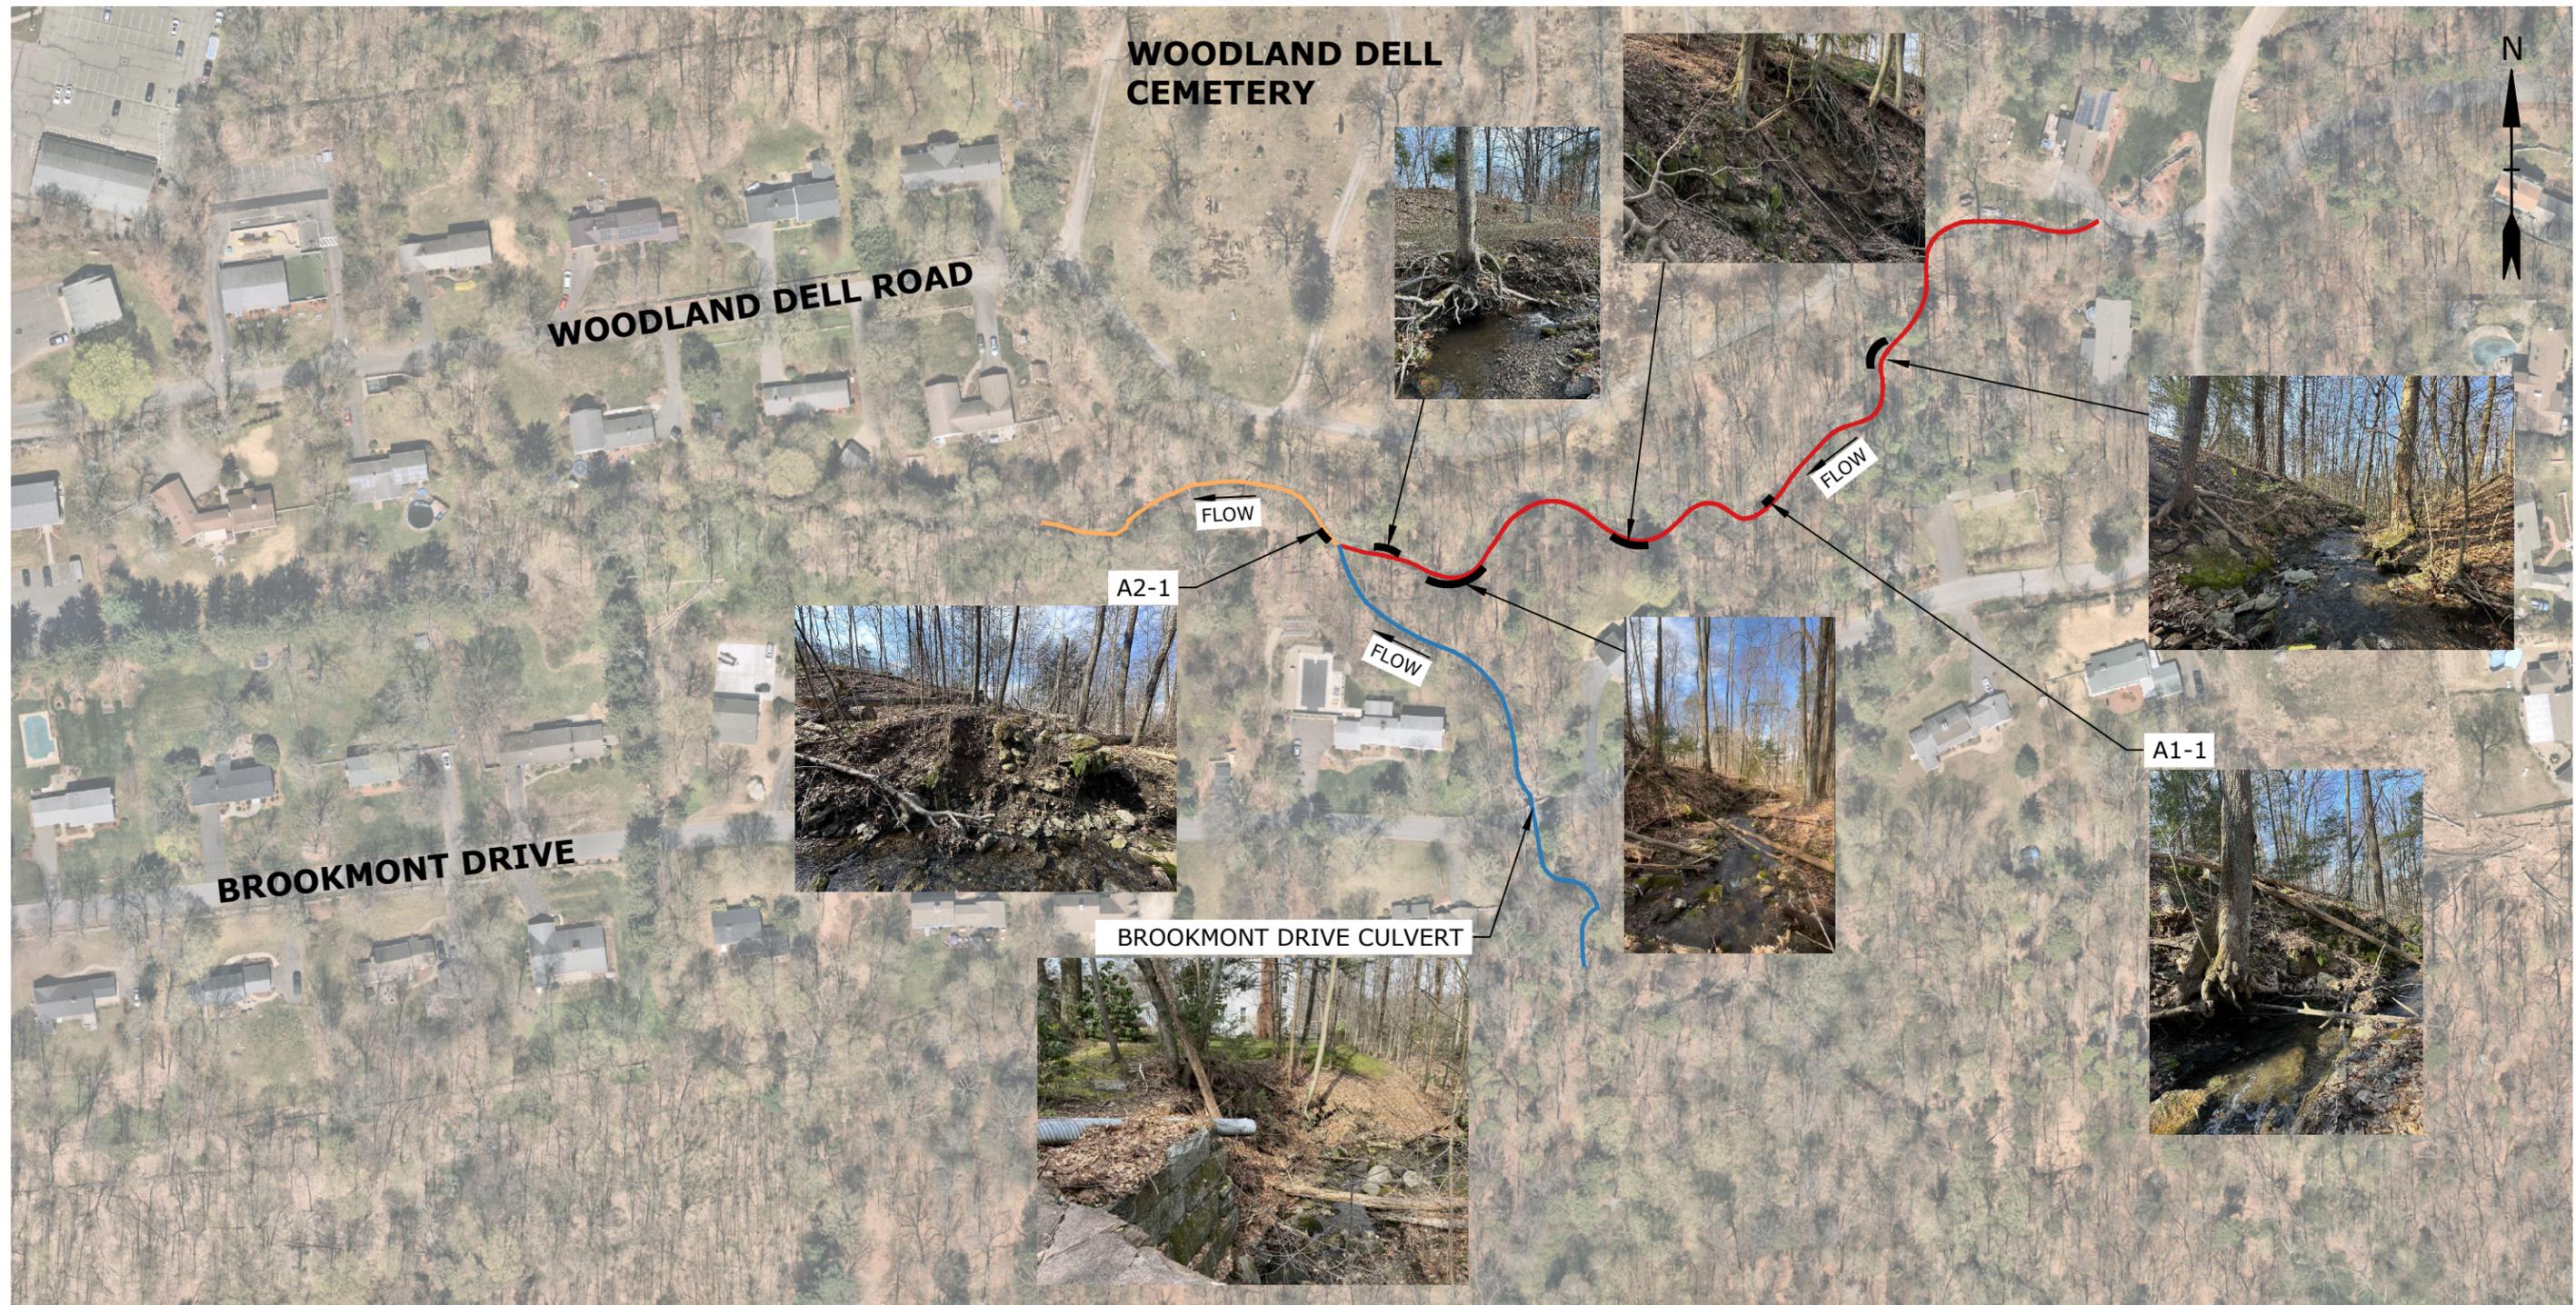
Reaches A1 and A3 are characterized by steep banks, with notable bank failures observed adjacent to the Cemetery and downstream of the Brookmont Drive culvert. The culvert through Brookmont Drive is under consideration for rehabilitation or replacement as part of the Culvert Asset Management Plan and conveys Reach A3 toward the confluence. Downstream of Reach A2, the Town noted that natural debris is often removed from the trash rack at the Main Street Culvert entrance.

APPROXIMATE LOCATION OF OBSERVED BANK EROSION
-

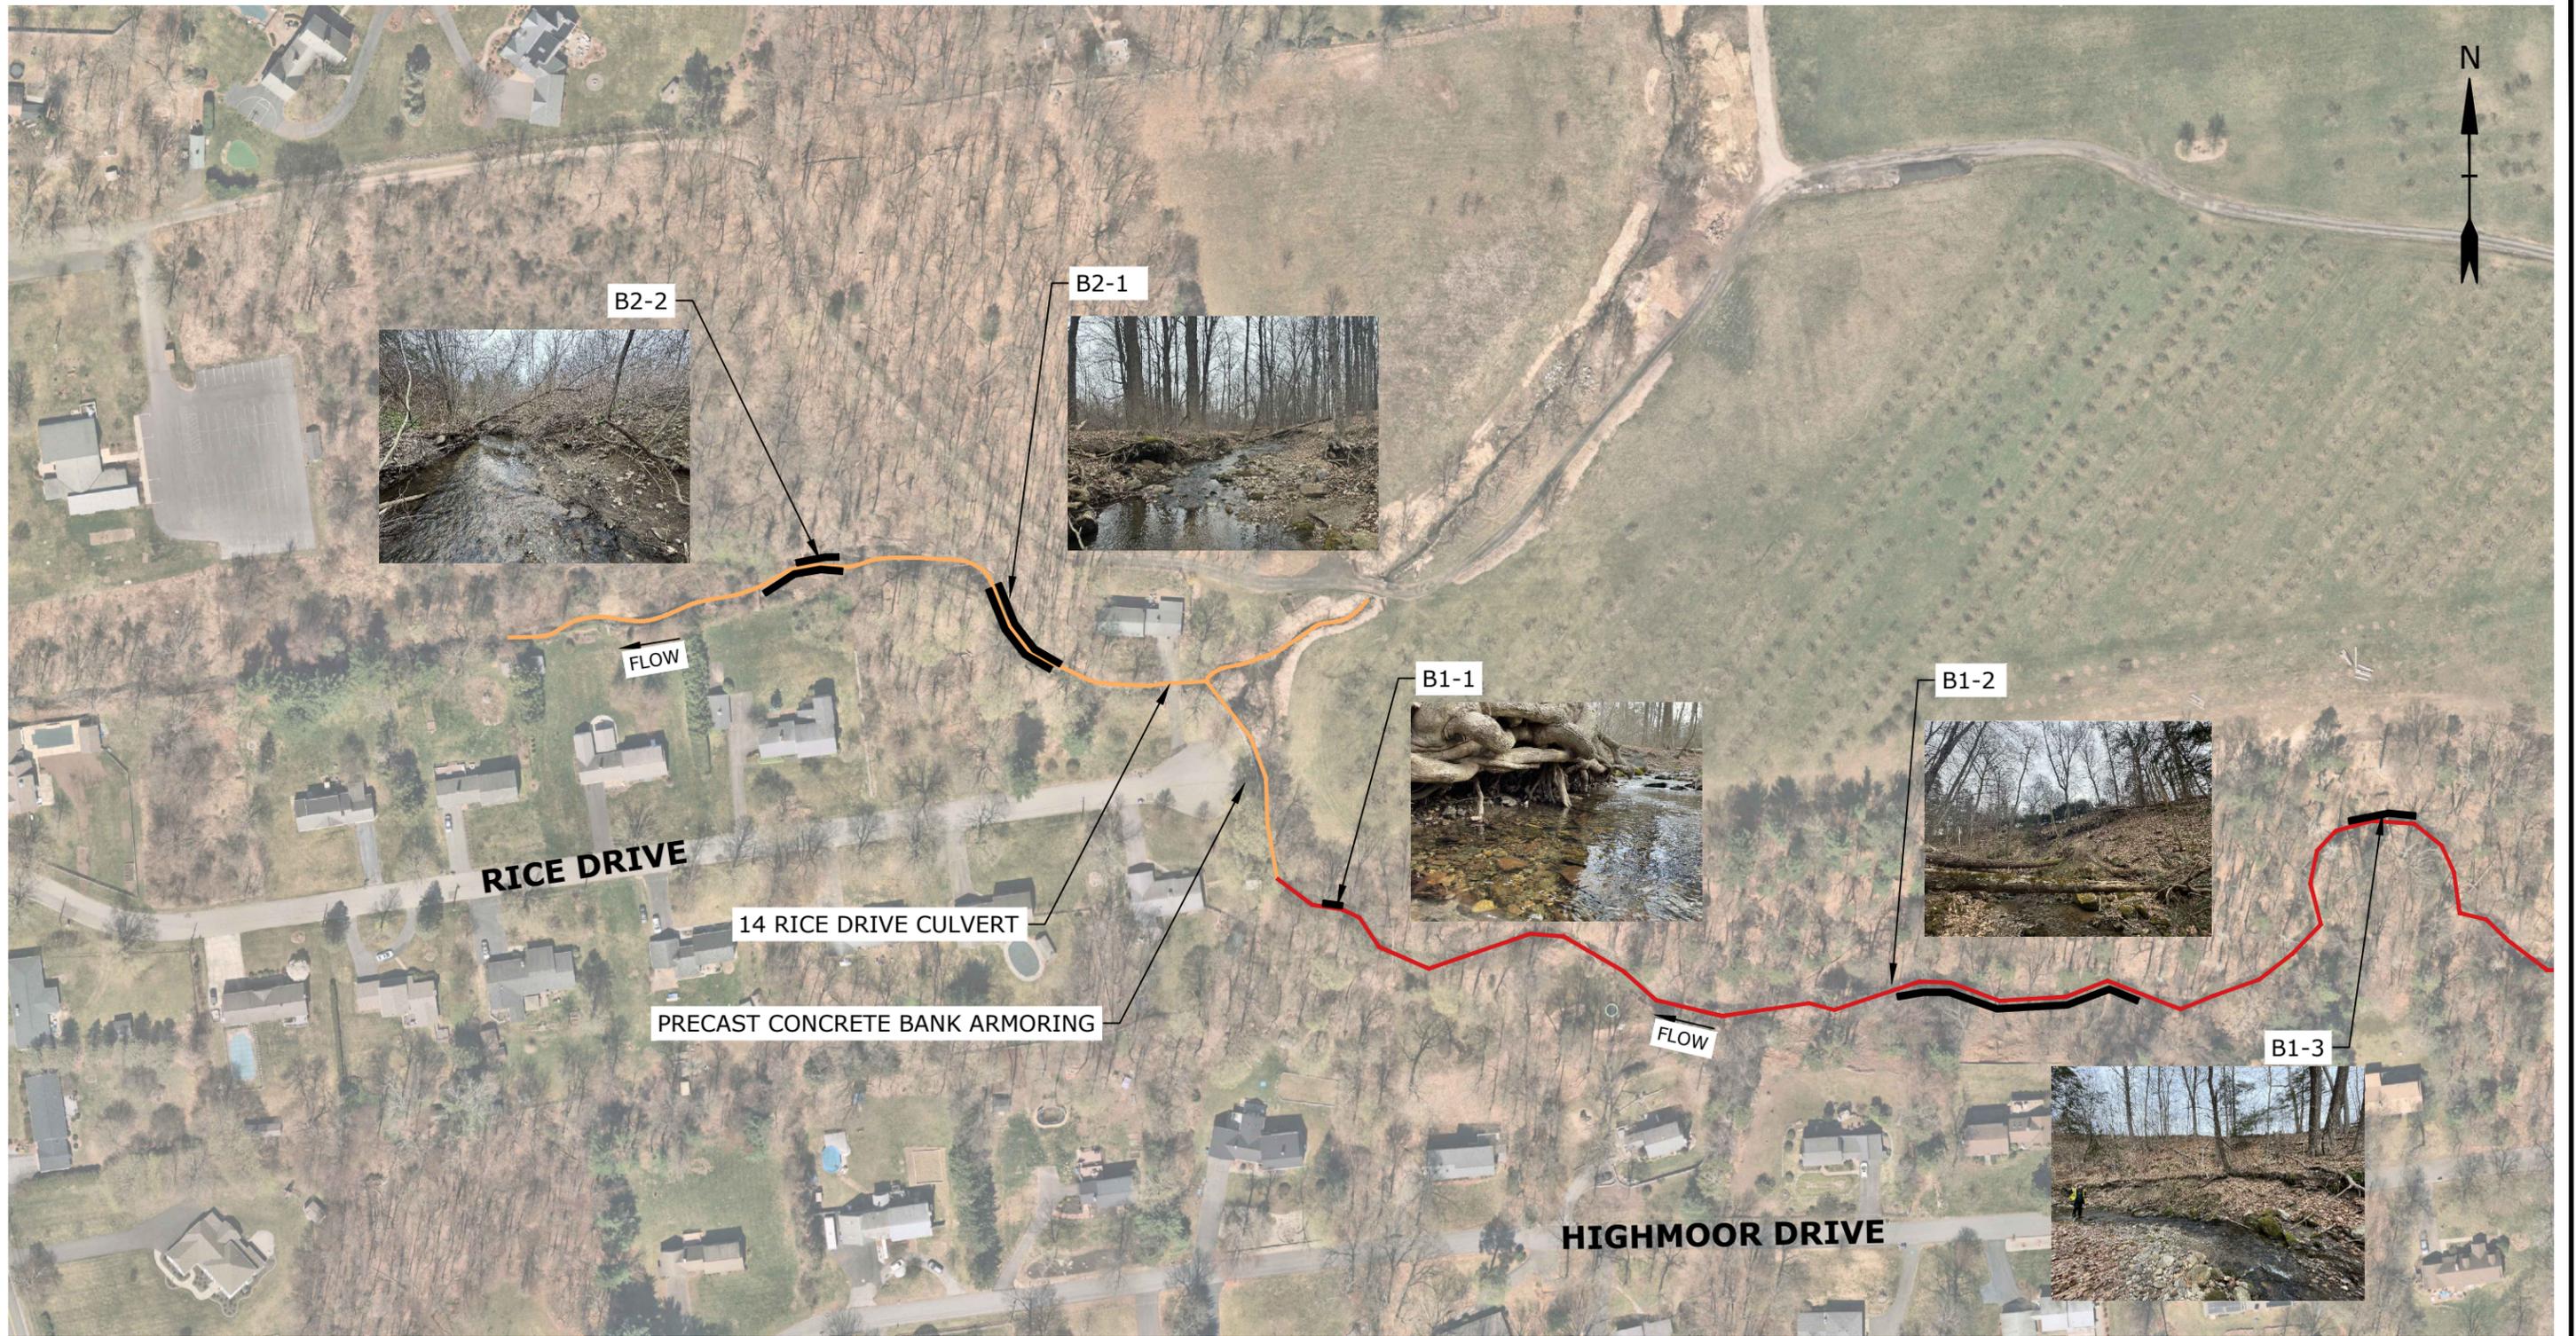
Undermining of the concrete blocks was observed. The confluence upstream of the 14 Rice Drive culvert is an open basin with undefined channels and contains deposited sediment. The 14 Rice Drive culvert was observed to be failing, with bare soils present and visible erosion of the fill material between the driveway and the culvert. Reach B2 meanders for approximately 430 feet before straightening into what appears to be a constructed channel along the northern edge of the Rice Drive residential properties. The Town has observed backyard flooding in this area.

APPROXIMATE LOCATION OF OBSERVED BANK EROSION
-

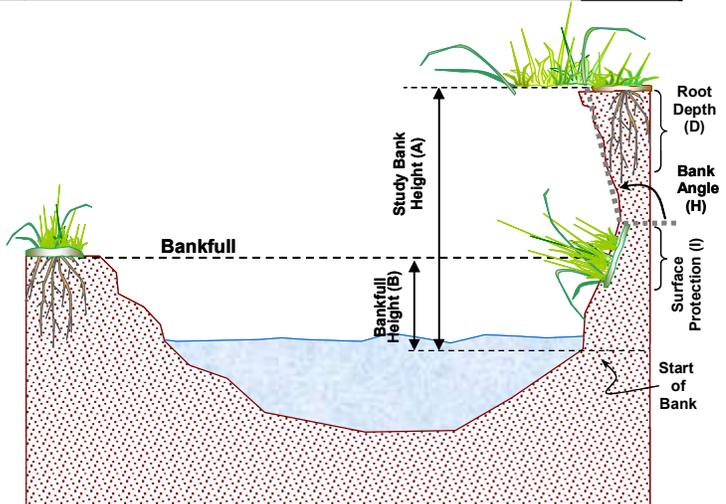
Very Low	Low	Moderate	High	Very High	Extreme	Adjective Rating and Total Score
5 – 9.5	10 – 19.5	20 – 29.5	30 – 39.5	40 – 45	46 – 50	Very Low 8.0

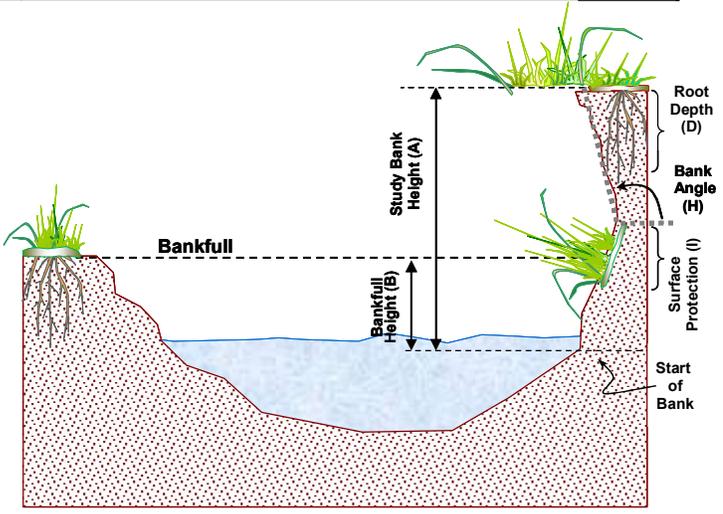
Very Low	Low	Moderate	High	Very High	Extreme	Adjective Rating and Total Score
5 – 9.5	10 – 19.5	20 – 29.5	30 – 39.5	40 – 45	46 – 50	High 30.5

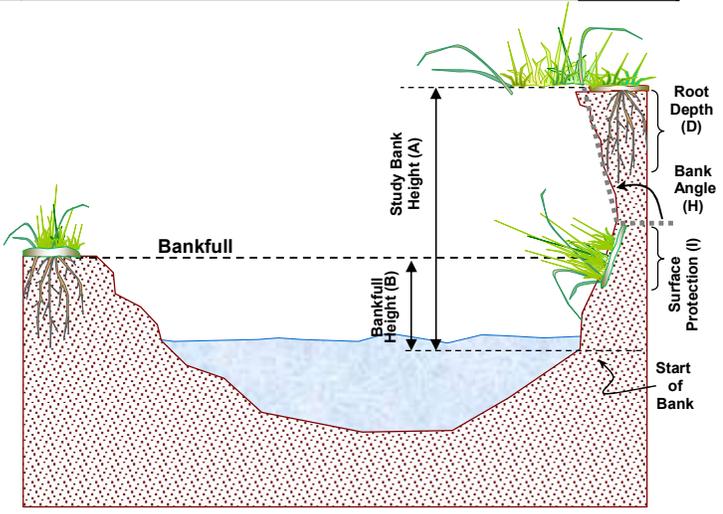
Very Low	Low	Moderate	High	Very High	Extreme	Adjective Rating and Total Score
5 – 9.5	10 – 19.5	20 – 29.5	30 – 39.5	40 – 45	46 – 50	High 37.5

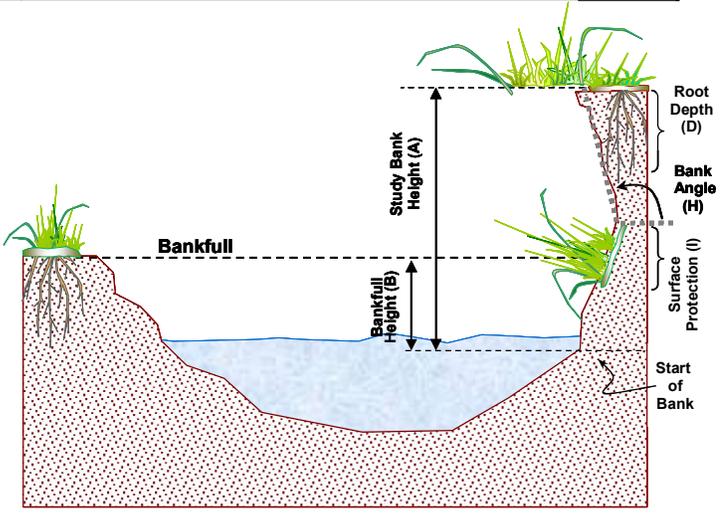
Very Low	Low	Moderate	High	Very High	Extreme	Adjective Rating and Total Score
5 – 9.5	10 – 19.5	20 – 29.5	30 – 39.5	40 – 45	46 – 50	Very High 44.5

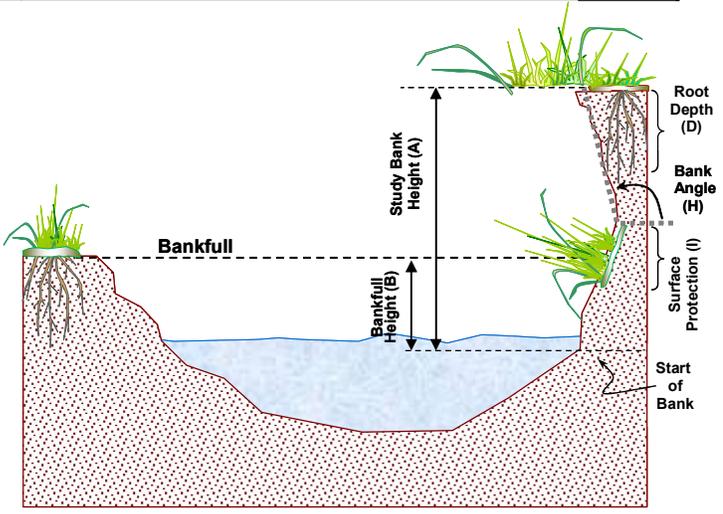
Very Low	Low	Moderate	High	Very High	Extreme	Adjective Rating and Total Score
5 – 9.5	10 – 19.5	20 – 29.5	30 – 39.5	40 – 45	46 – 50	Extreme 50.0

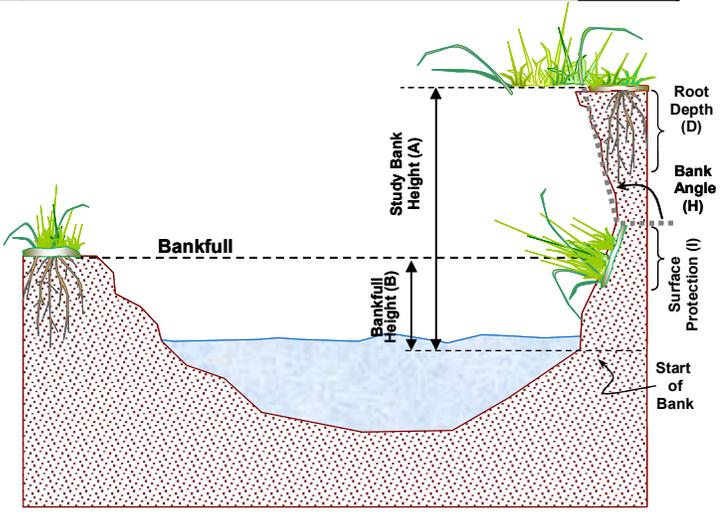
Very Low	Low	Moderate	High	Very High	Extreme	Adjective Rating and Total Score
5 – 9.5	10 – 19.5	20 – 29.5	30 – 39.5	40 – 45	46 – 50	Extreme 48.0

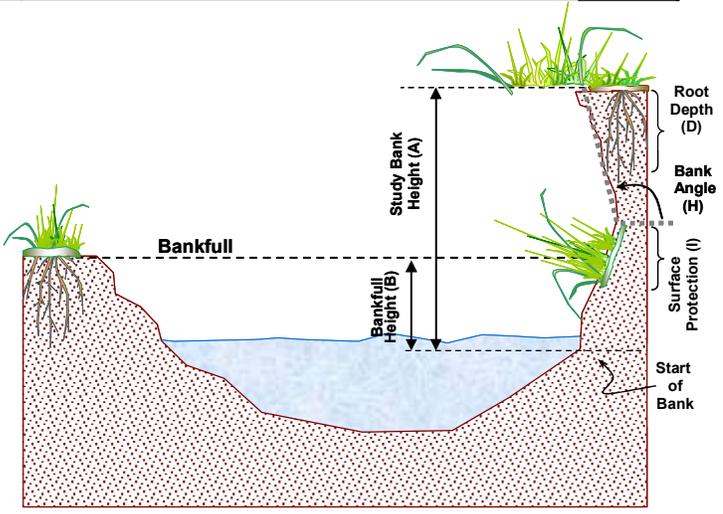
Very Low	Low	Moderate	High	Very High	Extreme	Adjective Rating and Total Score
5 – 9.5	10 – 19.5	20 – 29.5	30 – 39.5	40 – 45	46 – 50	Very High 42.0
