WilbrahamOutfallInspection

Submitted by: Wilbrahameng

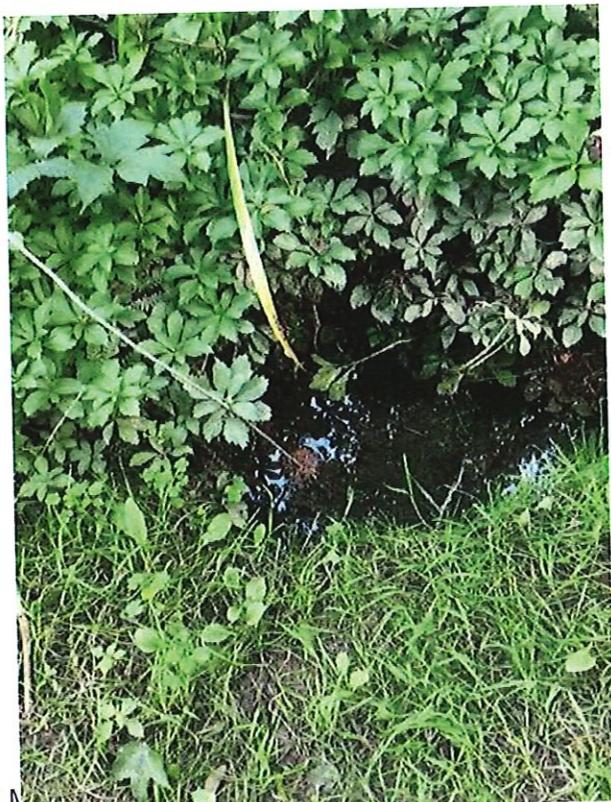
198

Partially

- **Clogged with Debris**

Pipe clogged. Concerns with flooding in back yard. Extend pipe?

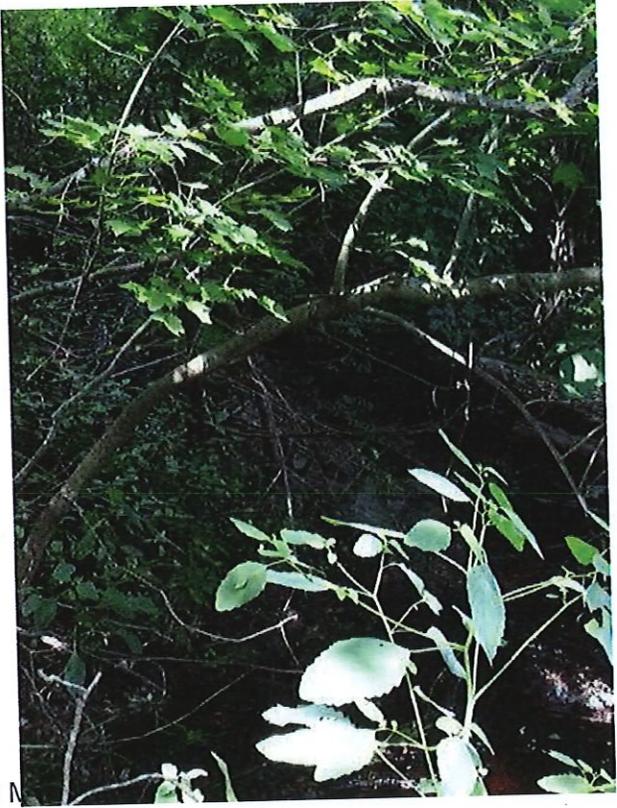
21

- Crushed

Fallen trees on pipe

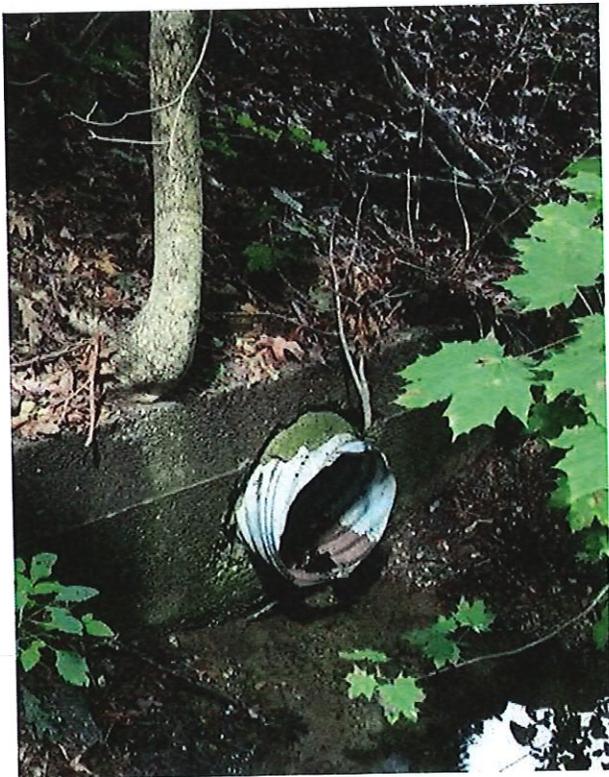
20

- **Corroded (metal)**

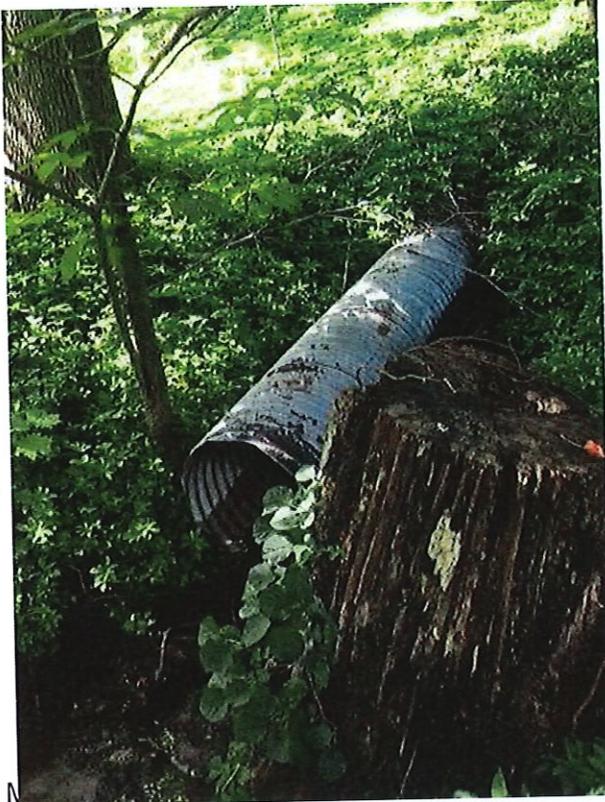
19

- **Corroded (metal)**

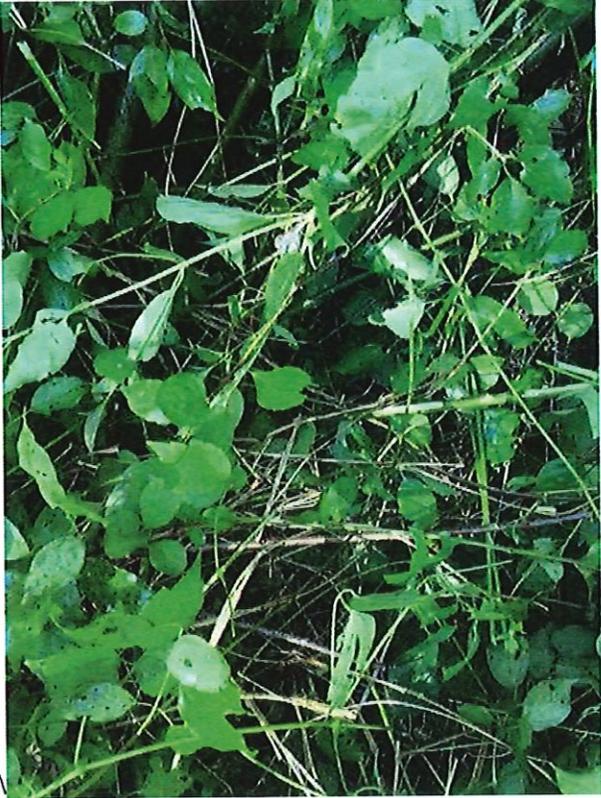
102

1 foot of exposed pipe with a hole in it

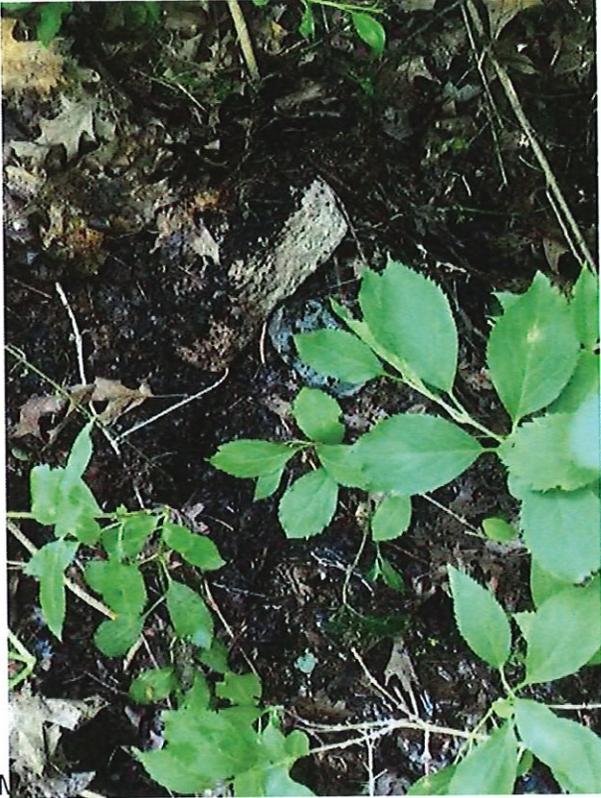
356

Fully

- Clogged with Debris

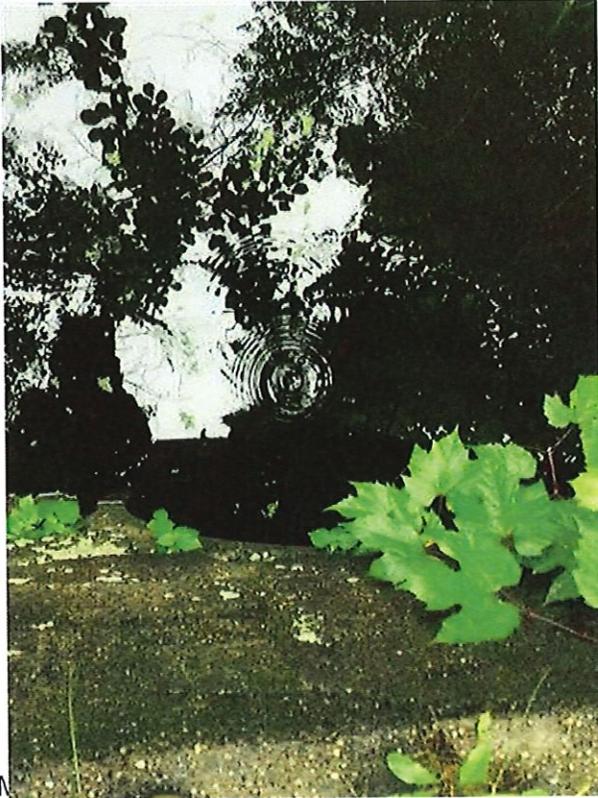
116

Water going into outfall

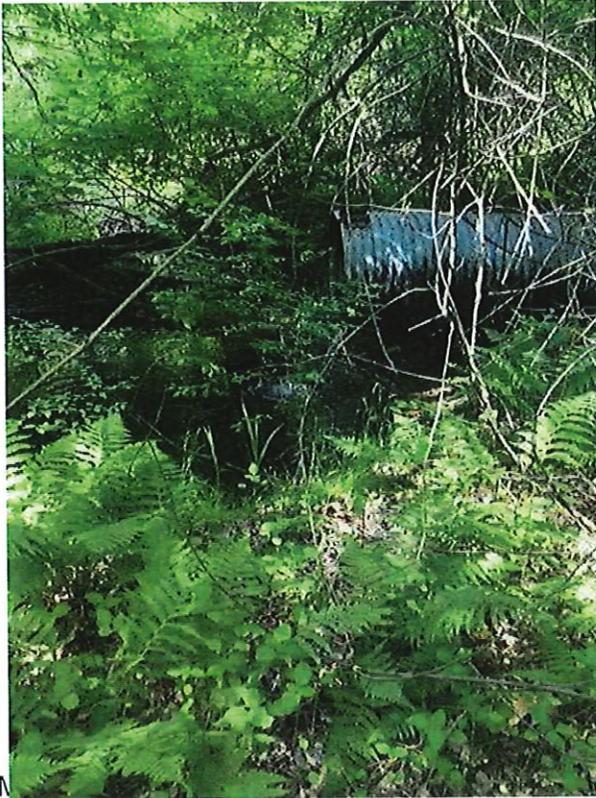
- **Good**
- **Corroded (metal)**

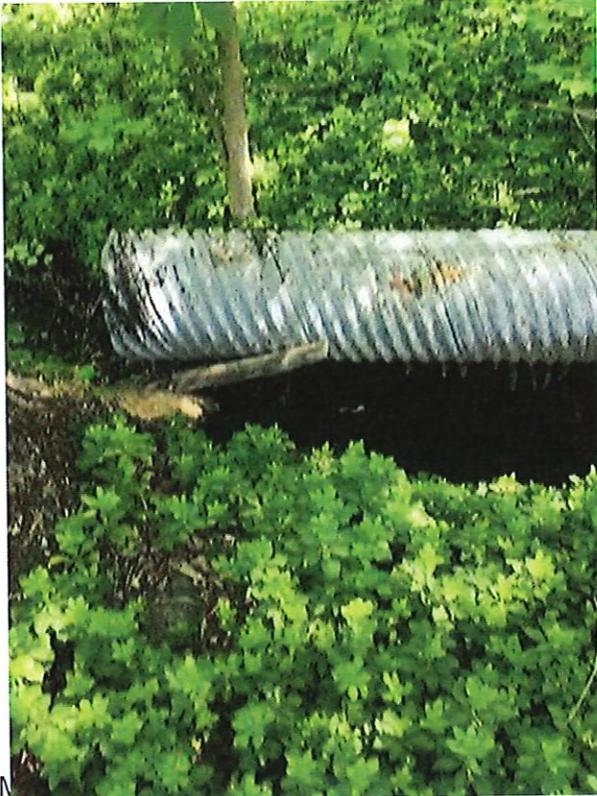
- **Corroded (metal)**

Very exposed and corroded

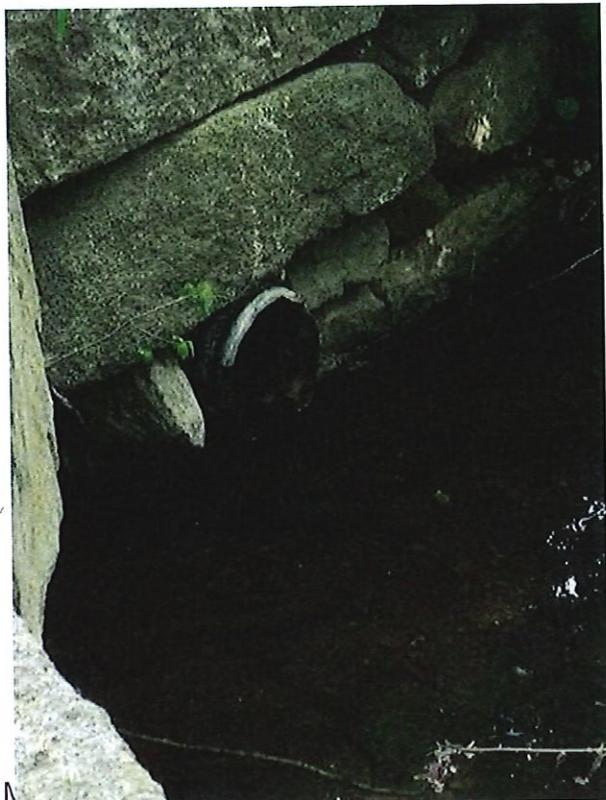
- **Good**
- **Corroded (metal)**

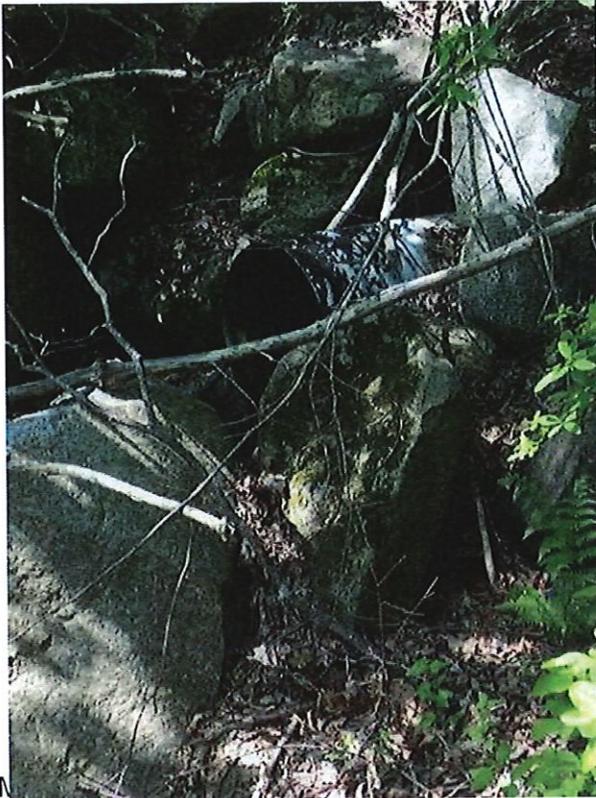
- **Corroded (metal)**
- **Good**
