CAPITAL NEEDS ASSESSMENT

Town of Wilbraham Portfolio

**Various Addresses
(17 Scattered Properties)
Wilbraham MA 01095**

EBI Project No. 1321000388

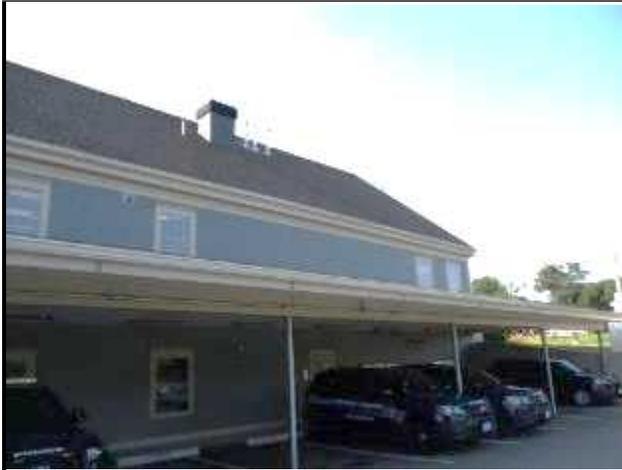
60. Representative missing sealant at Building 4 window

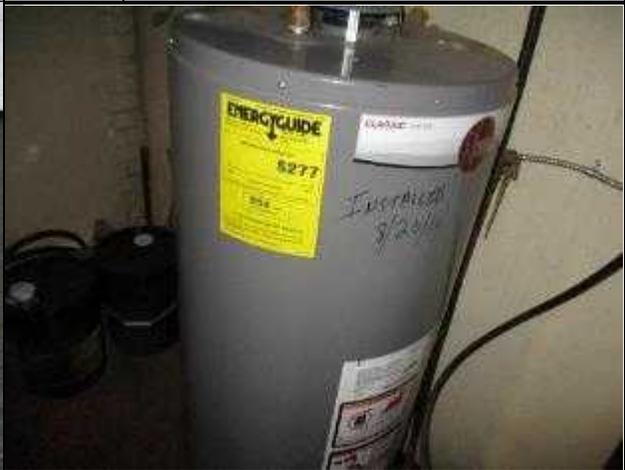
87. Non-compliant accessible parking sign < 60" height from grade at Building 5	88. Water heater at Building 5 basement

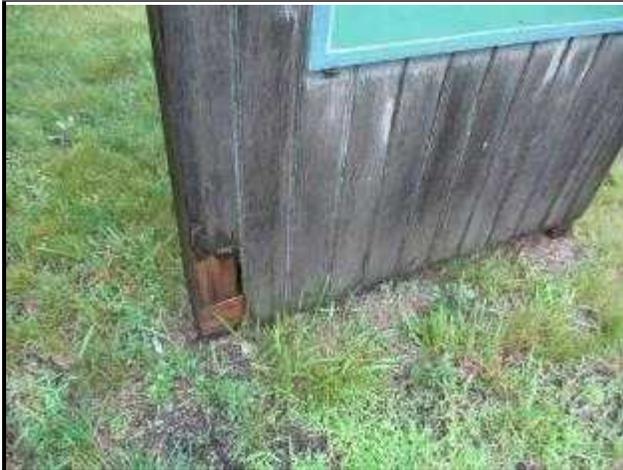
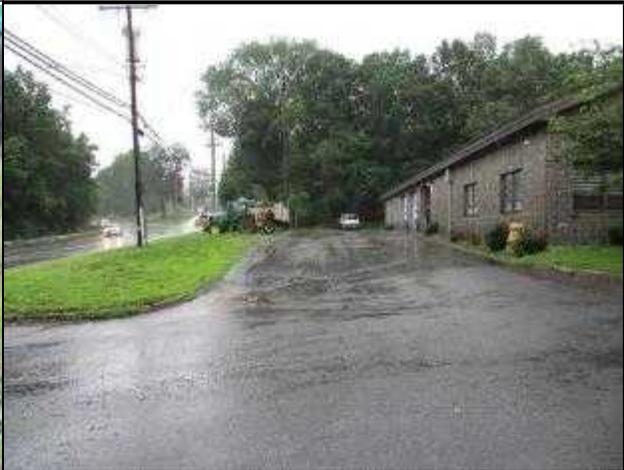
97. Worn and deteriorated wood at pylon sign at Building 6	98. Front asphalt drive aisle at Building 6

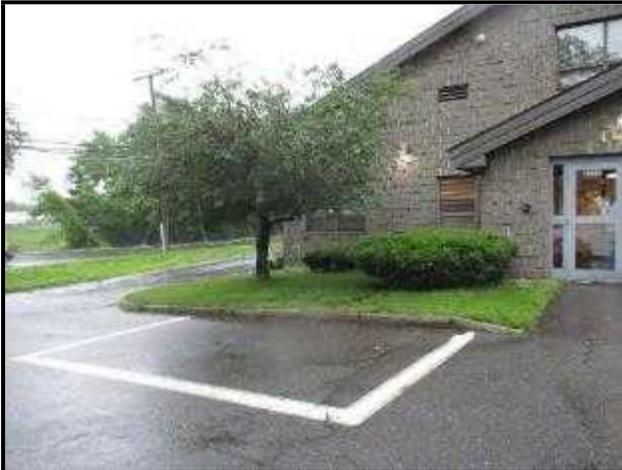
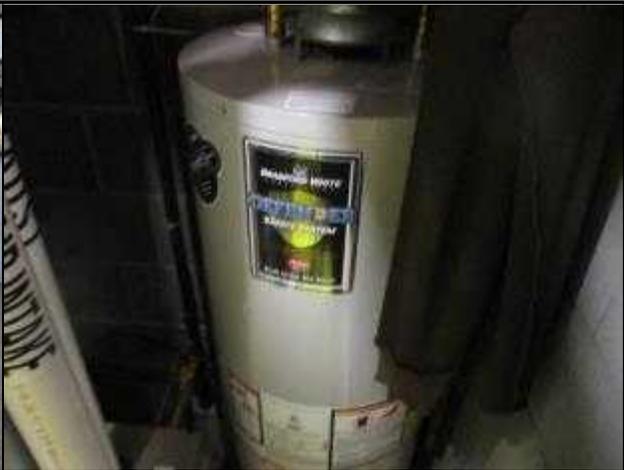
109.	Accessible parking with no signage or access aisle at Building 6	110.	Representative water heater in Building 6

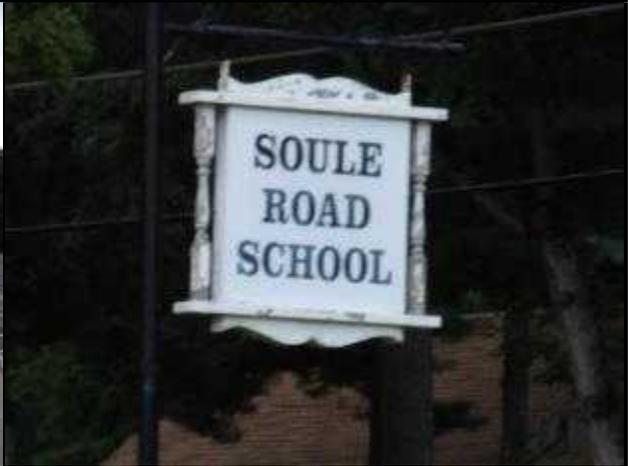
116. Worn signage with peeling paint at Building 7

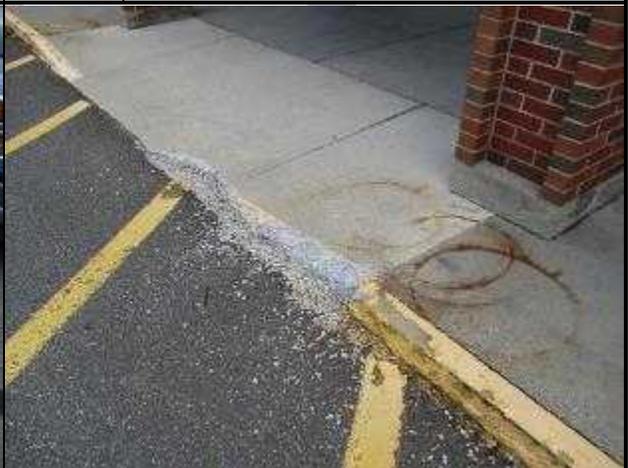
118. Trip hazard at Building 7 front entrance

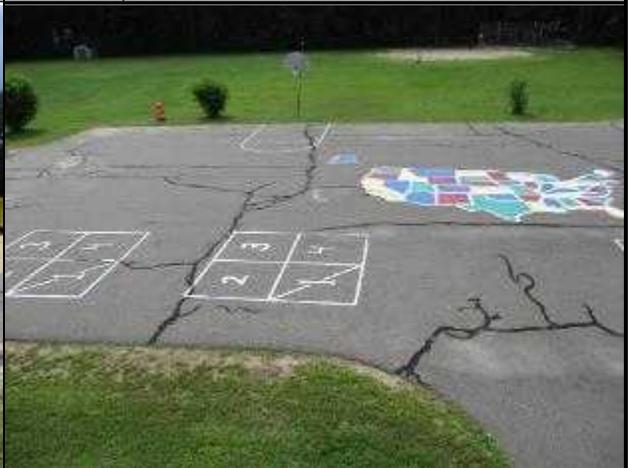
120. Sport court with cracking at Building 7

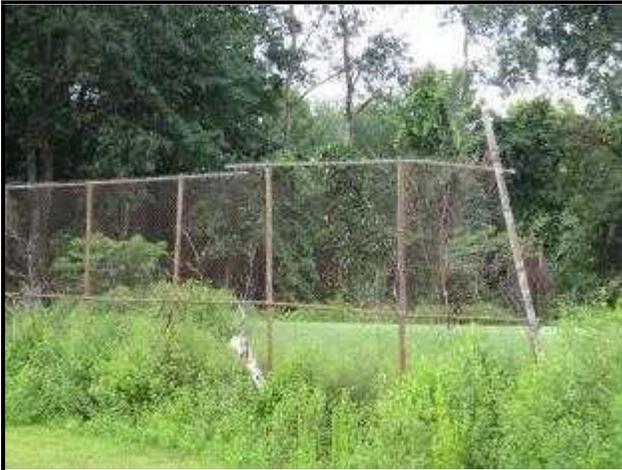
<p>145. Damaged fencing at south end of Building 8 parking lot</p>	<p>146. Representative cracked and settled pavement at Building 8 parking lot</p>

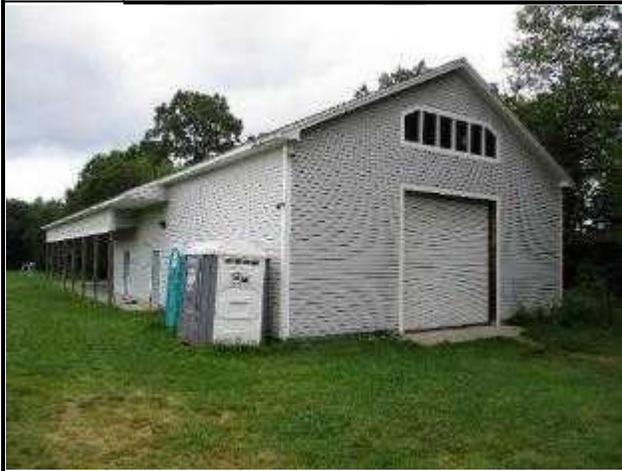
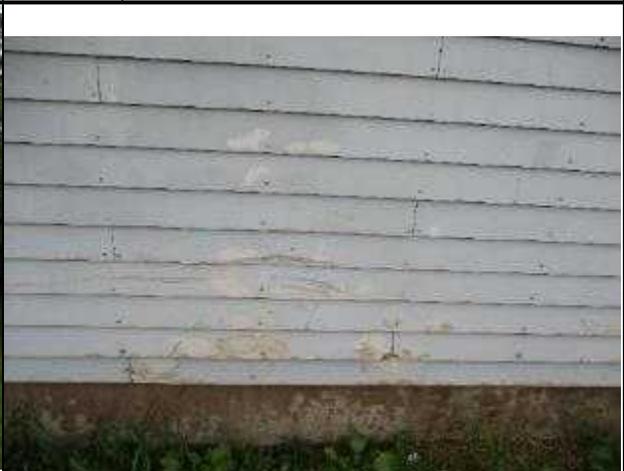
<p>149. Soccer pavilion at south side of Building 8 property</p>	<p>150. Representative paint peeling at Building 8 soccer pavilion facade</p>

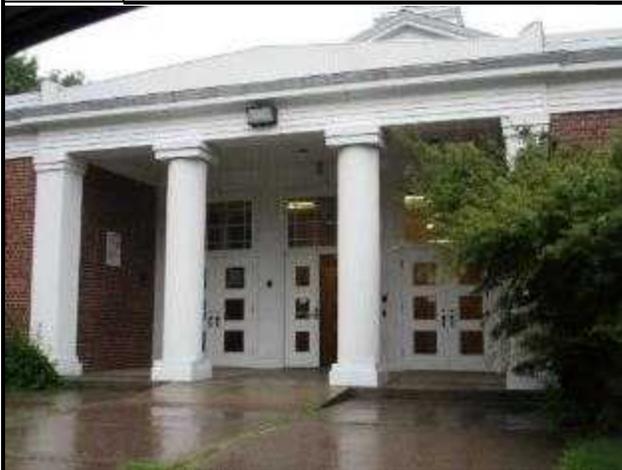
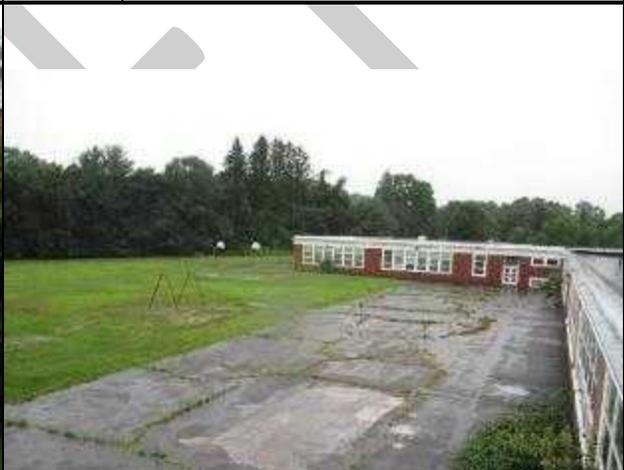
<p>177. Concrete sidewalk at main entrance of Building 9</p>	<p>178. Cracking and vegetation overgrowth throughout rear hardscape at Building 9</p>

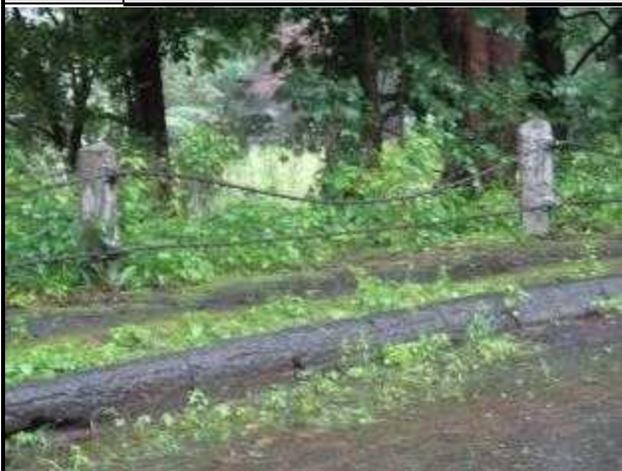
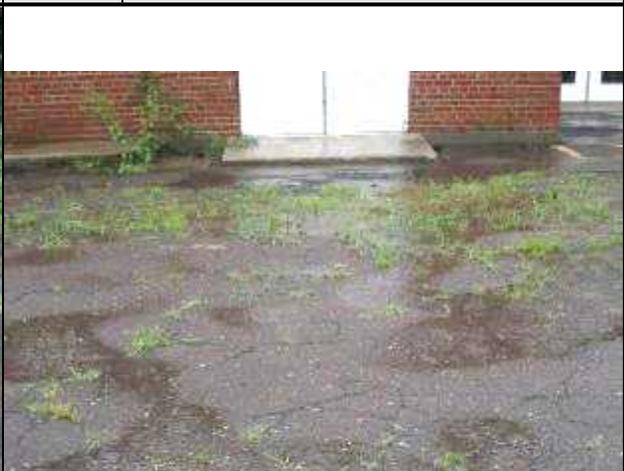
<p>179. Loose fence line, vegetation at sidewalk at Building 9</p>	<p>180. Representative cracking with vegetation overgrowth at Building 9 rear parking lot</p>

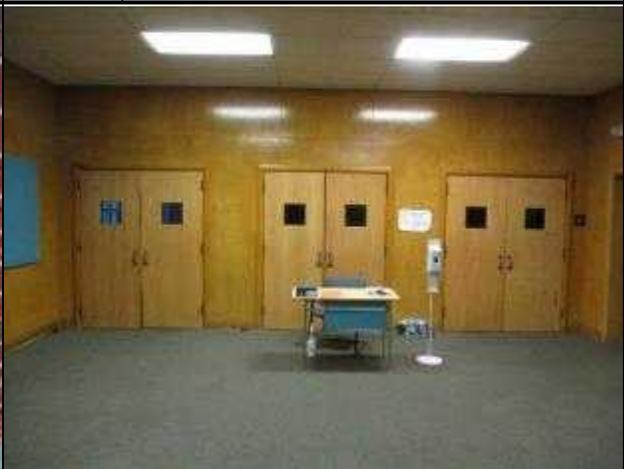
<p>191. Broken block window at south Building 9 auditorium wall</p>	<p>192. Lobby entrance area of Building 9</p>

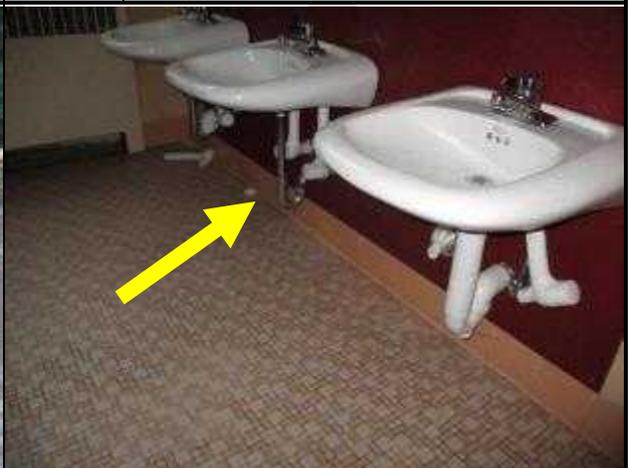
196. Sink pipe protection missing at Building 9

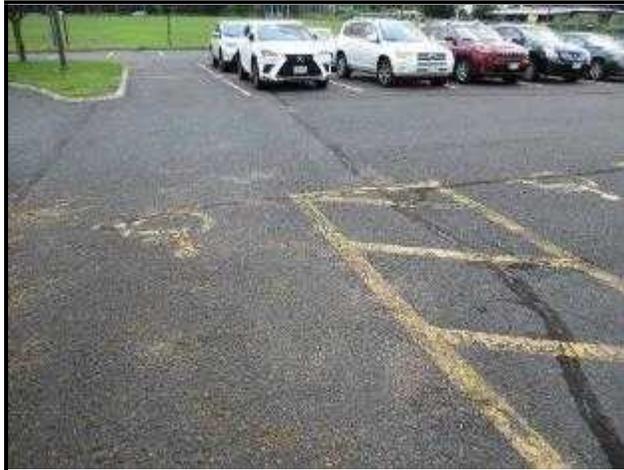
205. Representative parking lot with worn paint and cracking at Building 10

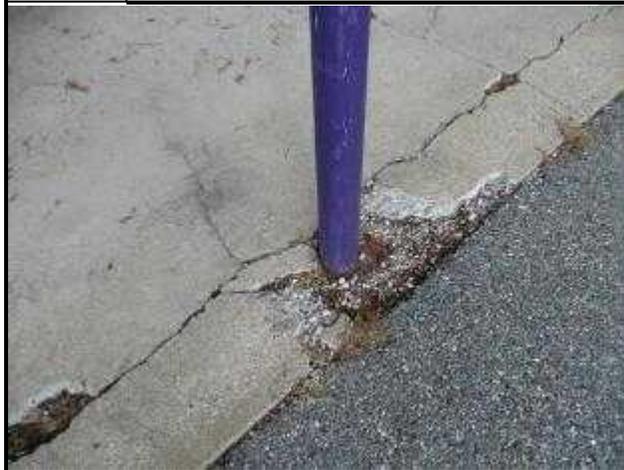
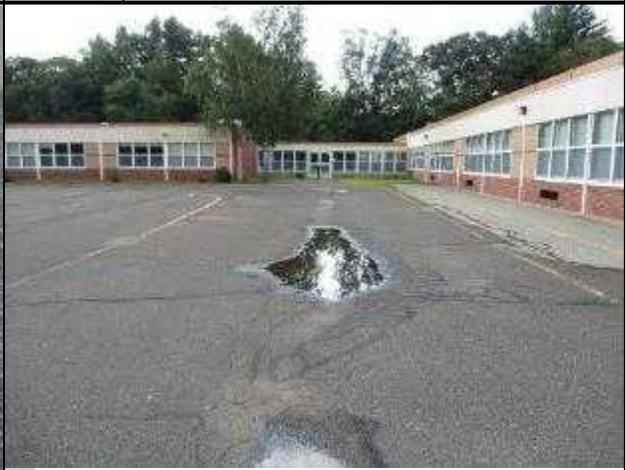
<p>219. Concrete spall and trip hazard at Building 11</p>	<p>220. Representative cracking and settlement in parking lot of Building 11</p>

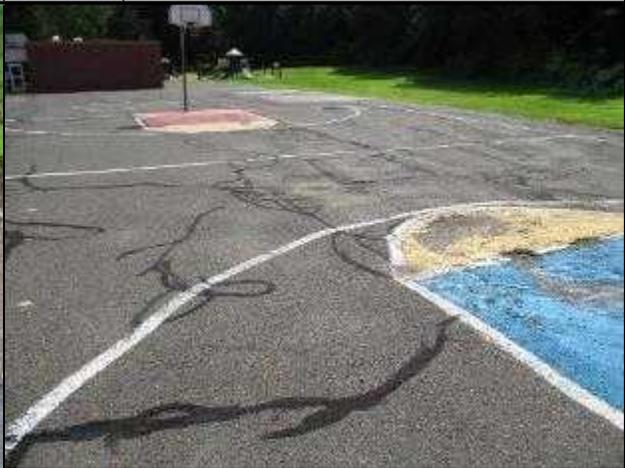
<p>221. Representative cracking and settlement in parking lot of Building 11</p>	<p>222. Representative cracking and settlement at Building 11 sport court</p>

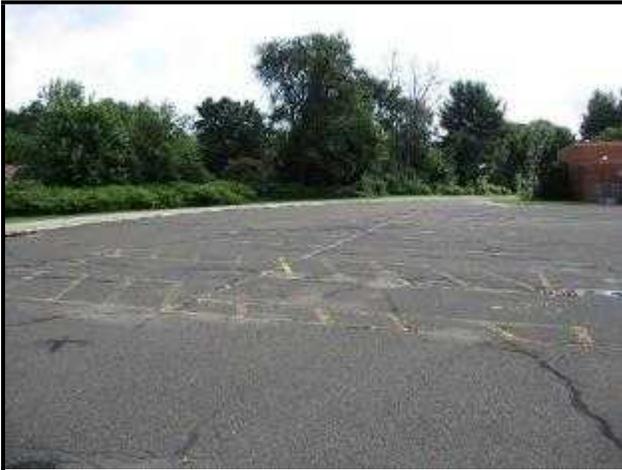
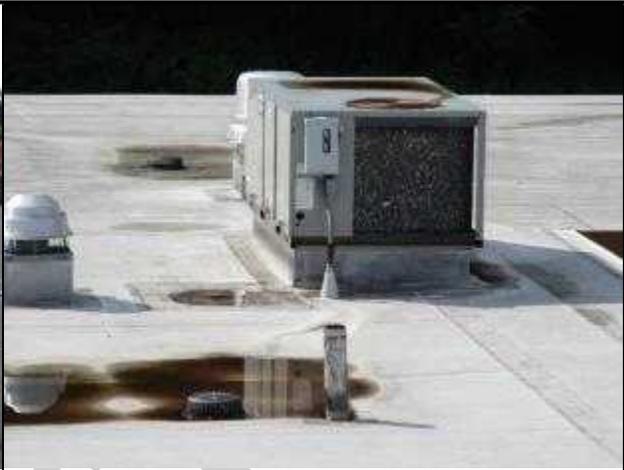
<p>229. Accessible parking with no signage at Building 11</p>	<p>230. RTU past expected useful life at Building 11</p>

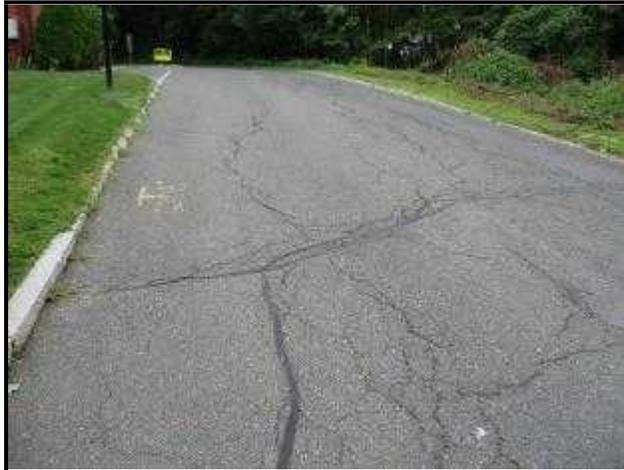
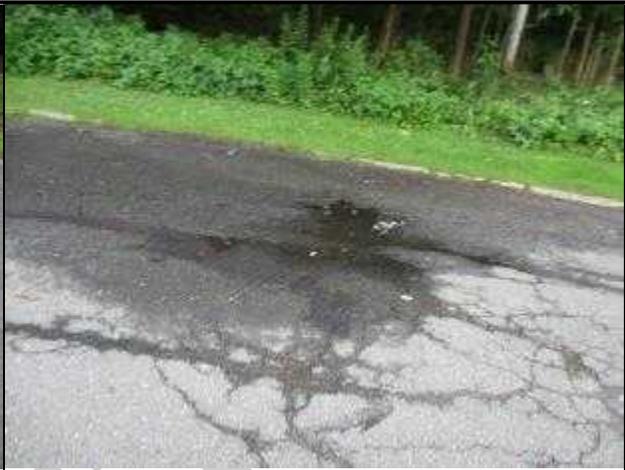
<p>235. Representative parking lot cracking at Building 12</p>	<p>236. Representative parking lot cracking at Building 12</p>

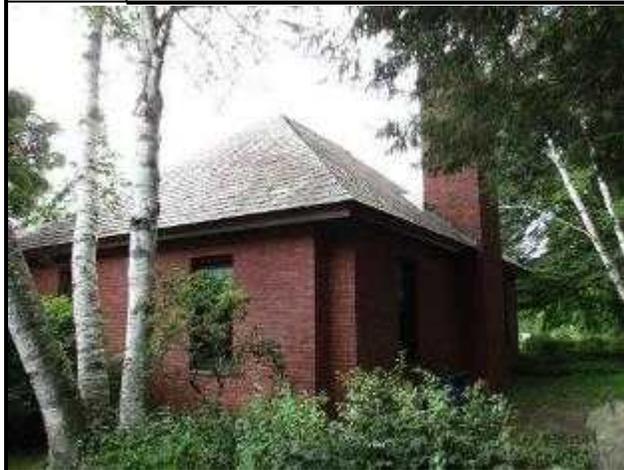
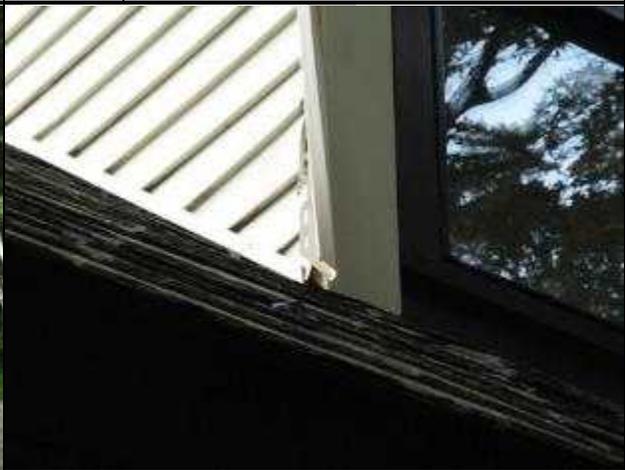
<p>237. Representative slate tile roof and façade of Building 12</p>	<p>238. Representative dislodged trim piece at Building 12 dormer</p>

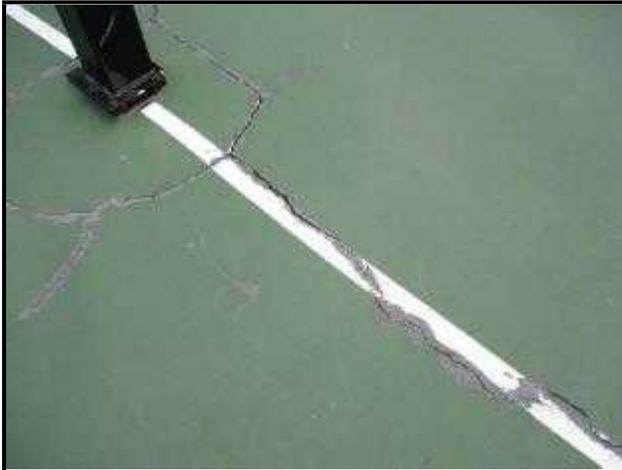
271. Representative cracking at Building 14

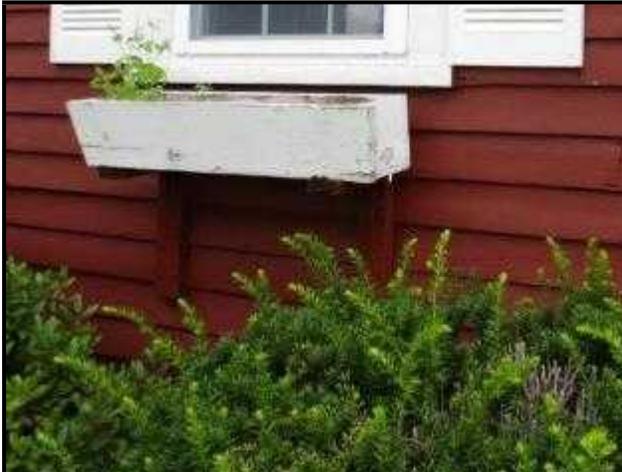
277. Worn and peeling paint at Building 15

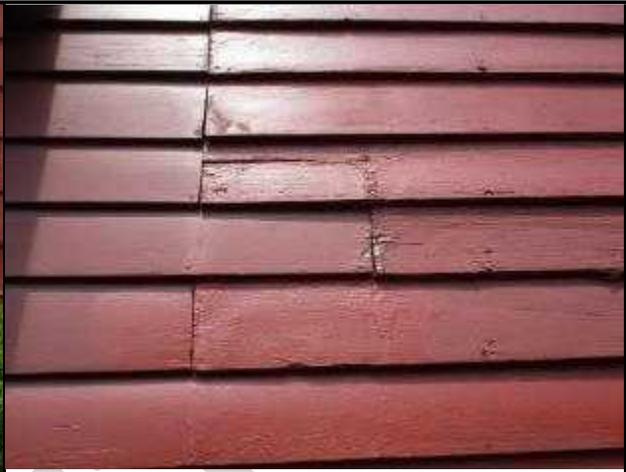
278. Worn and peeling paint at Building 15
