CAPITAL NEEDS ASSESSMENT

Town of Wilbraham Portfolio

**Various Addresses
(17 Scattered Properties)
Wilbraham MA 01095**

EBI Project No. 1321000388

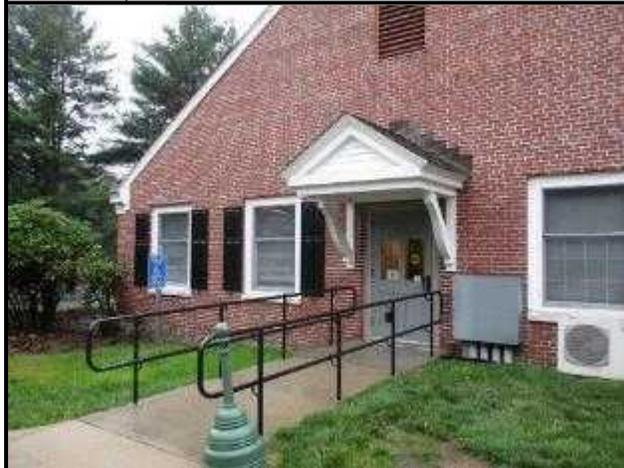
10. Worn and dislodged sealant at window of Building 1

4.3	Windows and Doors	Renew/recaulk windows and doors	1,100	\$3.65	25.0%	\$4.56	linear foot		\$5,017.25	Worn and dislodged sealant, typical	
5.0 BUILDING INTERIORS											
		None Recommended.

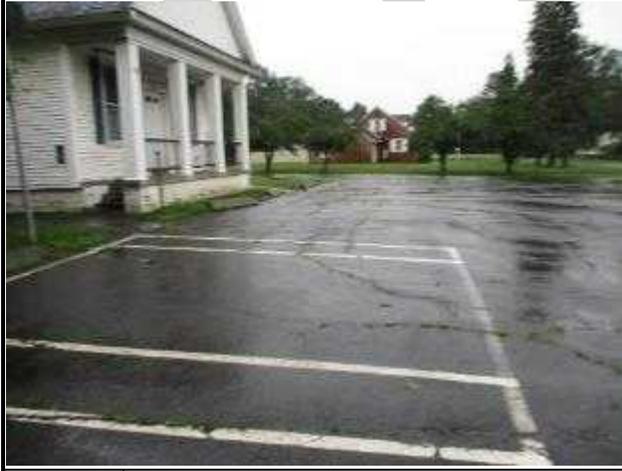
<p>75. Representative landscaping and front asphalt driveway at Building 5</p>	<p>76. Representative pavement cracking and settlement at Building 5</p>

2.0 SITE CONDITIONS										
2.1	Site Features	None								
2.2	Landscaping / Improvements	None								
2.3	Pavement/ Parking	Patching, crack sealing, sealing and striping of asphalt pavement	7,560	\$0.22	25.0%	\$0.27	square foot		\$2,067.85	Pavement is cracked and settled with worn striping throughout

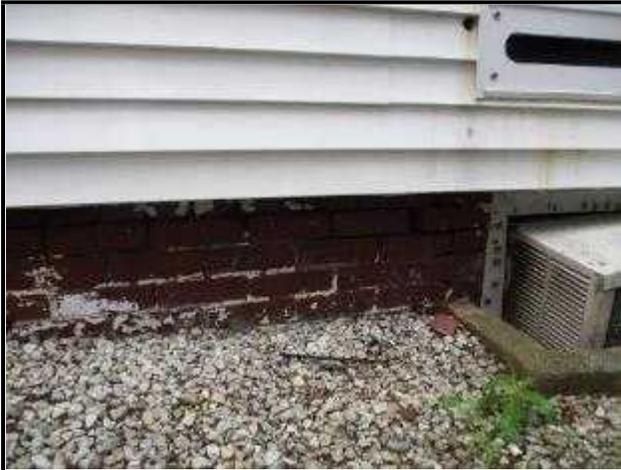
<p>77. Representative pavement cracking and worn striping at Building 5</p>	<p>78. Representative brick foundation with deteriorated mortar joints, on north side of Building 5</p>

2.4	Amenities	None								
2.5	Utilities	None								
3.0 STRUCTURE										
3.1	Substructure	Repointing/Sealing brick foundation	1	\$4,000.00	25.0%	\$5,000.00	allowance	\$5,000.00		Planned capex per town. Cost provided by town. Water observed in basement at area of cracked foundation.

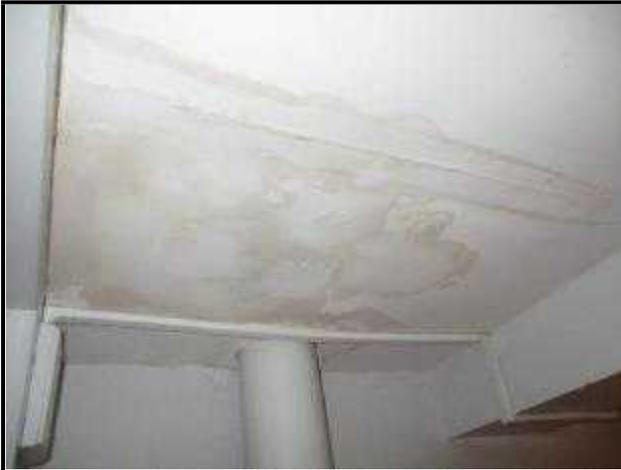
85. Representative water stained ceiling in Building 5 basement	86. Representative office at Building 5

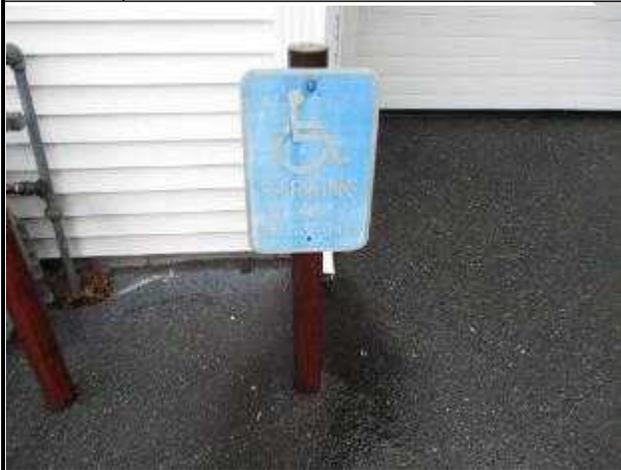
87. Non-compliant accessible parking sign < 60" height from grade at Building 5	88. Water heater at Building 5 basement

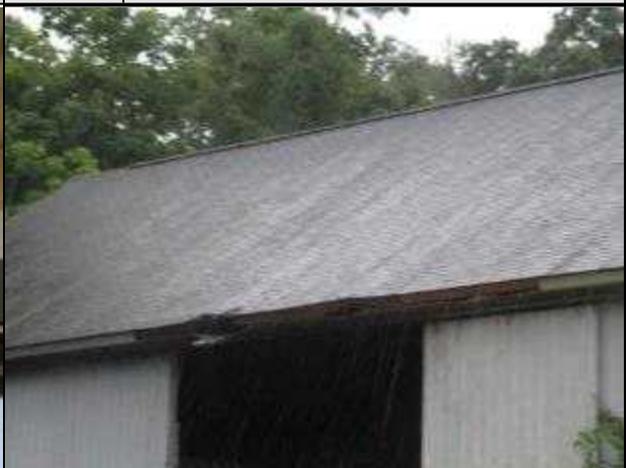
102. Worn roof at Building 6 outbuilding

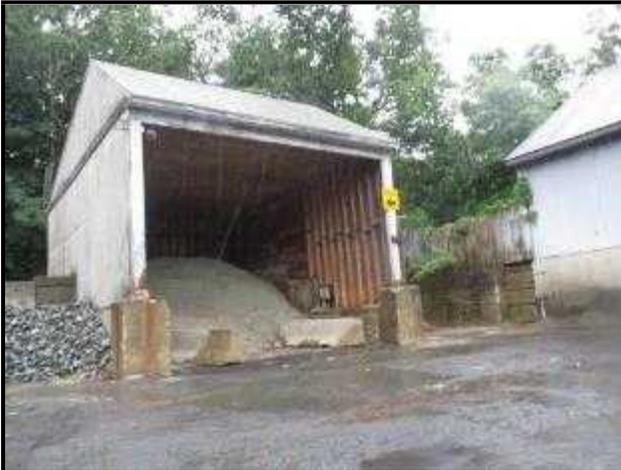
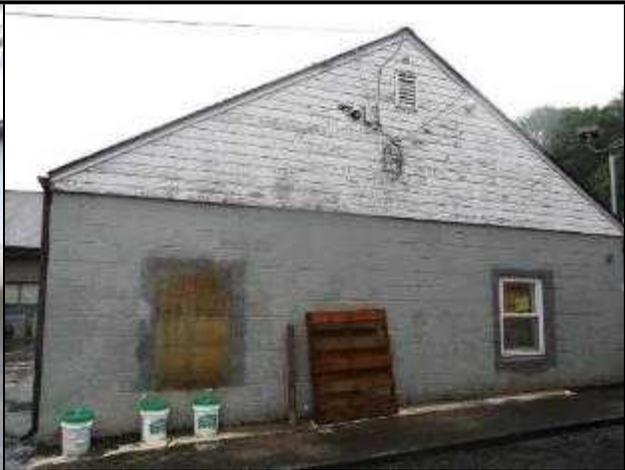
103. Worn roof at Building 6 outbuilding	104. Rear façade with worn paint at Building 6

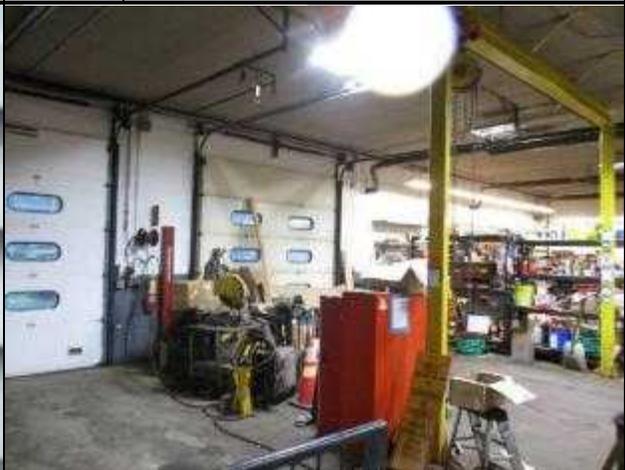
105. Representative worn and cracked window sealant at Building 6	106. Representative garage interior at Building 6

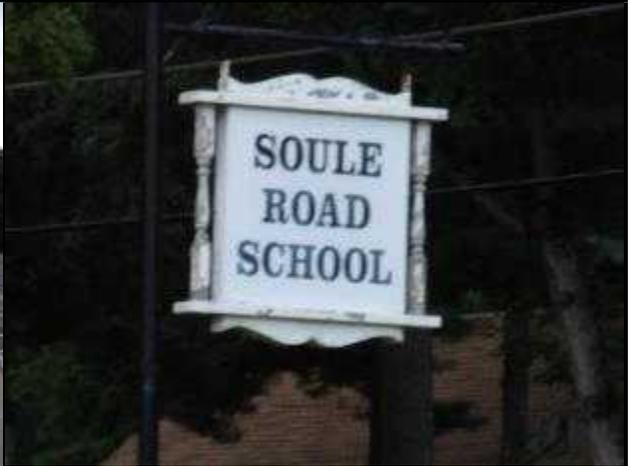
116. Worn signage with peeling paint at Building 7

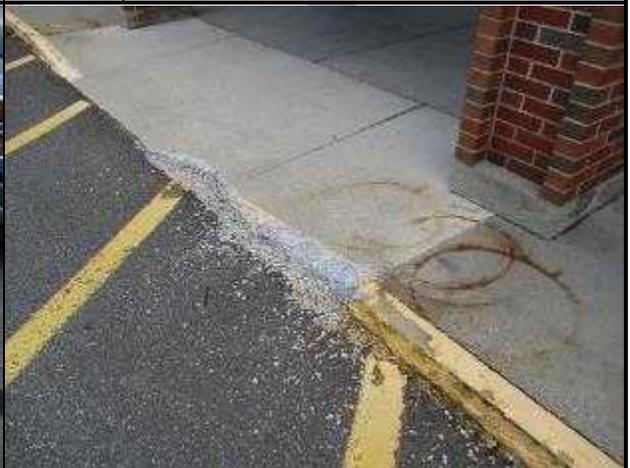
118. Trip hazard at Building 7 front entrance

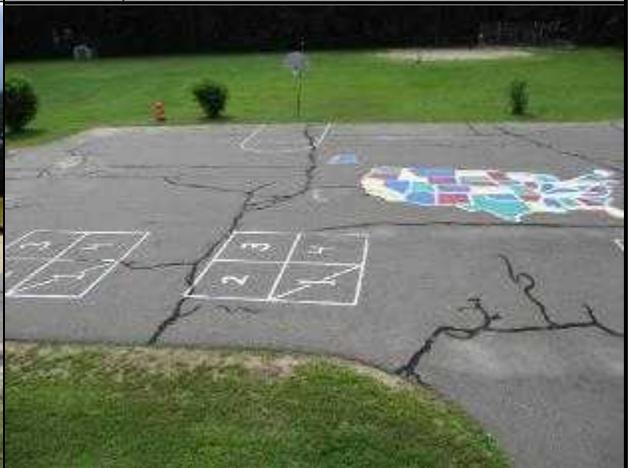
120. Sport court with cracking at Building 7

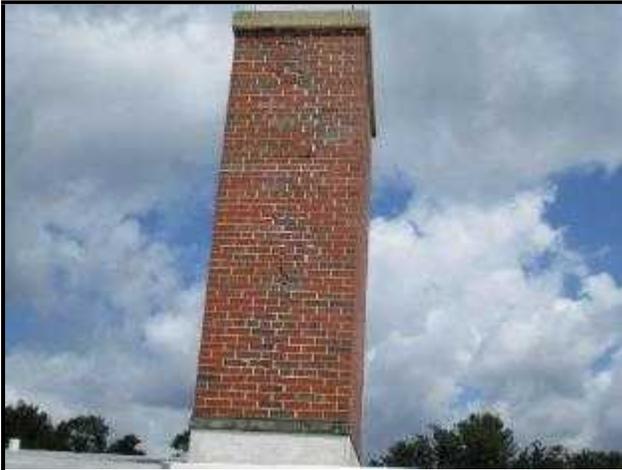
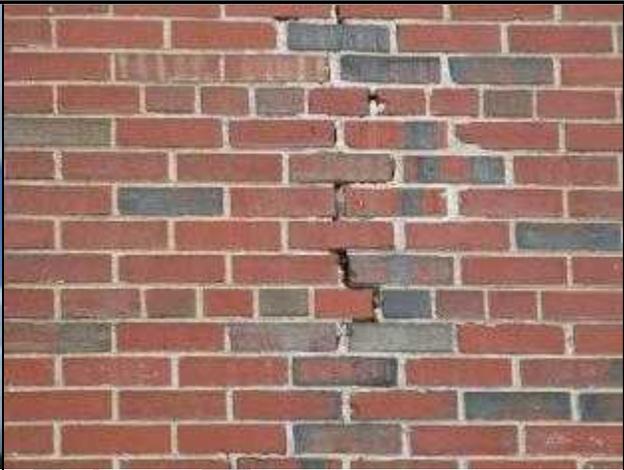
127. Brick chimney with cracking at Building 7	128. Brick chimney with cracking at Building 7

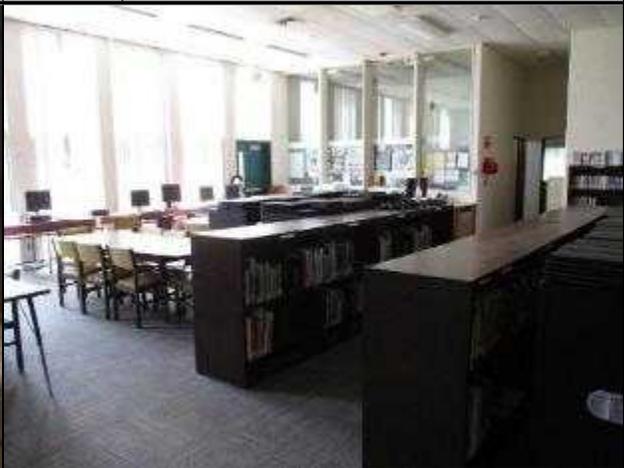
131. Deteriorated window sealant at Building 7	132. Library at Building 7

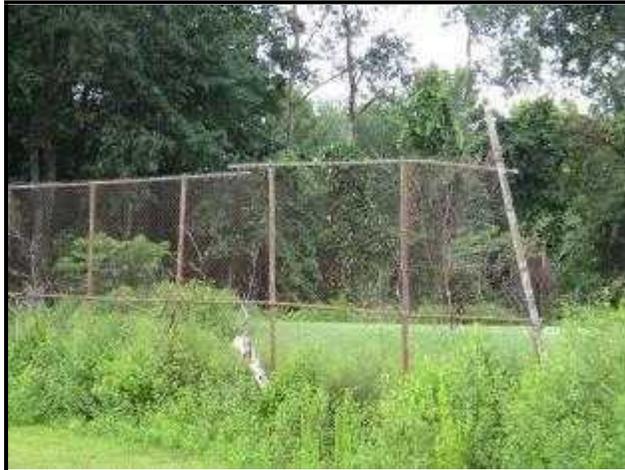
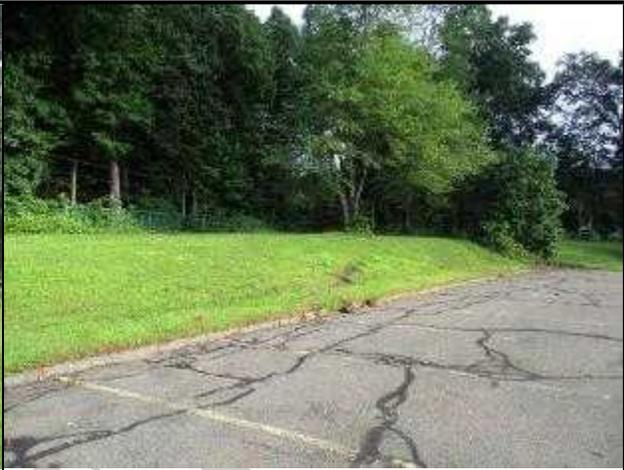
<p>145. Damaged fencing at south end of Building 8 parking lot</p>	<p>146. Representative cracked and settled pavement at Building 8 parking lot</p>

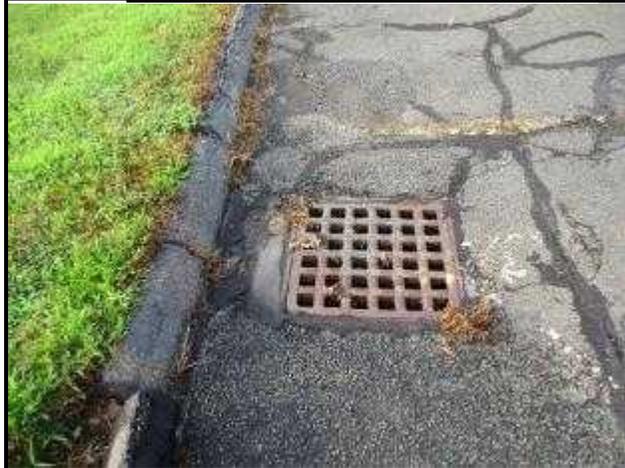
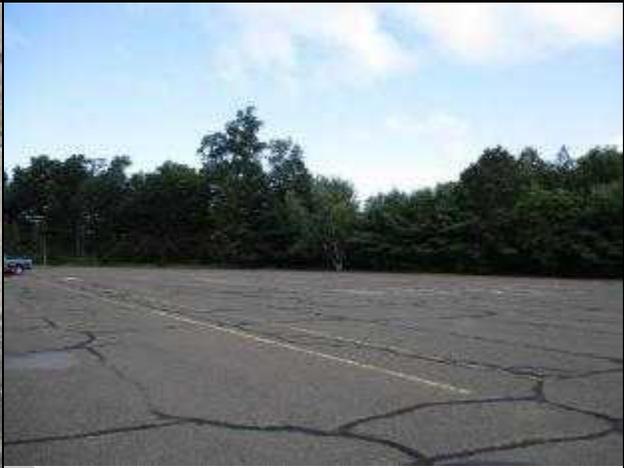
<p>147. Representative cracked and settled pavement with worn curbing at Building 8 parking lot</p>	<p>148. Cracked pavement at sport court, north of Building 8</p>

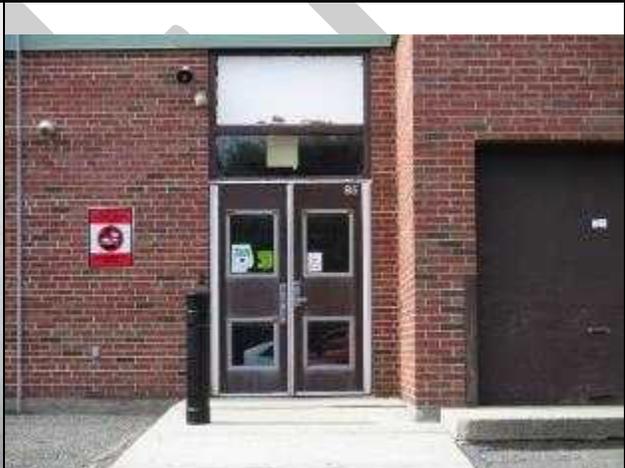
160. Worn and rusted door on north side of Building 8

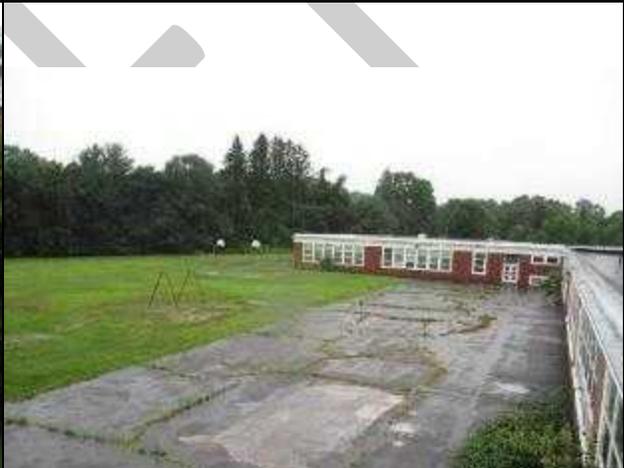
<p>177. Concrete sidewalk at main entrance of Building 9</p>	<p>178. Cracking and vegetation overgrowth throughout rear hardscape at Building 9</p>

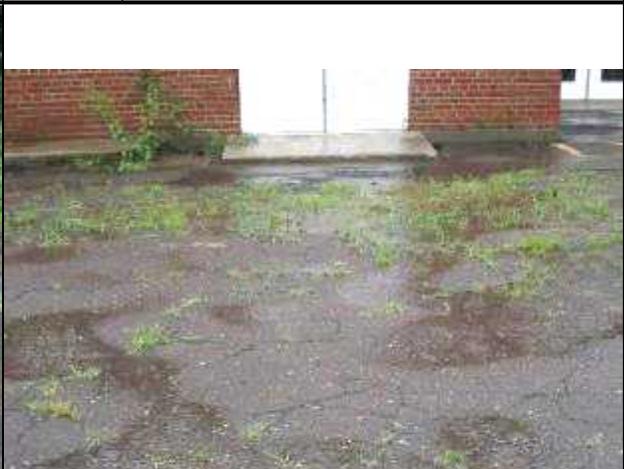
<p>179. Loose fence line, vegetation at sidewalk at Building 9</p>	<p>180. Representative cracking with vegetation overgrowth at Building 9 rear parking lot</p>

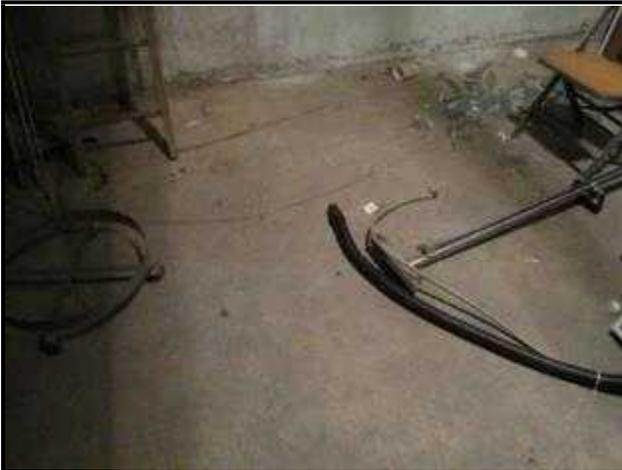
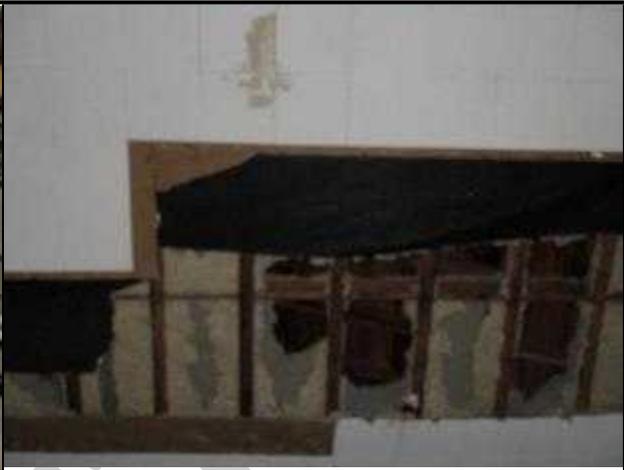
181. Representative concrete floor slab at Building 9	182. Wood roof joists and ceiling damage in auditorium at Building 9

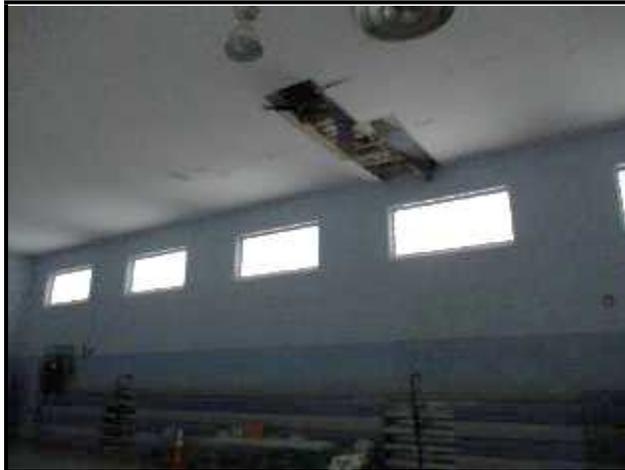
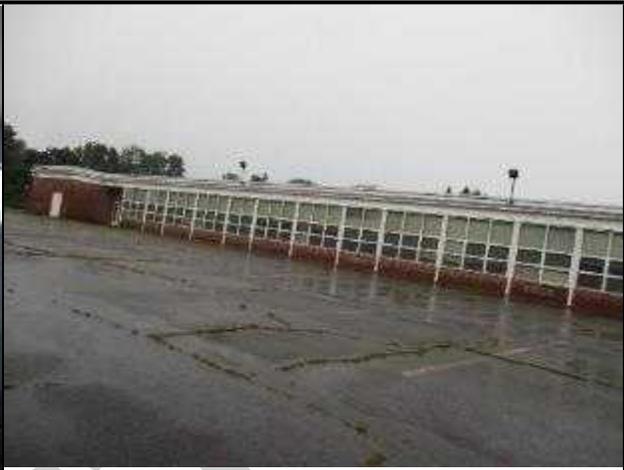
<p>187. Active roof leaks and water infiltration at auditorium of Building 9</p>	<p>188. Representative rear, east, façade of Building 9</p>

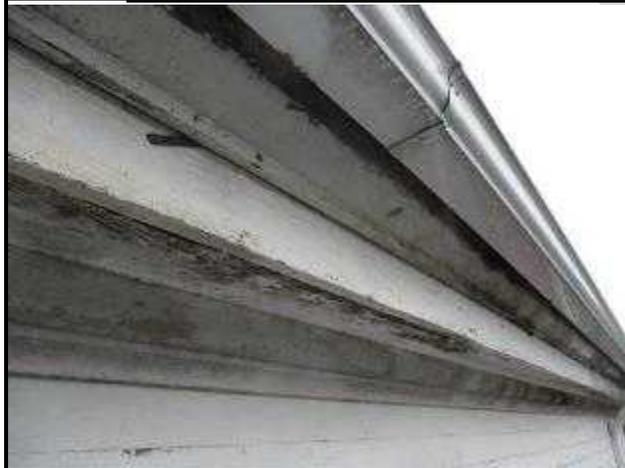
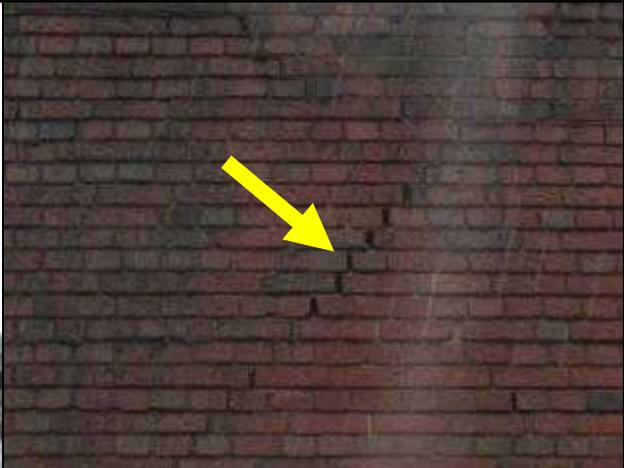
<p>189. Worn and chipped paint throughout wood siding, fascias and soffits of Building 9</p>	<p>190. Significant step cracking at Building 9 chimney</p>

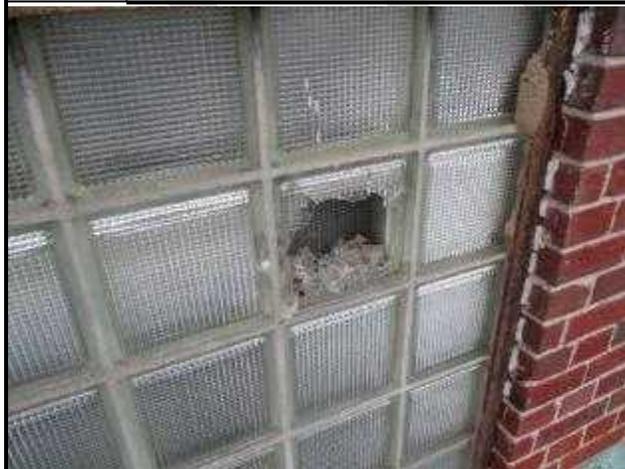
<p>191. Broken block window at south Building 9 auditorium wall</p>	<p>192. Lobby entrance area of Building 9</p>

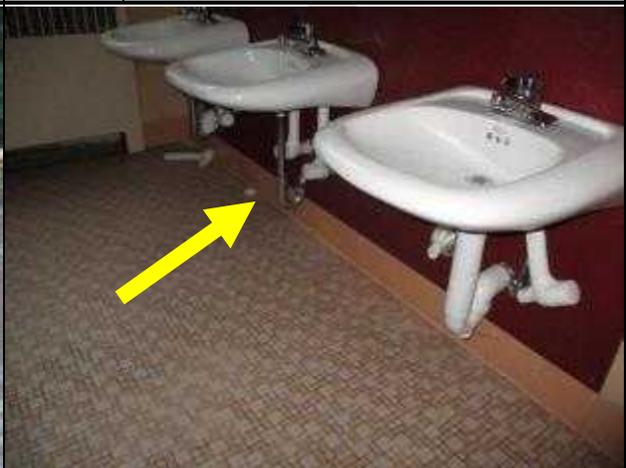
196. Sink pipe protection missing at Building 9

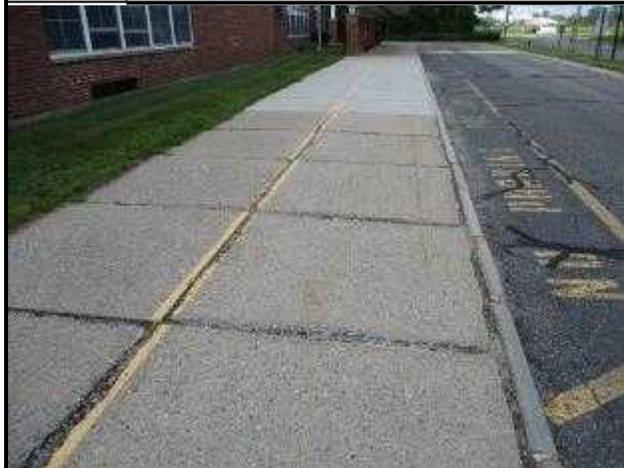
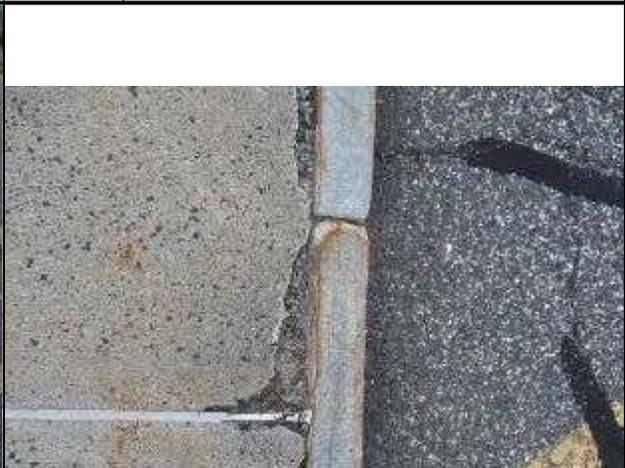
<p>203. Representative front sidewalk with edge spalling throughout at Building 10</p>	<p>204. Representative trip hazard at Building 10</p>

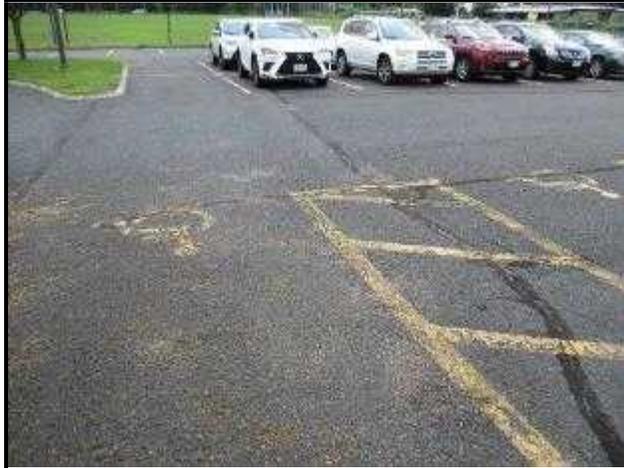
205. Representative parking lot with worn paint and cracking at Building 10

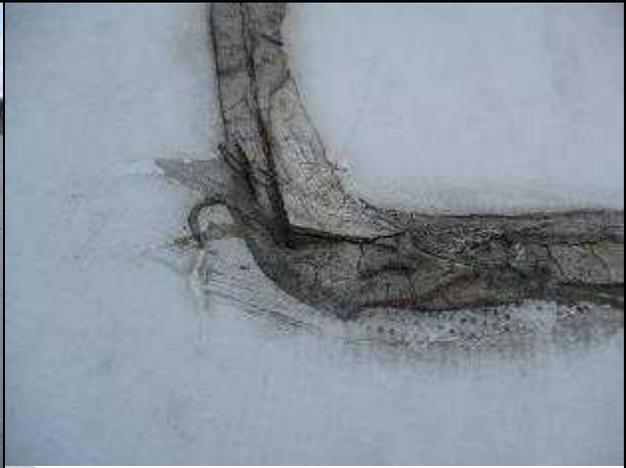
208. Representative worn roof patch/sealant at Building 10

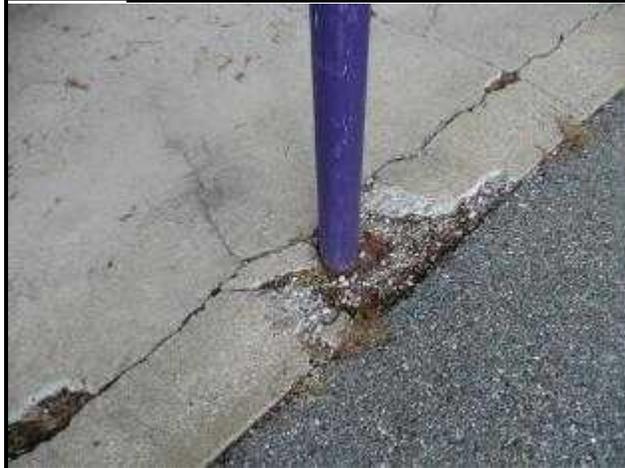
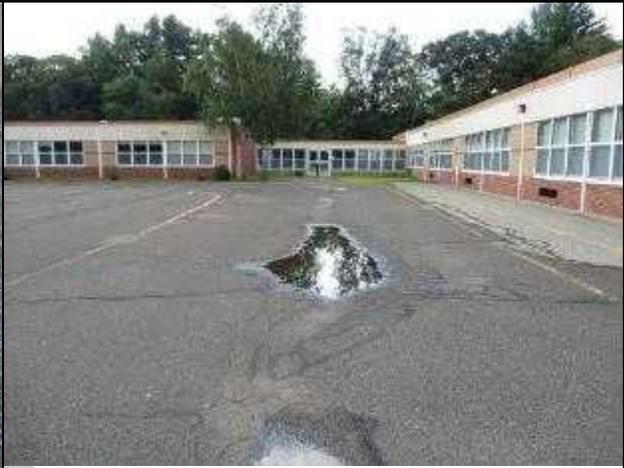
<p>219. Concrete spall and trip hazard at Building 11</p>	<p>220. Representative cracking and settlement in parking lot of Building 11</p>

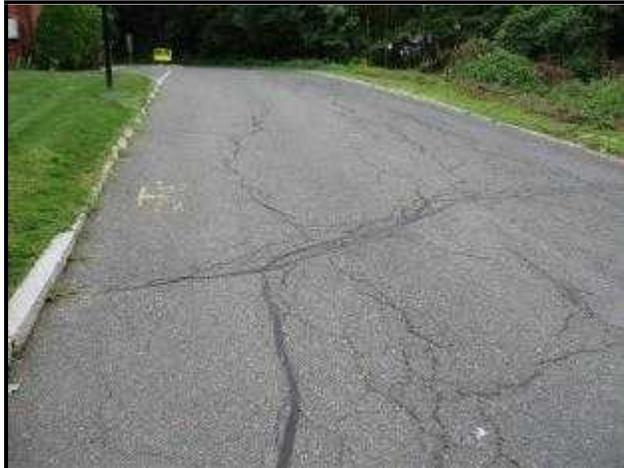
235. Representative parking lot cracking at Building 12

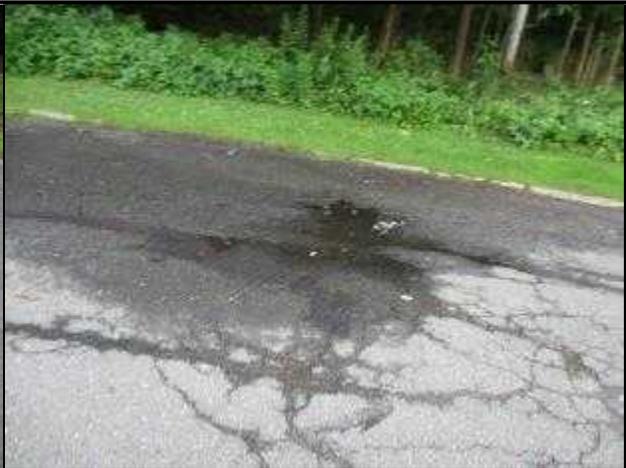
236. Representative parking lot cracking at Building 12

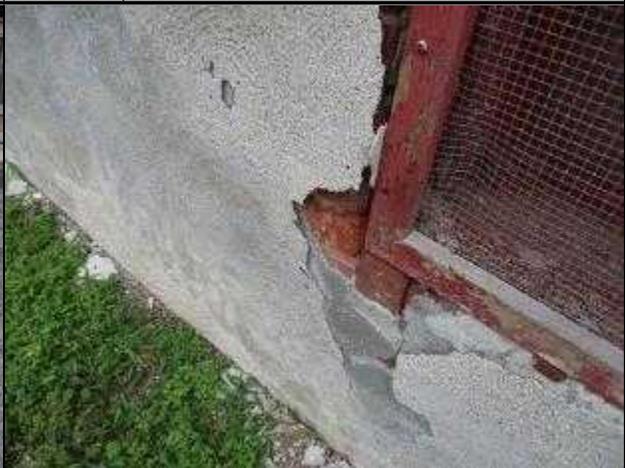
<p>251. Spalling at basement foundation at Building 13</p>	<p>252. Spalling and delamination of wall at Building 13 foundation</p>

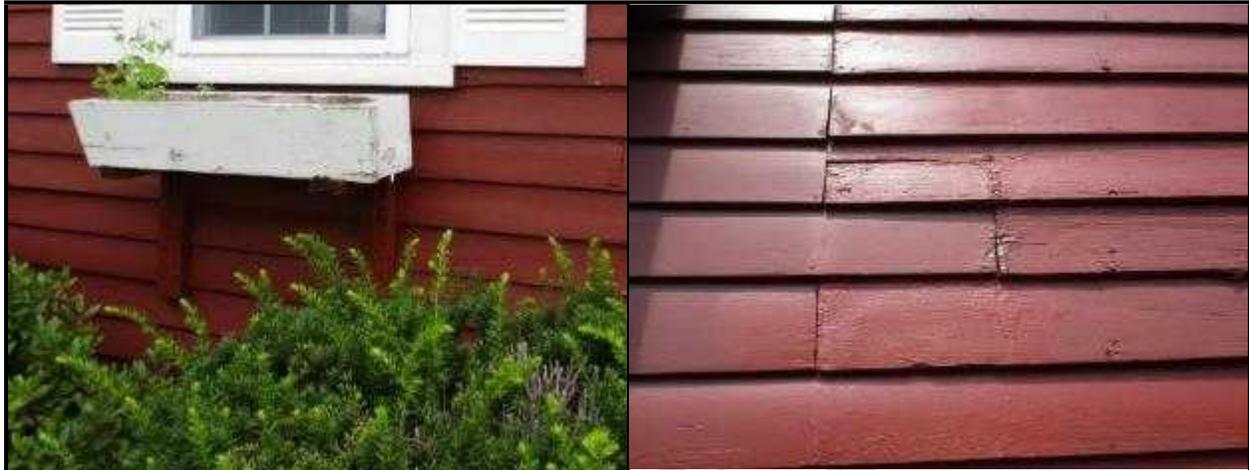
277. Worn and peeling paint at Building 15

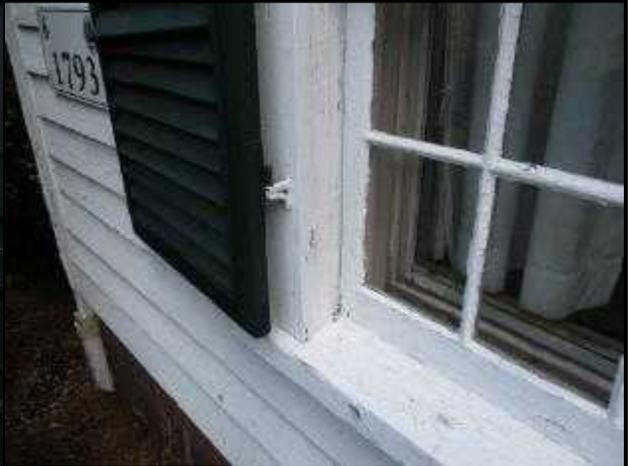
288. Worn and peeling paint at Building 16

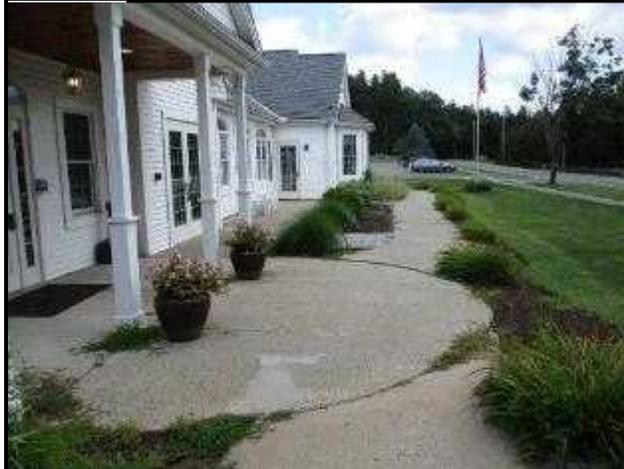
299. Concrete sidewalk with cracking and trip hazards at Building 17

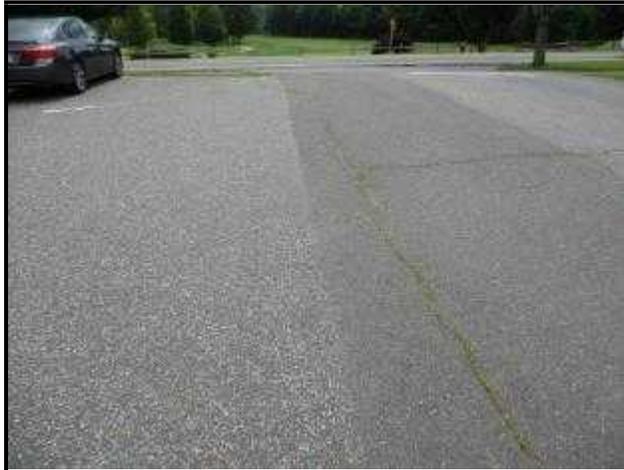
301. Representative parking lot with cracking and worn striping at Building 17

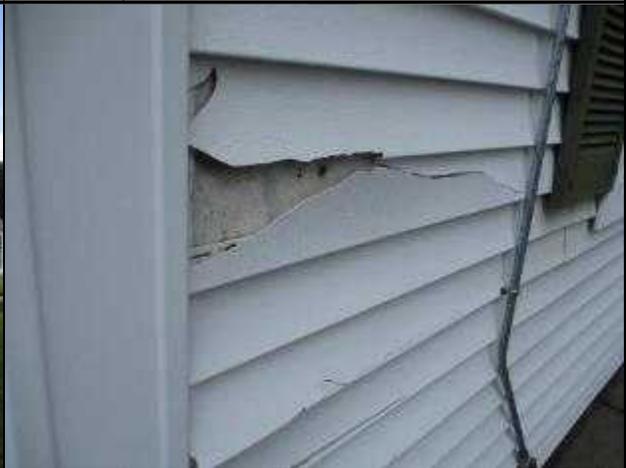
304. Damaged trim at front of Building 17 Clubhouse
