CAPITAL NEEDS ASSESSMENT

Town of Wilbraham Portfolio

**Various Addresses
(17 Scattered Properties)
Wilbraham MA 01095**

EBI Project No. 1321000388

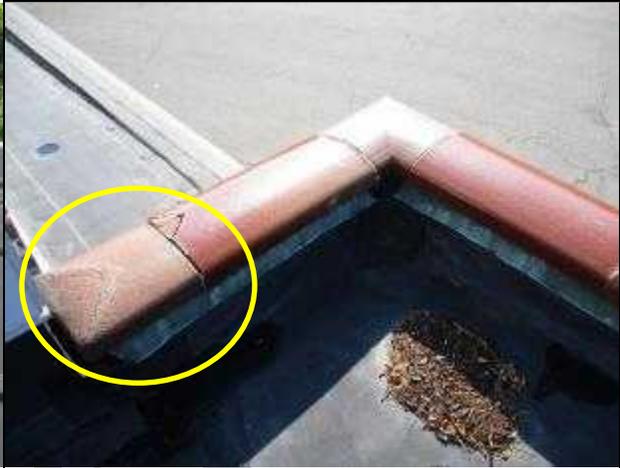
4.1	Roof	Repair coping tiles	1	\$1,000.00	25.0%	\$1,250.00	allowance	\$1,250.00		Cracked coping tiles along front parapet
4.2	Facades	Repair composite siding	1	\$10,000.00	25.0%	\$12,500.00	allowance	\$12,500.00		Cracked siding throughout, primarily at anchor screws

26. Coping stone cracks at Building 2

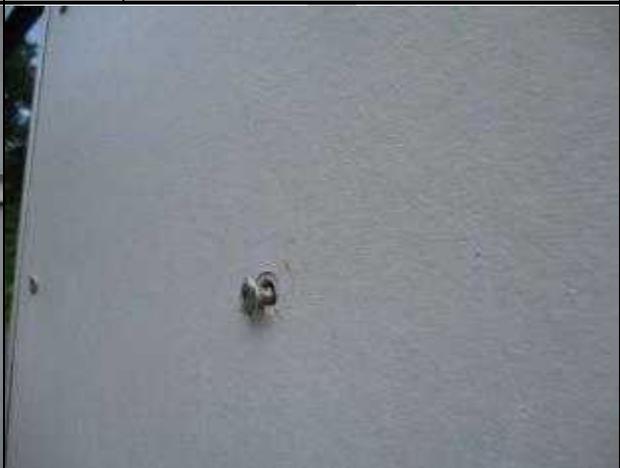
28. Loose screw at composite siding at west wall of Building 2

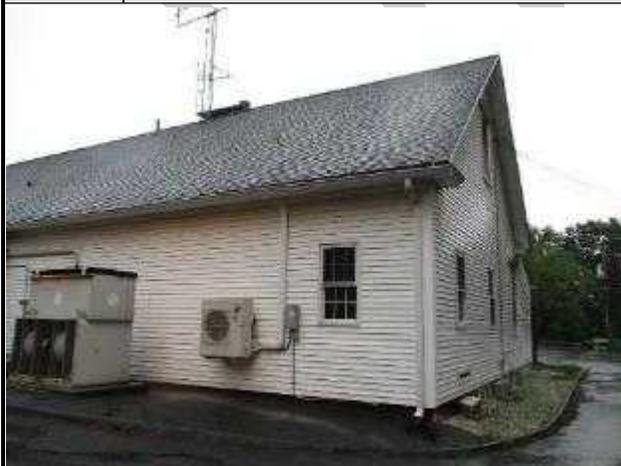
83. North and rear façade of Building 5	84. Representative single pane window with storm window at Building 5

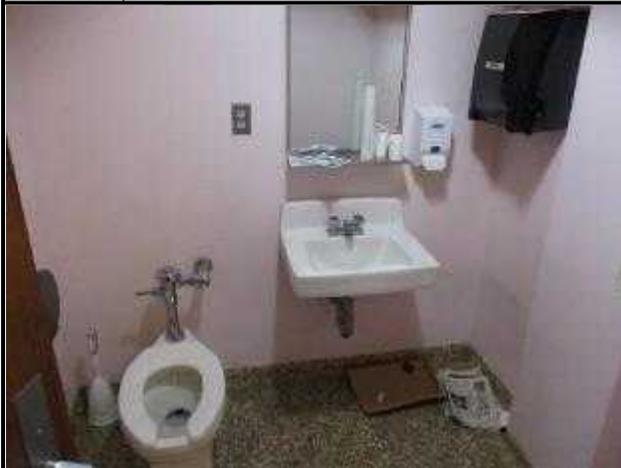
89. Representative rest room in Building 5	90. Boiler in basement of Building 5

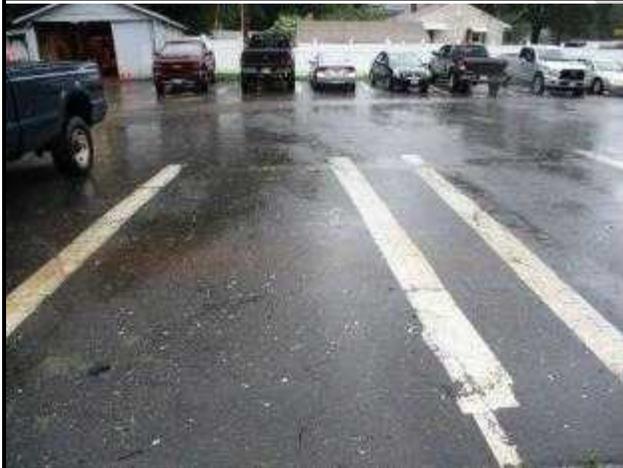
99. Representative pavement cracking at west side of Building 6	100. New garage/storage building mid-construction at Building 6

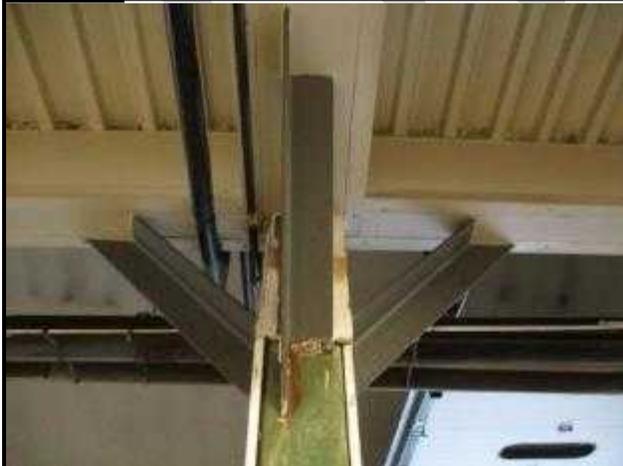
101. Representative steel framing in Building 6	102. Worn roof at Building 6 outbuilding

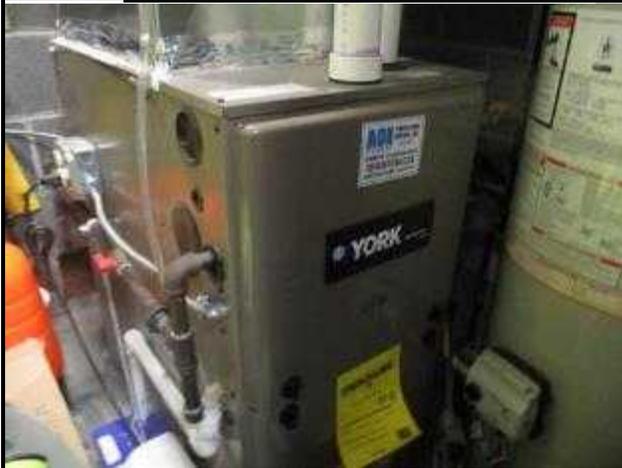
111.	New furnace in Building 6	112.	Stored materials blocking front of main electrical switch in Building 6

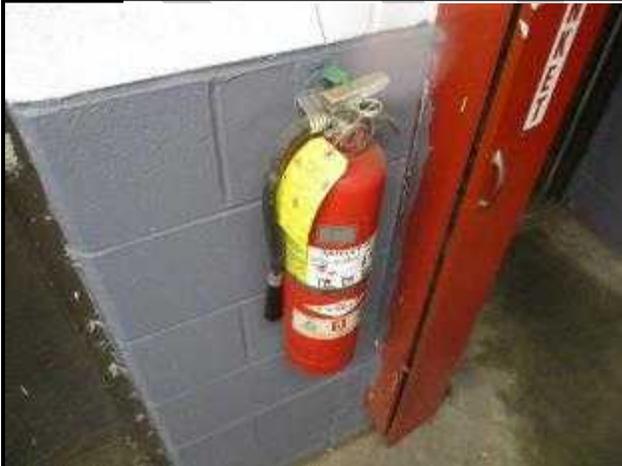
113.	Representative fire extinguisher in Building 6	114.	Fire alarm control panel at Building 6

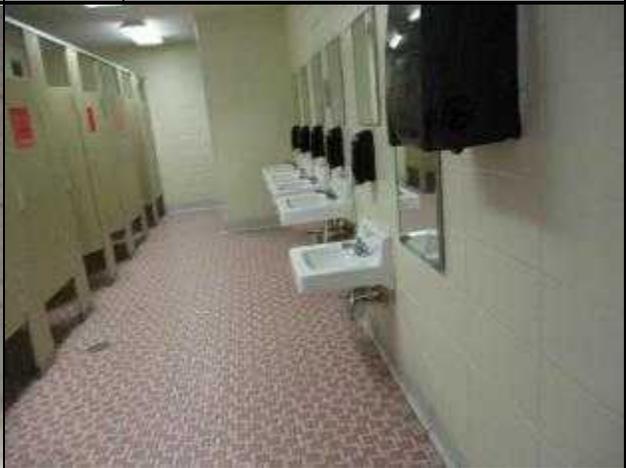
136. Representative restrooms at Building 7

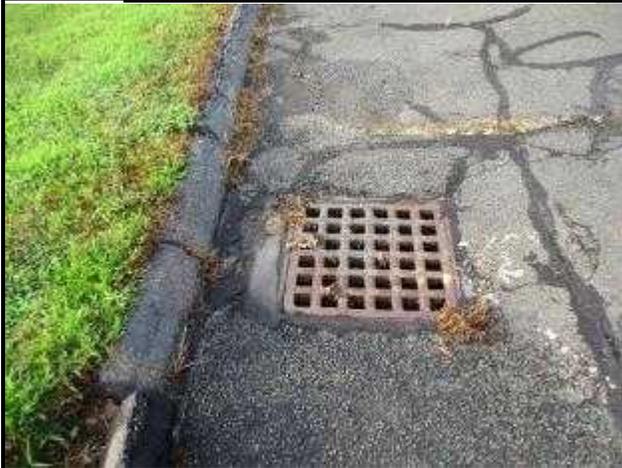
<p>147. Representative cracked and settled pavement with worn curbing at Building 8 parking lot</p>	<p>148. Cracked pavement at sport court, north of Building 8</p>

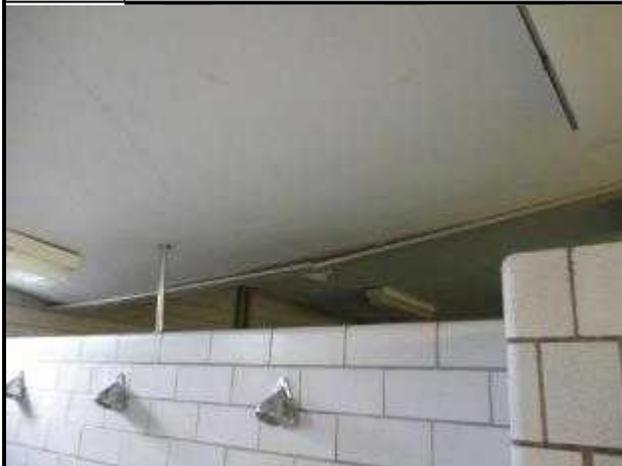
168. Dislodged ceiling in Building 8 locker room

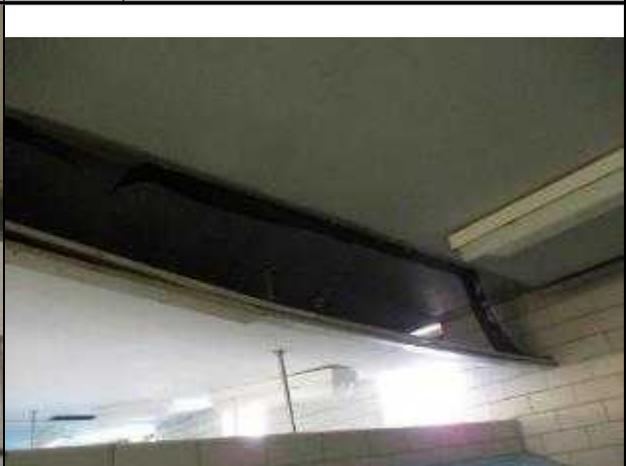
169. Dislodged ceiling in Building 8 locker room

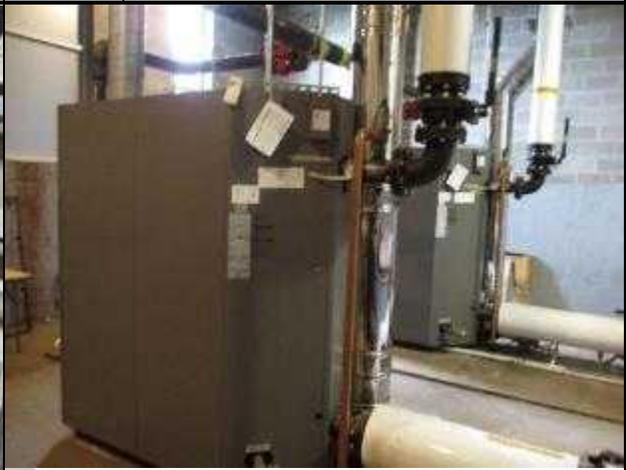
173. Storage and debris within 36" of and blocking electrical equipment

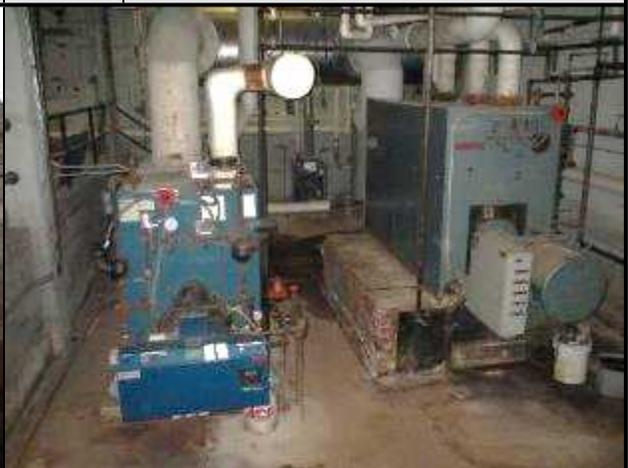
198. Boilers in Building 9 basement

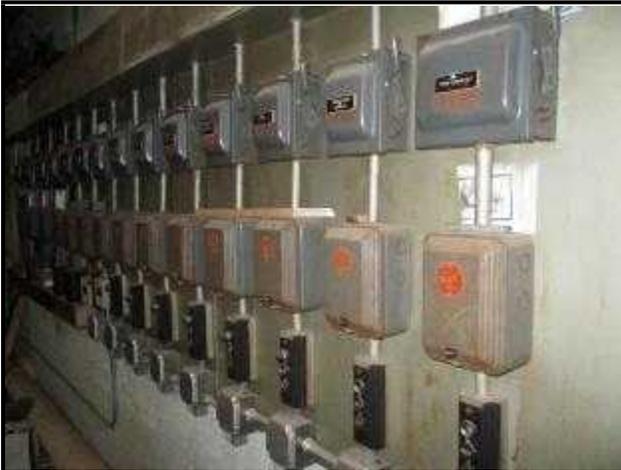
<p>199. Decommissioned <i>FPE</i> equipment in Building 9 basement</p>	<p>200. Fire alarm control panel with no known inspection information in Building 9</p>

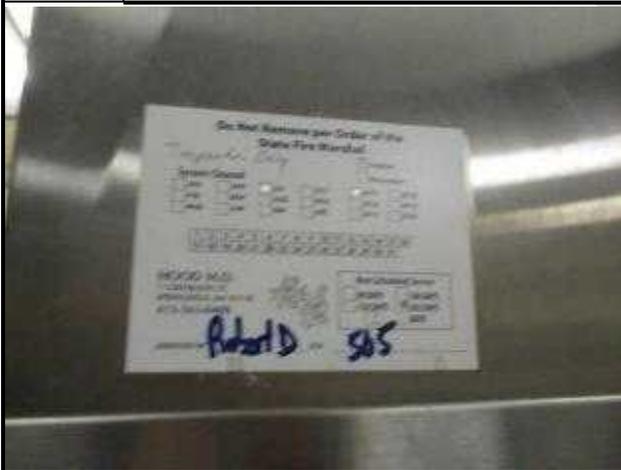
<p>201. Expired inspection tag on kitchen hood in Building 9</p>	<p>202. Entrance at Building 10</p>

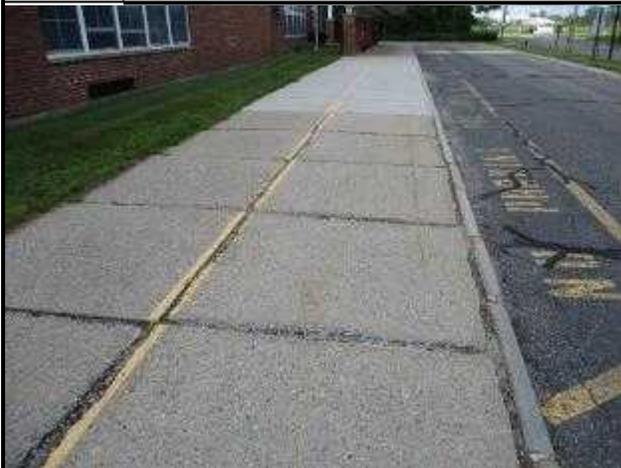
<p>203. Representative front sidewalk with edge spalling throughout at Building 10</p>	<p>204. Representative trip hazard at Building 10</p>

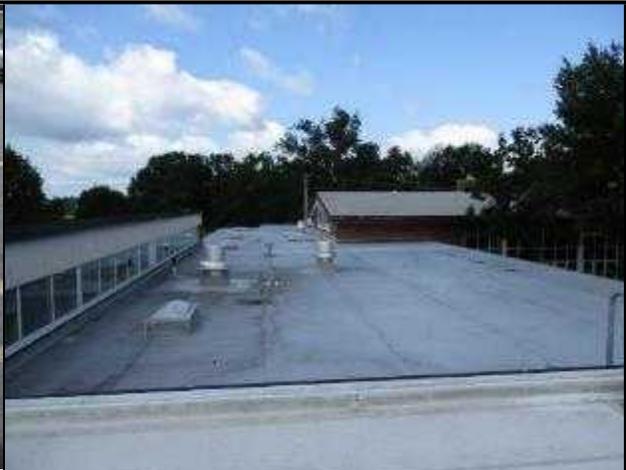
206. Representative roof at Building 10

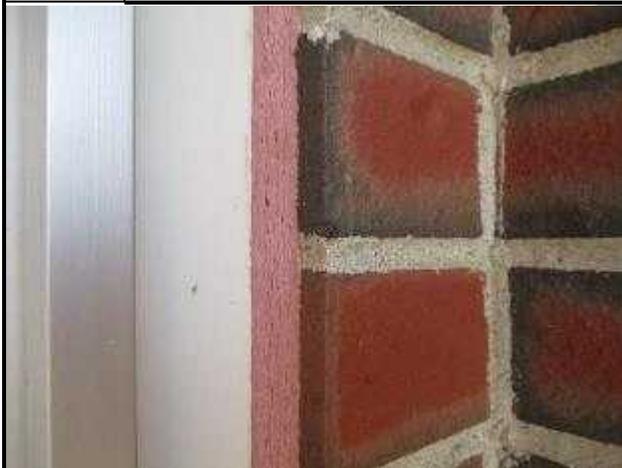
213. Building 11 front entry door jamb detail

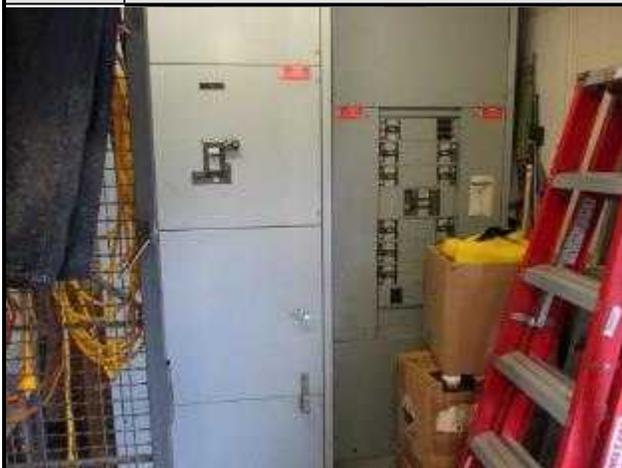
215. Stored equipment within 36" of and blocking electrical equipment

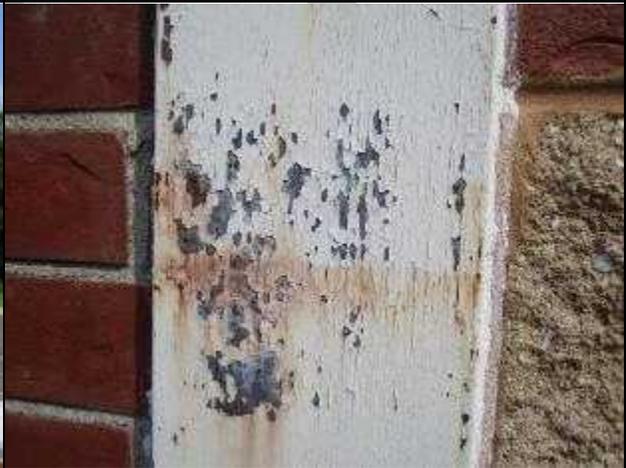
226. Representative paint peeling at Building 11 façade

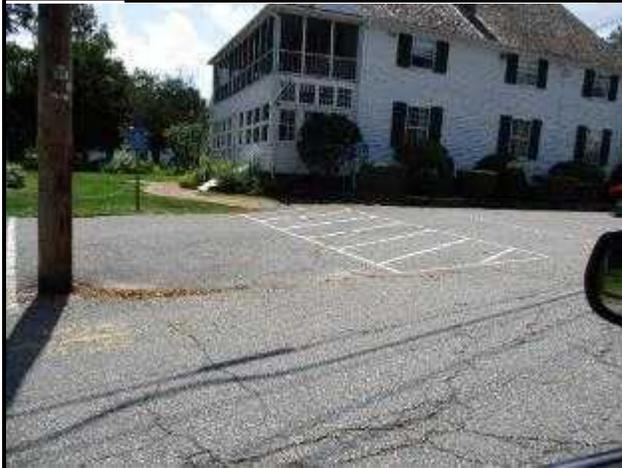
285. Representative cracking asphalt at Building 16 parking

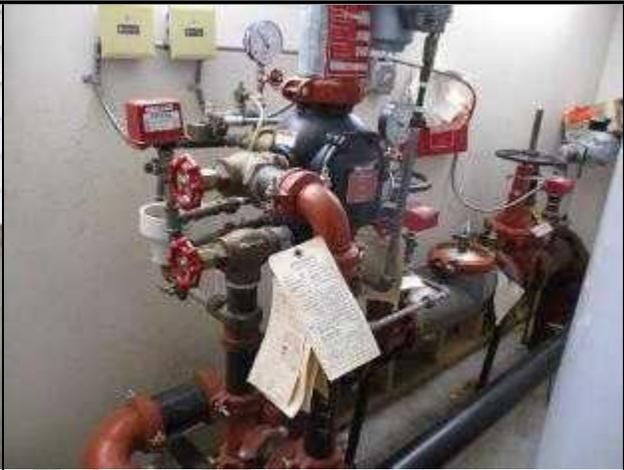
A photograph of a complex fire sprinkler system installed indoors. The system features a network of red pipes, valves, and a central control unit with various gauges and components. A white tag is attached to the system.
307. Typical condensers at Building 17	308. Fire sprinkler system at Building 17
