CAPITAL NEEDS ASSESSMENT

Town of Wilbraham Portfolio

**Various Addresses
(17 Scattered Properties)
Wilbraham MA 01095**

EBI Project No. 1321000388

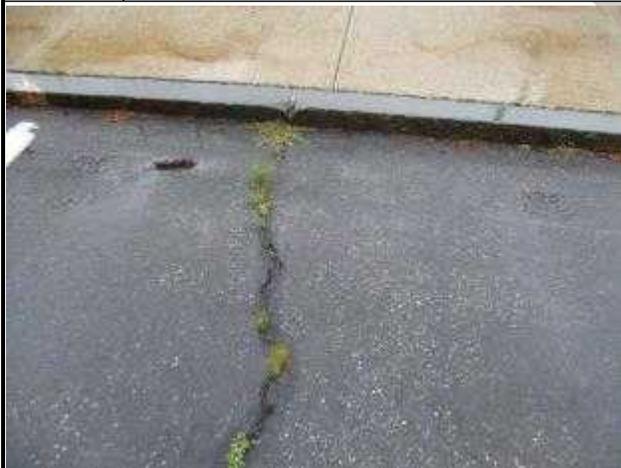
2.0 SITE CONDITIONS											
2.1	Site Features	None									
2.2	Landscaping / Improvements	None									
2.3	Pavement/ Parking	Patching, crack sealing, sealing and striping of asphalt pavement	19,440	\$0.22	25.0%	\$0.27	square foot		\$5,317.33	Cracked paving throughout, some with vegetation growing through. Striping is worn.

<p>3. Representative cracking with vegetation in asphalt parking lot of Building 1</p>	<p>4. Representative worn striping at Building 1</p>

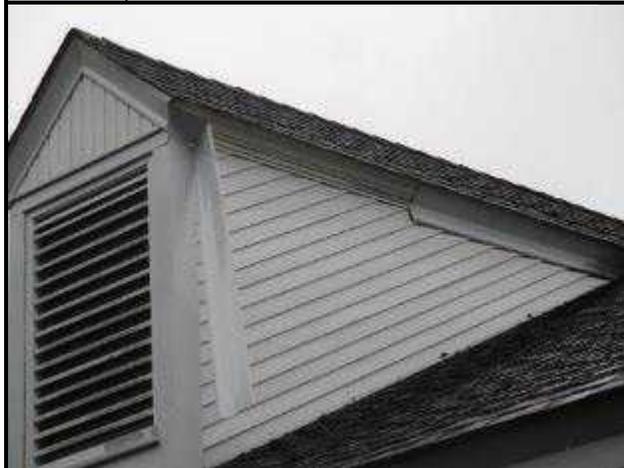
3.0 STRUCTURE											
		None Recommended.									
4.0 BUILDING ENVELOPE											
4.1	Roof	None									
4.2	Facades	Repair damaged siding	1	\$500.00	25.0%	\$625.00	allowance	\$625.00		Dislodged siding at dormers on east side

9. Dislodged trim at dormer of Building 1

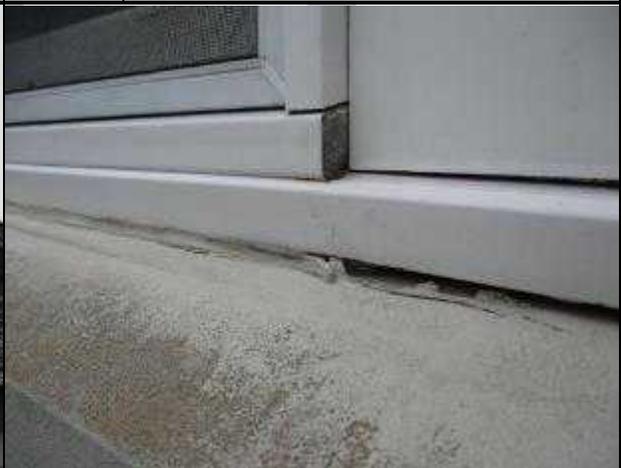
4.3	Windows and Doors	Renew/recaulk windows and doors	1,100	\$3.65	25.0%	\$4.56	linear foot		\$5,017.25	Worn and dislodged sealant, typical	
5.0 BUILDING INTERIORS											
		None Recommended.

10. Worn and dislodged sealant at window of Building 1

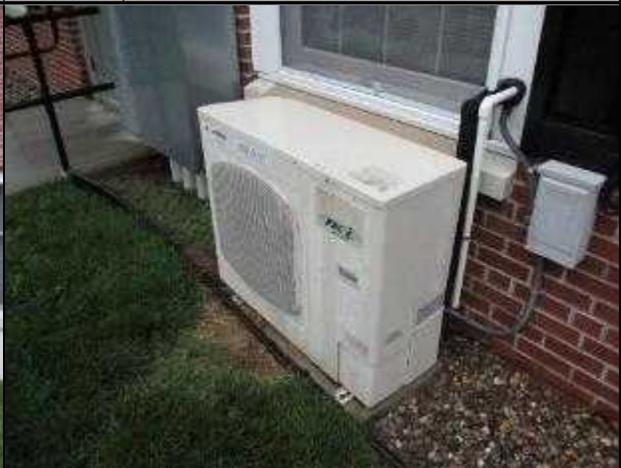
7.0 BUILDING SYSTEMS											
7.1	Plumbing	None									
7.2	HVAC	Replace air-cooled condensing unit (0.5 -1.5 tons)	1	\$2,730.40	25.0%	\$3,413.01	each		\$3,413.01	Planned capital improvement, per site contact (estimate provided by site contact)

12. Older condenser planned for replacement at Building 1

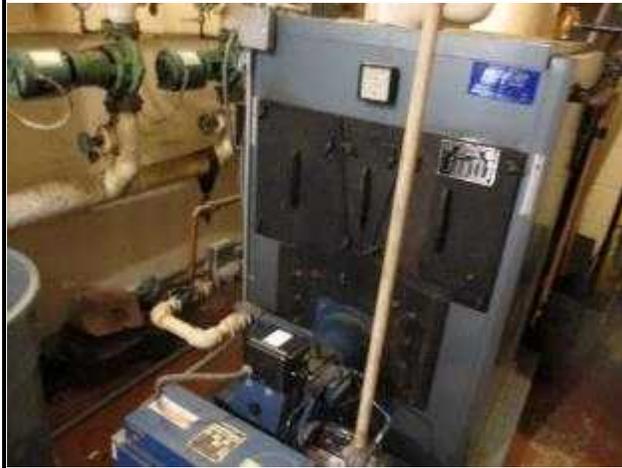
7.2	HVAC	Replace gas/oil-fired HW boiler (1088 MBH)	1	\$130,503.21	25.0%	\$163,129.01	each		\$163,129.01	Existing boiler is 43 years old and exceeds its expected useful life

13. Boiler original to Building 1

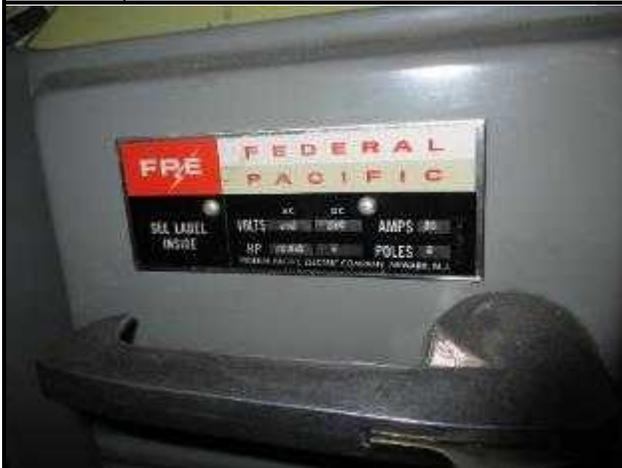
15. FPE electrical equipment that is obsolete at Building 1

7.3	Electric	Complete recommended repairs from electrical inspection	1	TBD	25.0%		Action Item		TBD	Complete any recommended repairs from inspection	
7.4	F/L Safety	None

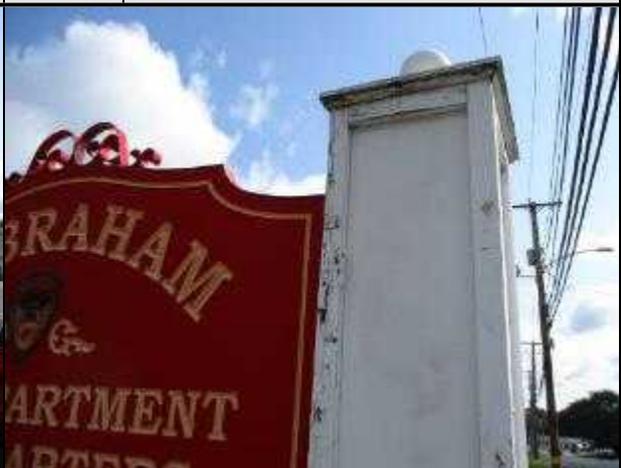
2.0 SITE CONDITIONS										
2.1	Site Features	None								
2.4	Amenities	Refurbish pylon sign	1	\$1,094.00	25.0%	\$1,367.50	each		\$1,367.50	Sign is worn with chipped paint at supports

18. Representative worn paint at pylon sign of Building 2

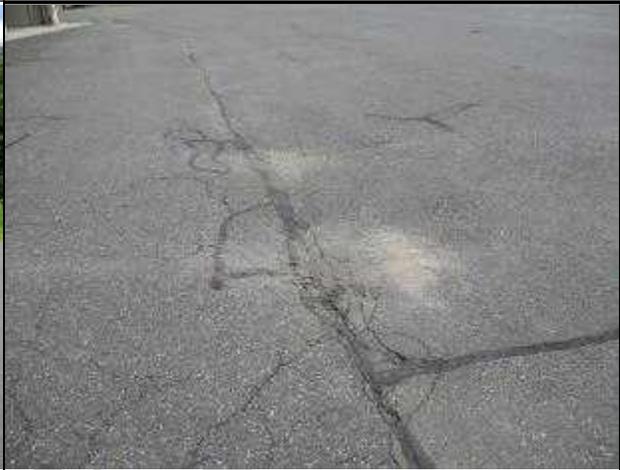
2.3	Pavement/ Parking	Patching, crack sealing, sealing and striping of asphalt pavement	36,000	\$0.22	25.0%	\$0.27	square foot		\$9,846.90	Pavement is cracked throughout

19. Representative rear parking lot at Building 2	20. Representative asphalt pavement cracking at Building 2

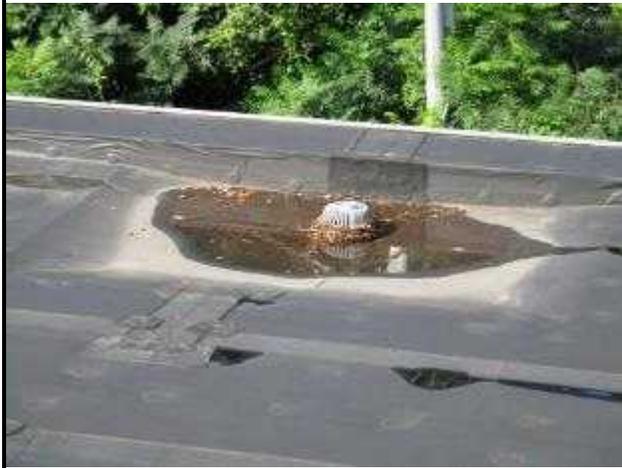
3.0 STRUCTURE										
		None Recommended.								
4.0 BUILDING ENVELOPE										
4.1	Roof	Proactive Maintenance Program (PMP)- General	11,800	\$0.10	25.0%	\$0.13	square foot	\$1,536.95		Provide preventative maintenance, such as cleaning clogged drains, etc.

25. Clogged roof drain at Building 2

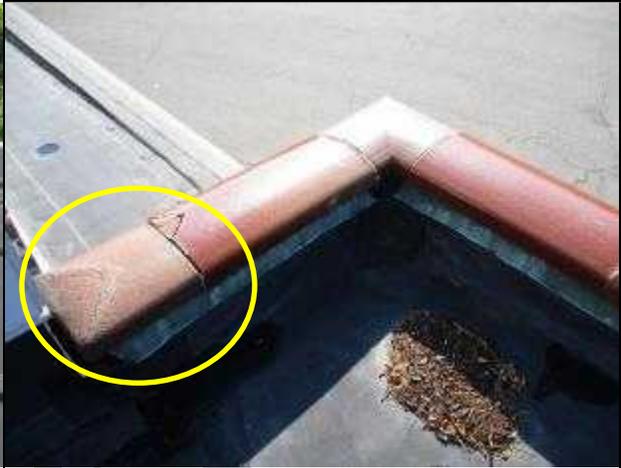
4.1	Roof	Repair coping tiles	1	\$1,000.00	25.0%	\$1,250.00	allowance	\$1,250.00		Cracked coping tiles along front parapet
4.2	Facades	Repair composite siding	1	\$10,000.00	25.0%	\$12,500.00	allowance	\$12,500.00		Cracked siding throughout, primarily at anchor screws

26. Coping stone cracks at Building 2

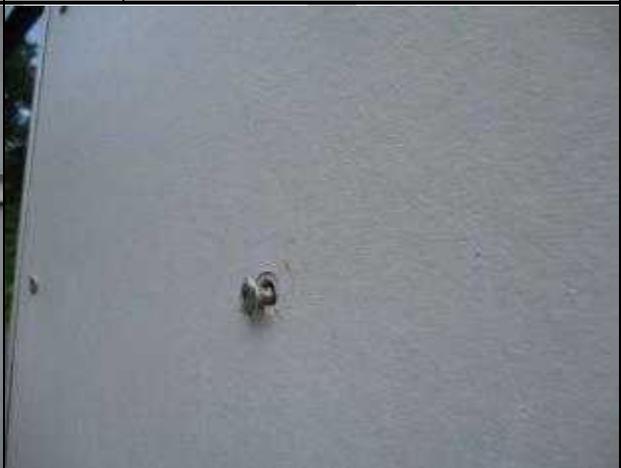
28. Loose screw at composite siding at west wall of Building 2

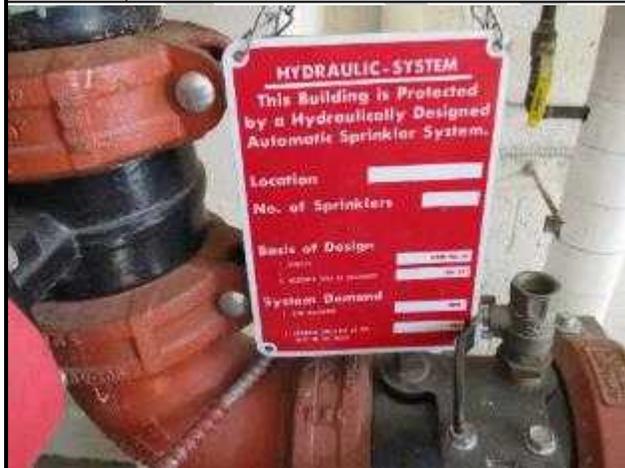
<p>35. Data plate with missing information at Building 2</p>	<p>36. Fire alarm control panel at Building 2</p>

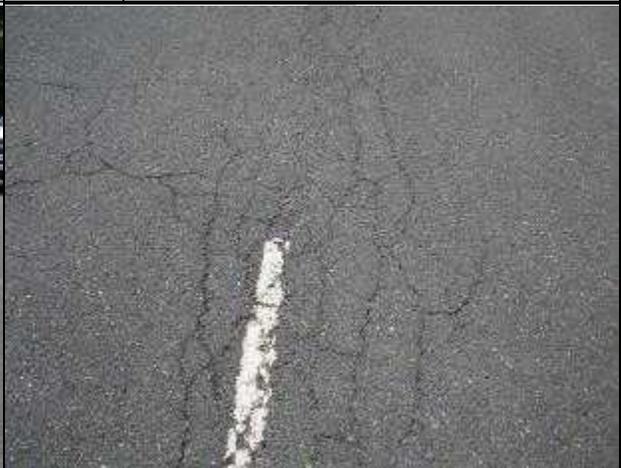
40. Representative asphalt cracking at Building 3

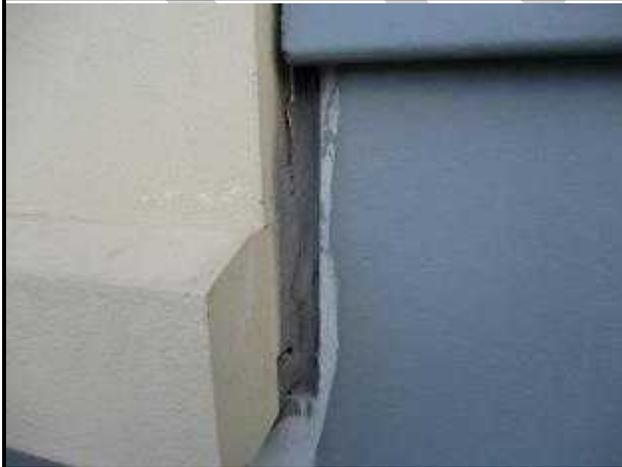
59. Representative missing sealant at Building 4 window

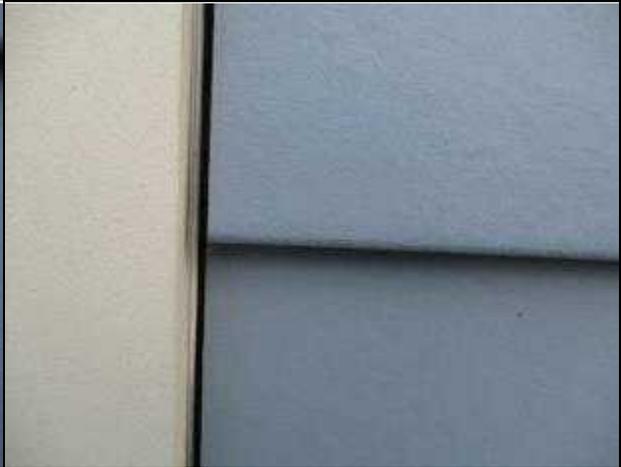
60. Representative missing sealant at Building 4 window

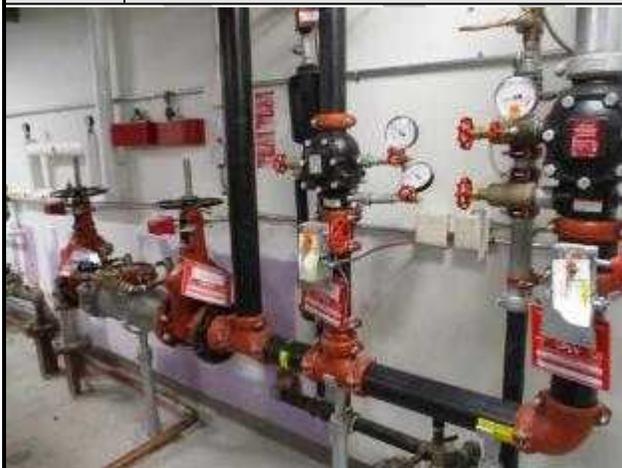
71. Sprinkler system with no inspection tags at Building 4

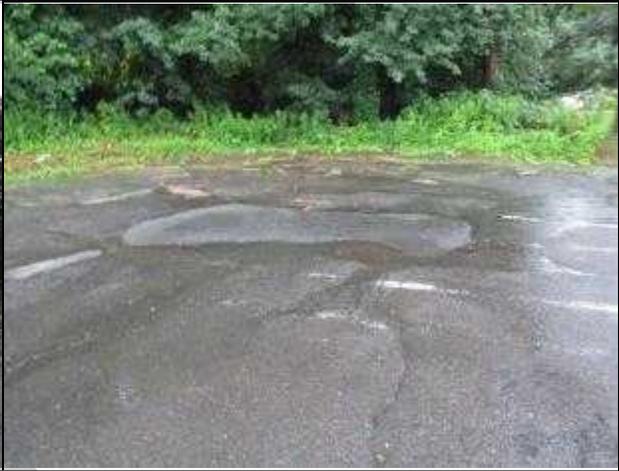
<p>75. Representative landscaping and front asphalt driveway at Building 5</p>	<p>76. Representative pavement cracking and settlement at Building 5</p>

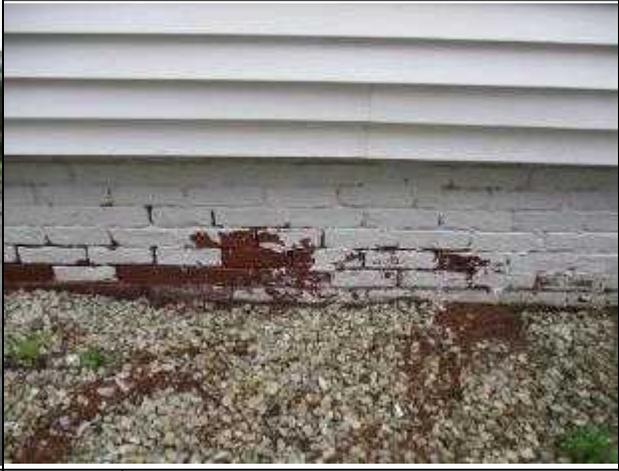
<p>77. Representative pavement cracking and worn striping at Building 5</p>	<p>78. Representative brick foundation with deteriorated mortar joints, on north side of Building 5</p>

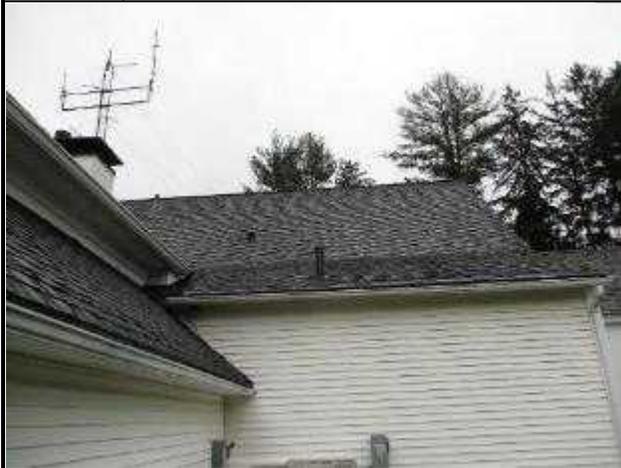
81. Representative asphalt shingle roofing at Building 5	82. Rear façade of Building 5

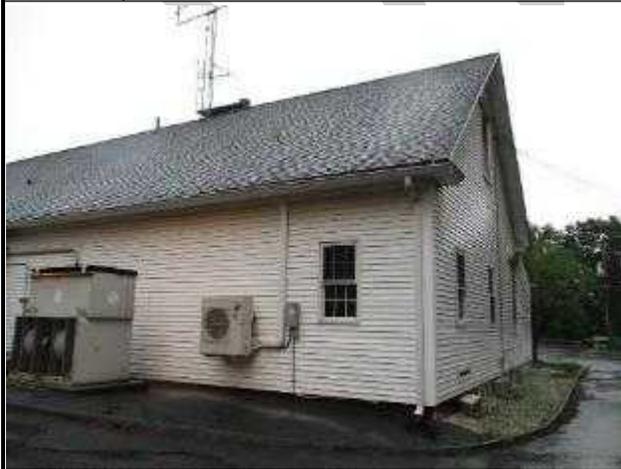
83. North and rear façade of Building 5	84. Representative single pane window with storm window at Building 5

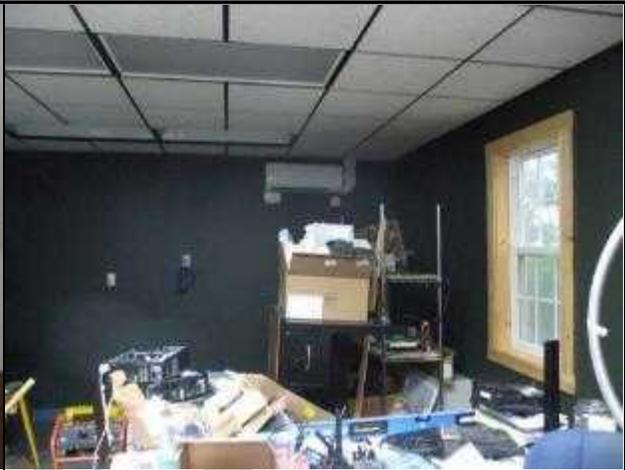
85. Representative water stained ceiling in Building 5 basement	86. Representative office at Building 5

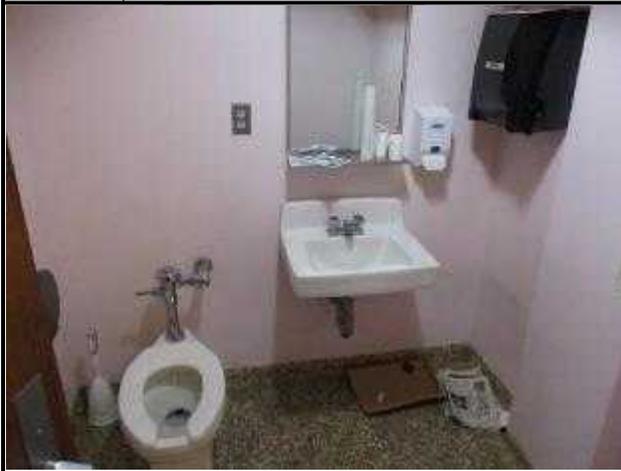
89. Representative rest room in Building 5	90. Boiler in basement of Building 5

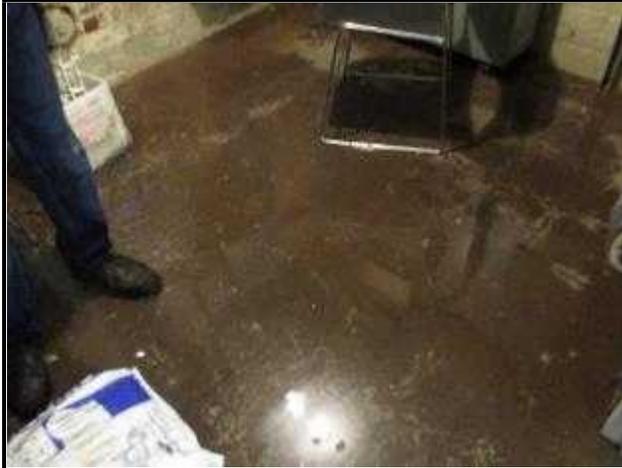
91. Standing water on the floor of the electrical room in Building 5 basement

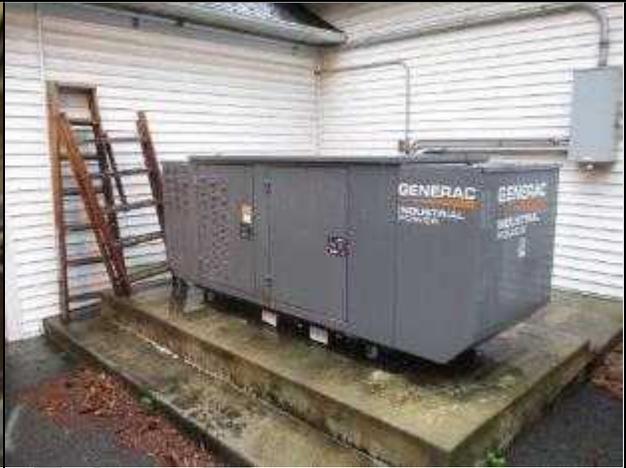
92. Generator at rear of Building 5

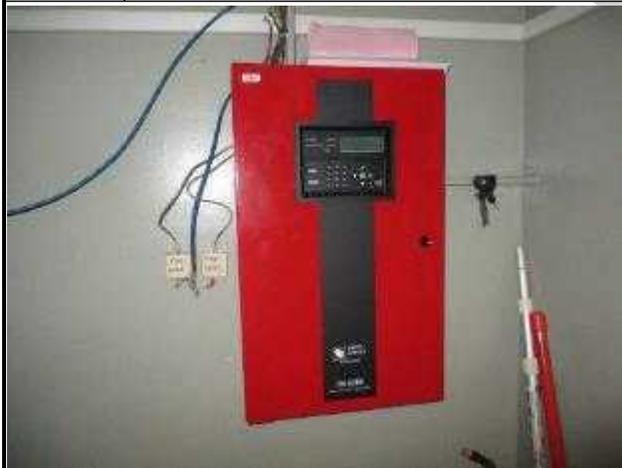
93. Fire alarm control panel in Building 5 basement

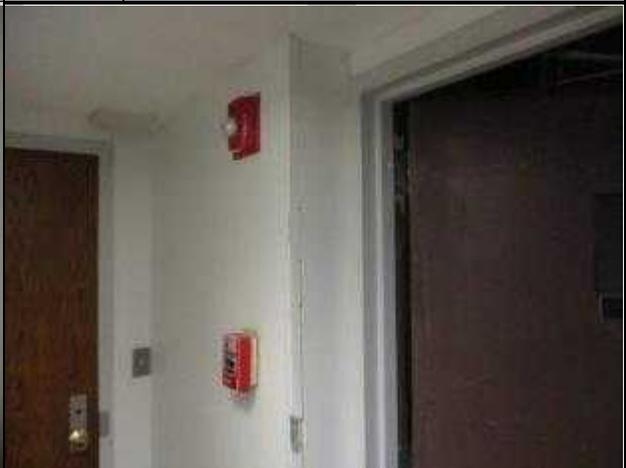
94. Representative life safety devices in Building 5

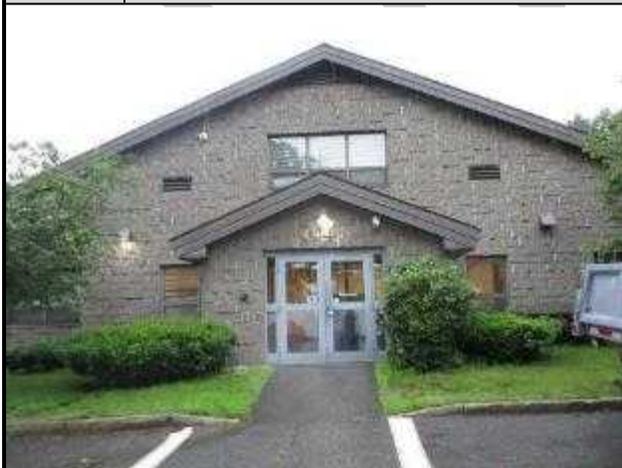
95. Side entrance with front landscaping at Building 6

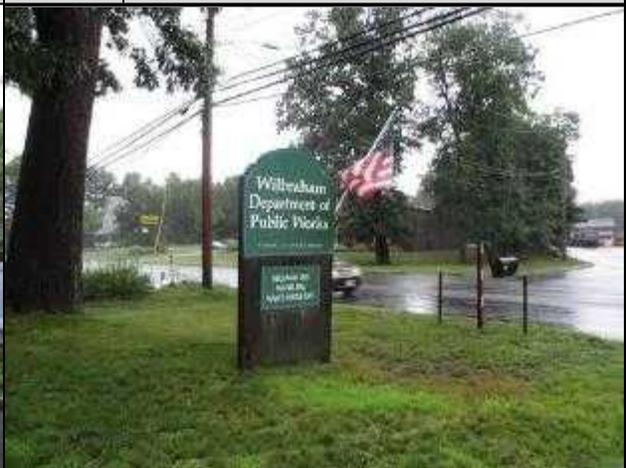
96. Pylon sign at Building 6

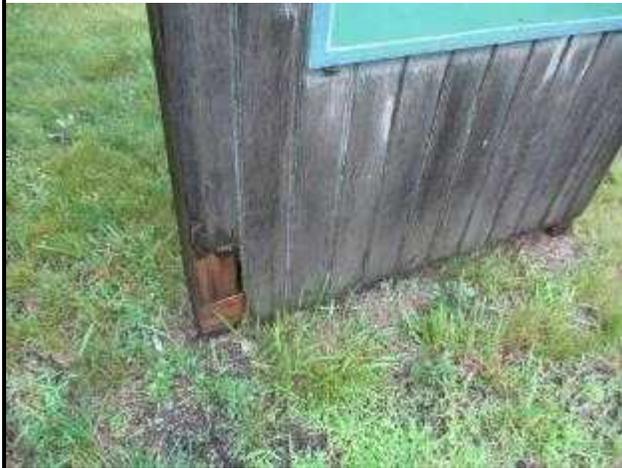
97. Worn and deteriorated wood at pylon sign at Building 6

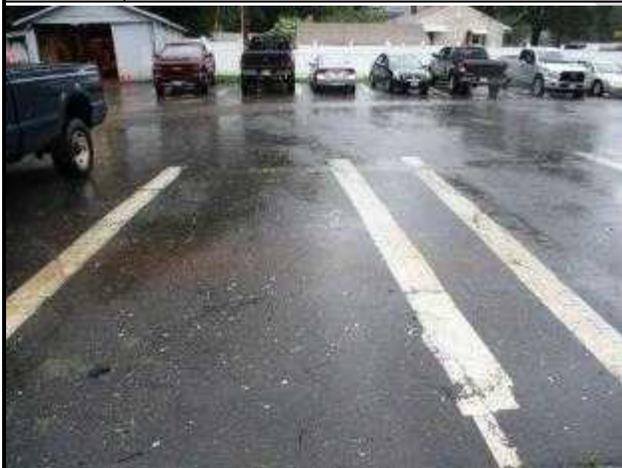
99. Representative pavement cracking at west side of Building 6

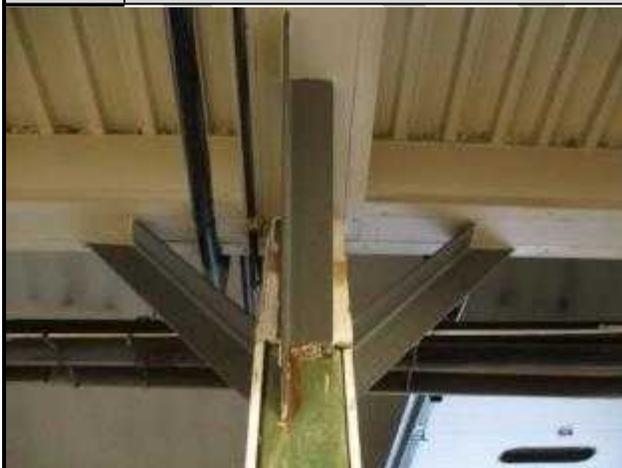
101. Representative steel framing in Building 6

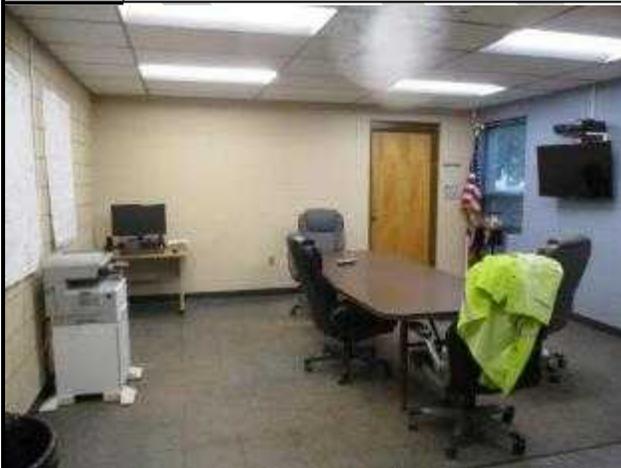
107. Representative conference room in Building 6	108. Ceiling stains in main office of Building 6

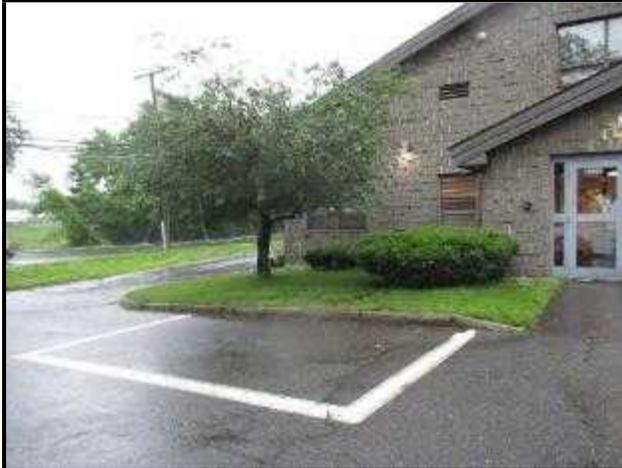
109. Accessible parking with no signage or access aisle at Building 6

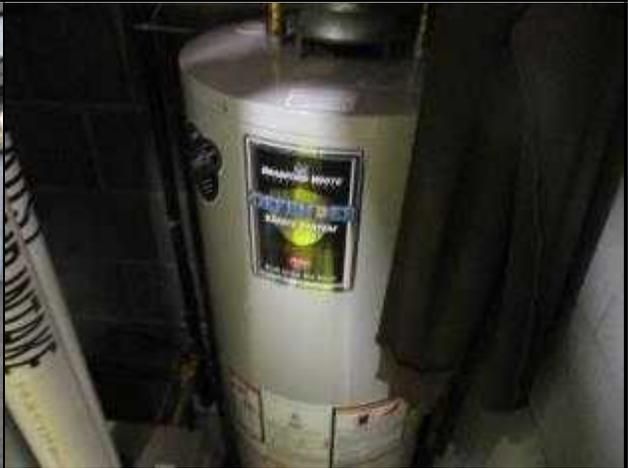
110. Representative water heater in Building 6

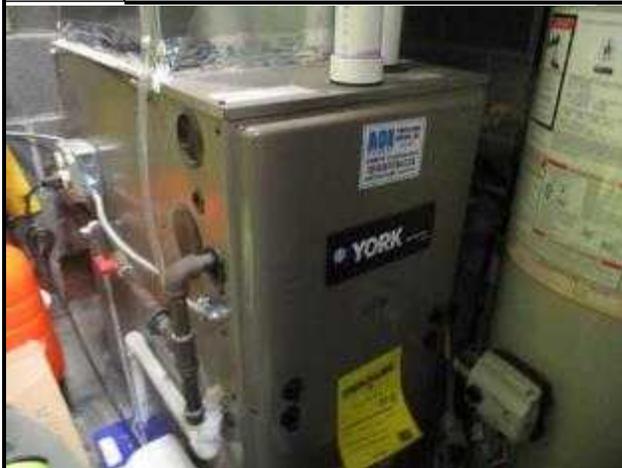
111. New furnace in Building 6

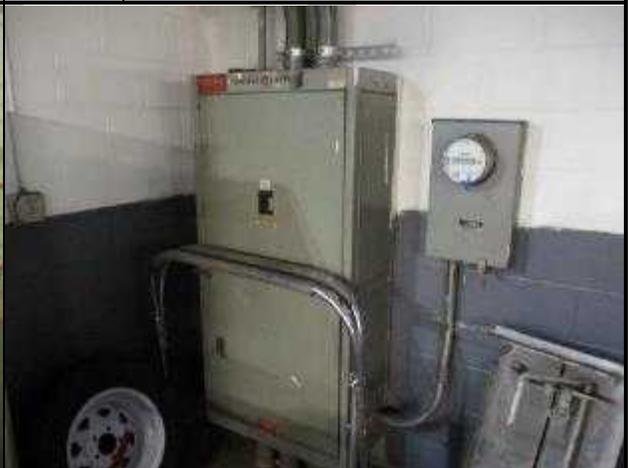
112. Stored materials blocking front of main electrical switch in Building 6

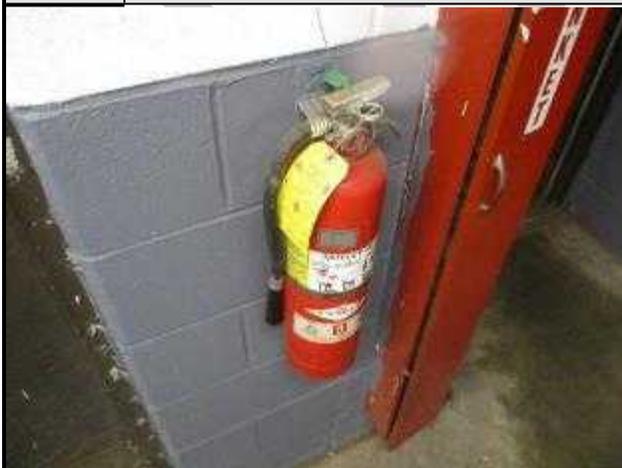
113. Representative fire extinguisher in Building 6

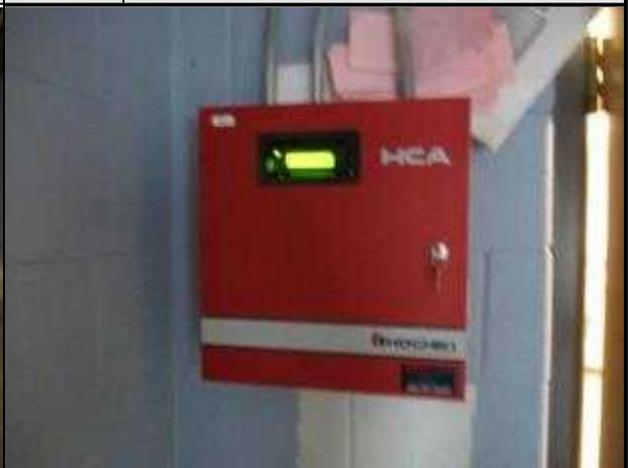
114. Fire alarm control panel at Building 6

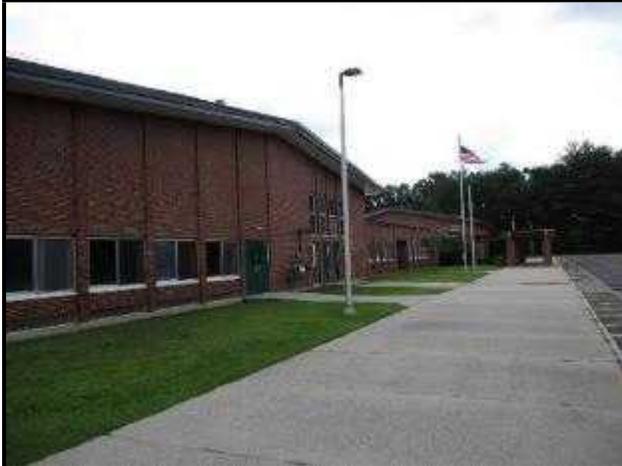
115. Front façade at Building 7

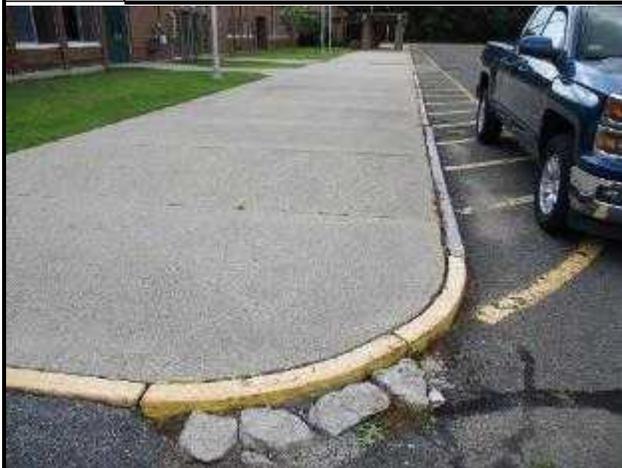
117. Representative sidewalk at Building 7

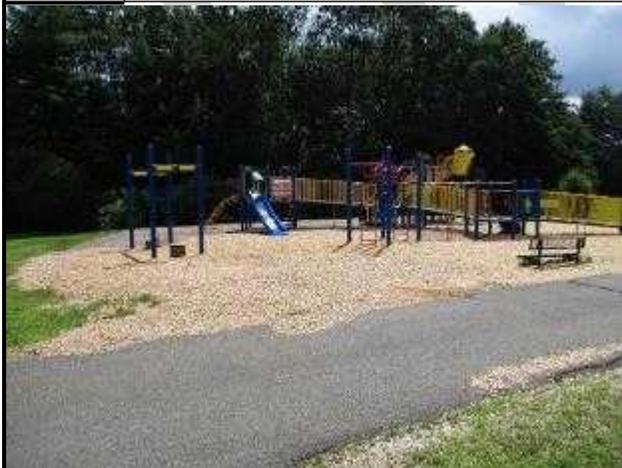
119. Playground at Building 7

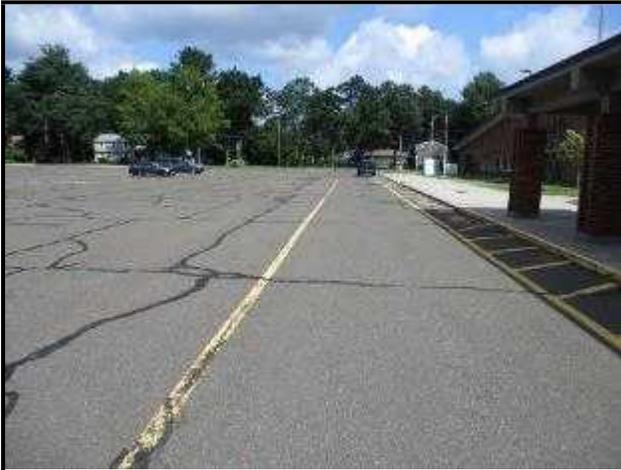
121. Representative parking lot at Building 7	122. Representative asphalt parking cracking and settlement at Building 7

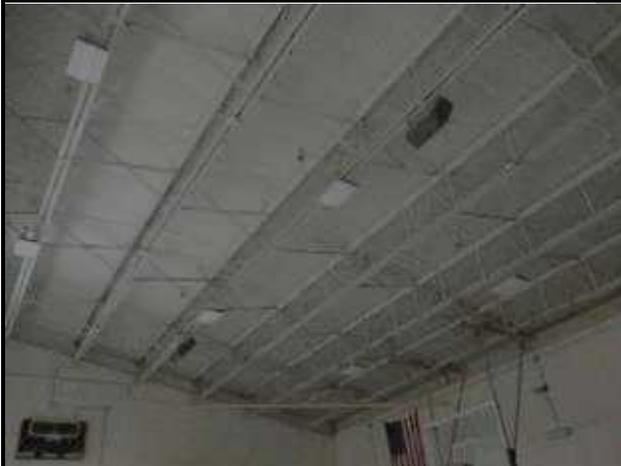
123. Representative structure at Building 7	124. Representative PVC-membrane roof at Building 7

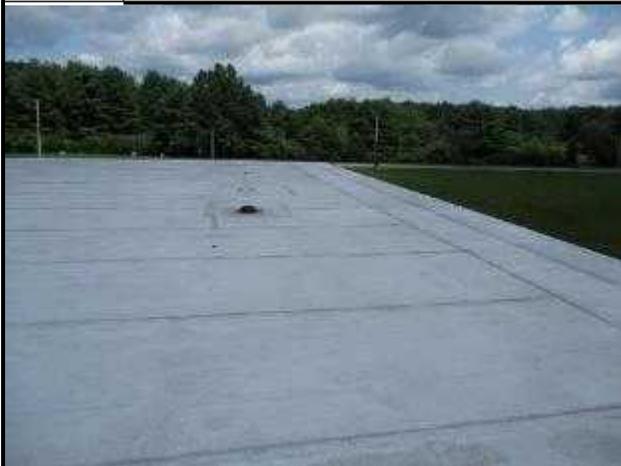
125. Representative PVC-membrane roof with internal drain at Building 7	126. Main entrance at Building 7

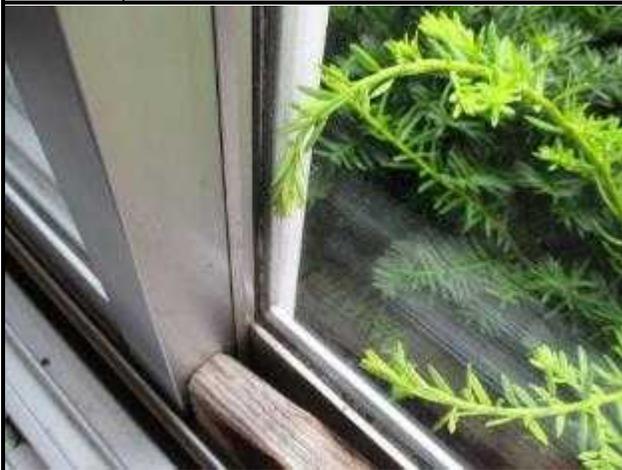
129. Older metal-framed windows at Building 7	130. Representative windows and doors at Building 7

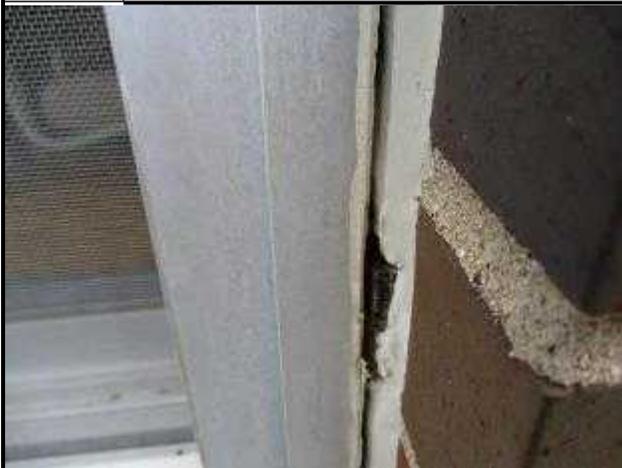
131. Deteriorated window sealant at Building 7	132. Library at Building 7

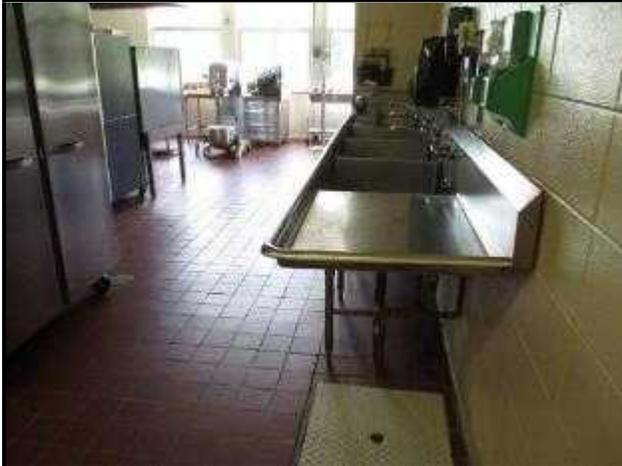
133. Kitchen at Building 7

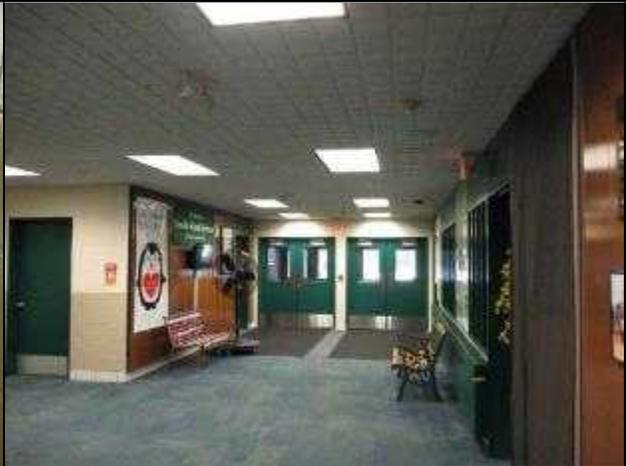
134. Entrance lobby at Building 7

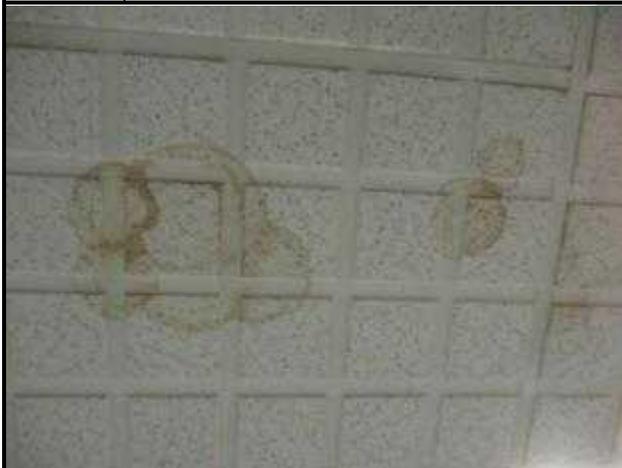
135. Representative ceiling staining at lobby of Building 7

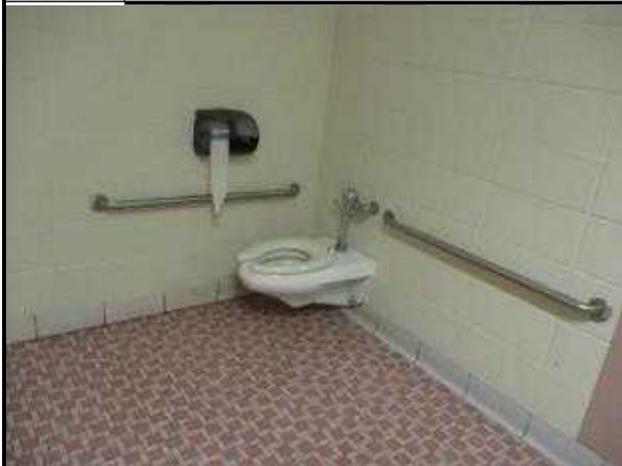
137. Accessible toilet at Building 7

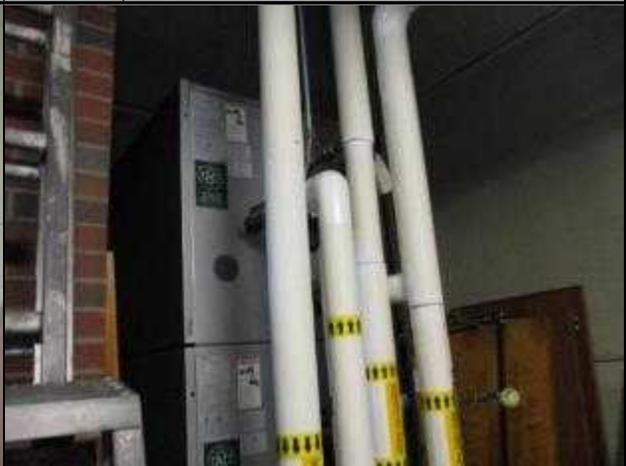
138. Heat exchangers for hot water at Building 7

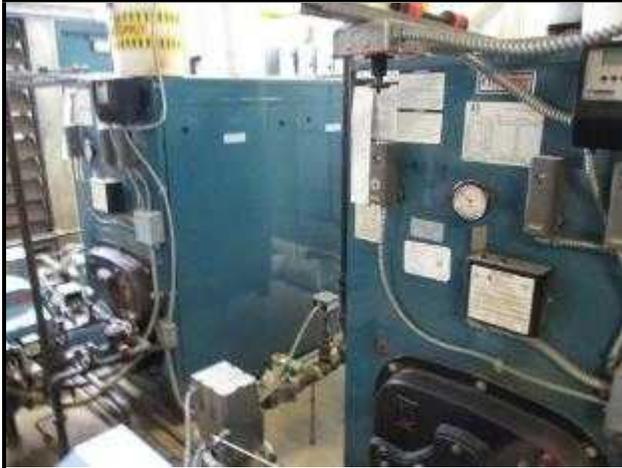
139. Boilers at Building 7

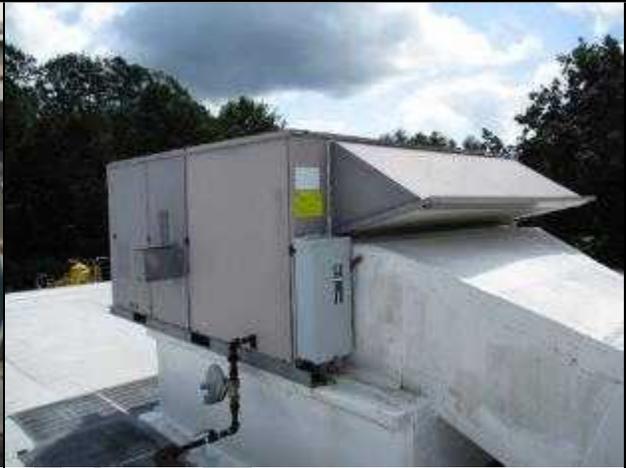
140. Rooftop unit with R-22 refrigerant

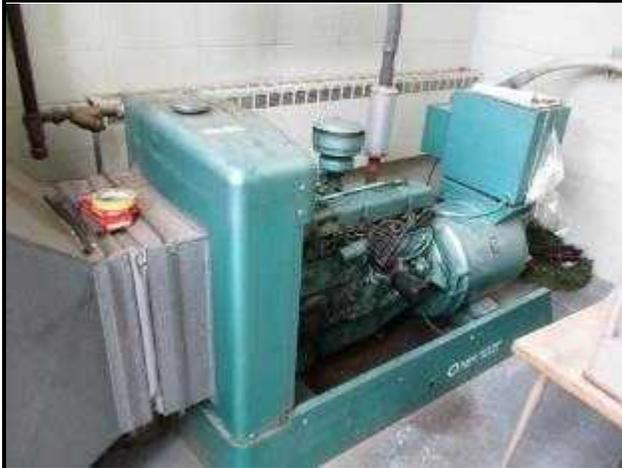
141. Original emergency generator at Building 7

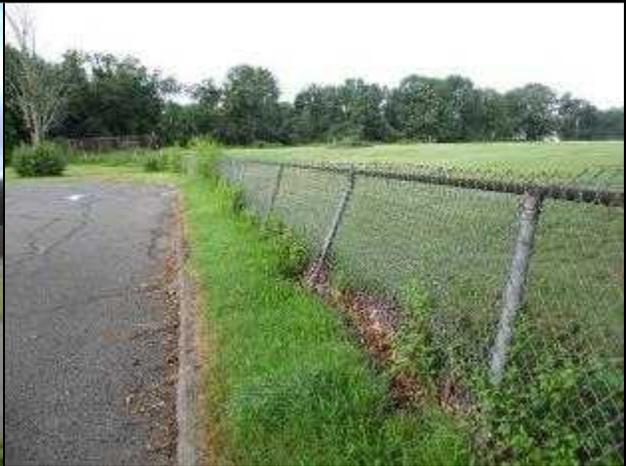
144. Out of plumb chain link fencing adjacent to Building 8 parking lot

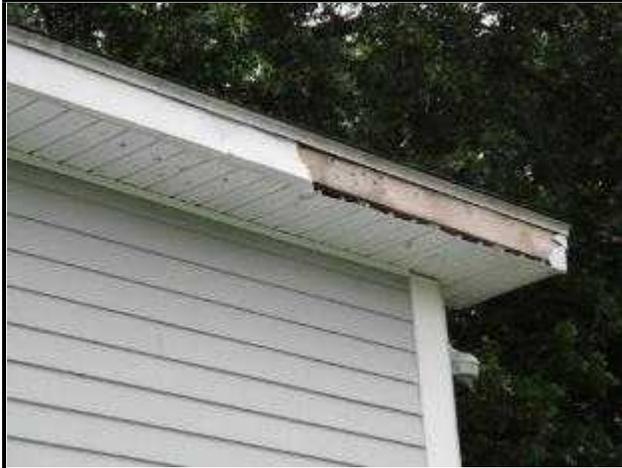
151. Dislodged siding at pavilion on Building 8 property

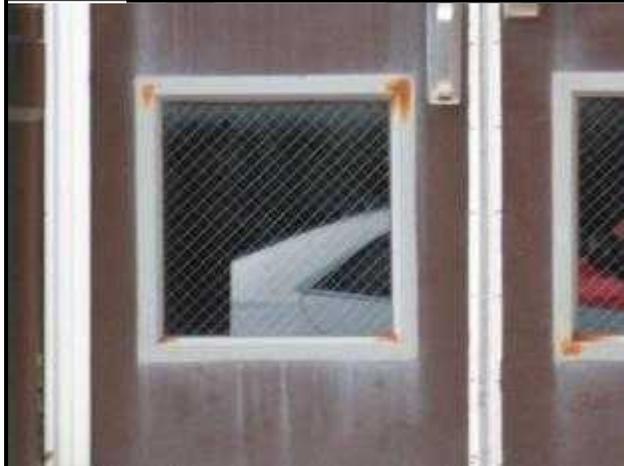
161. Worn paint and rust at Building 8 door

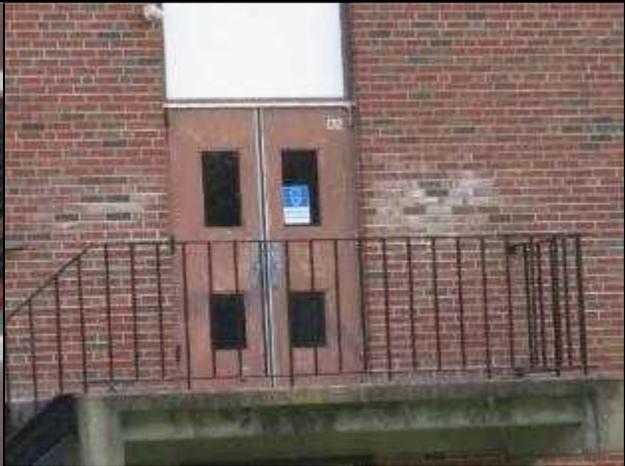
162. Worn and rusted door on south side of Building 8

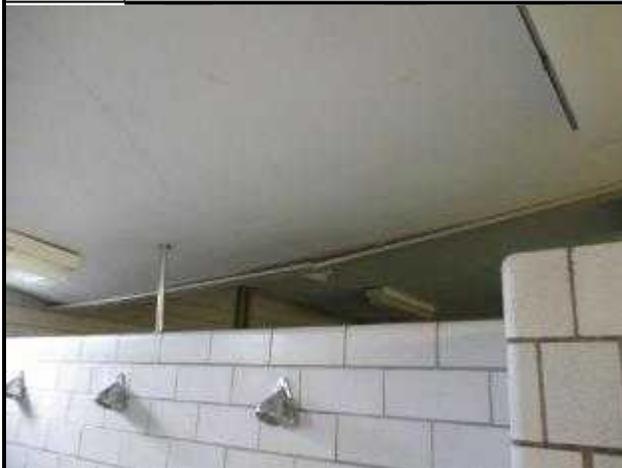
168. Dislodged ceiling in Building 8 locker room

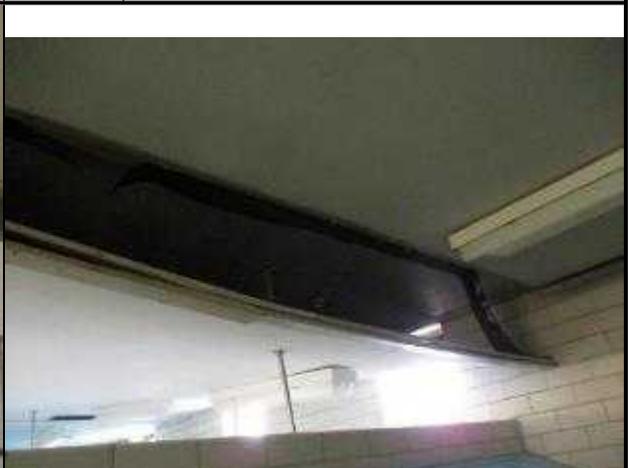
169. Dislodged ceiling in Building 8 locker room

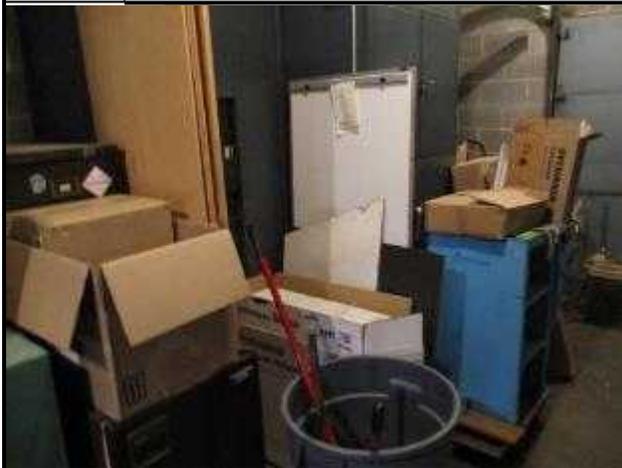
173. Storage and debris within 36" of and blocking electrical equipment

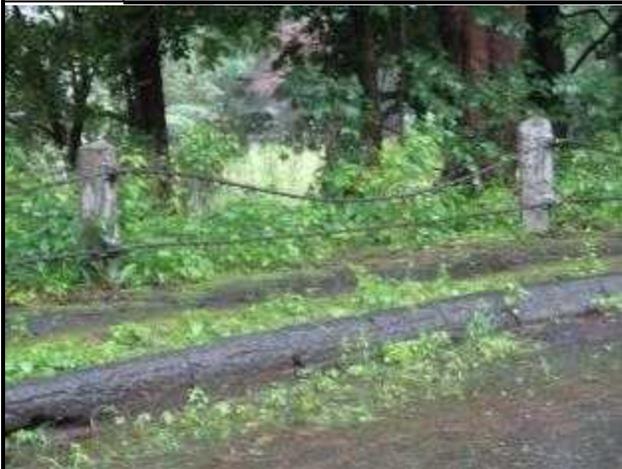
<p>179. Loose fence line, vegetation at sidewalk at Building 9</p>	<p>180. Representative cracking with vegetation overgrowth at Building 9 rear parking lot</p>

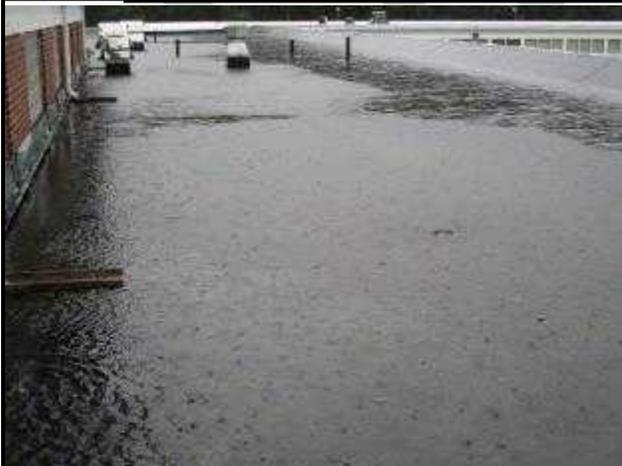
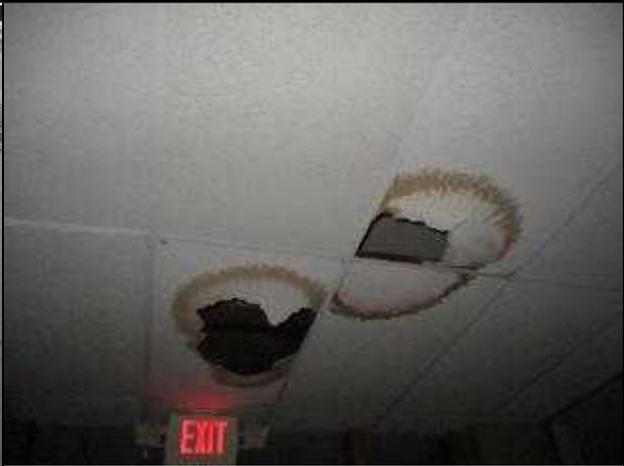
185. EPDM ponding before drains were cleared at Building 9	186. Active water infiltration at south side of east wing of Building 9

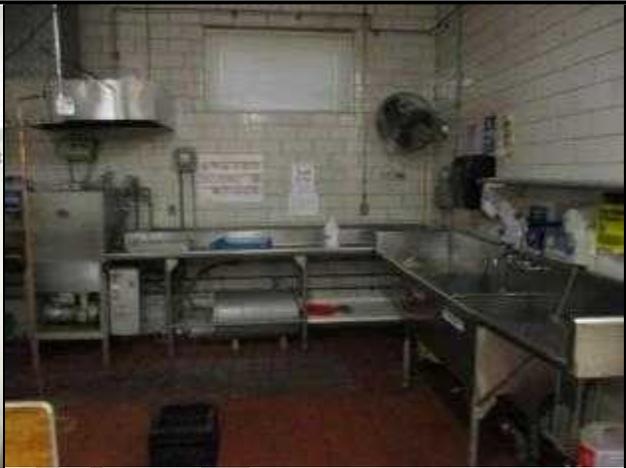
194. Kitchen of Building 9

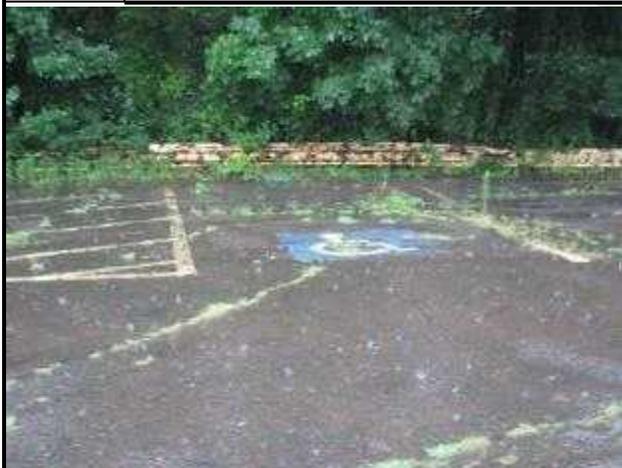
195. Accessible parking without signage at Building 9

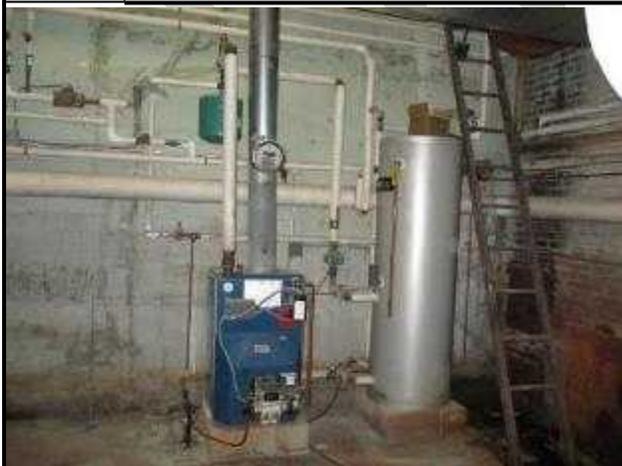
197. Domestic hot water boiler at Building 9

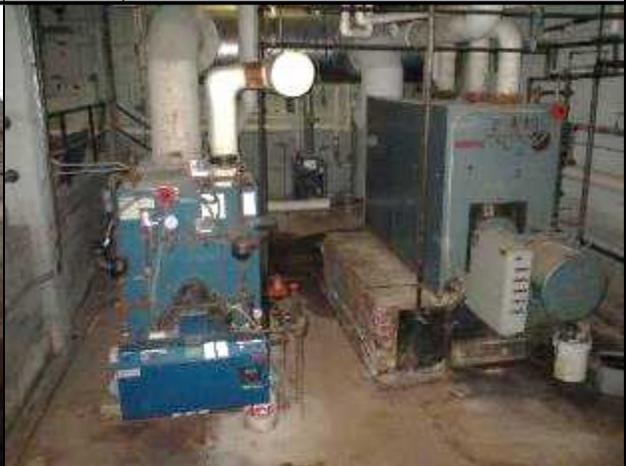
198. Boilers in Building 9 basement

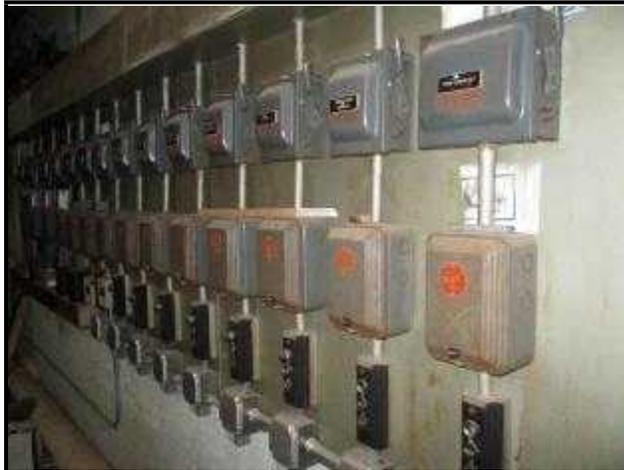
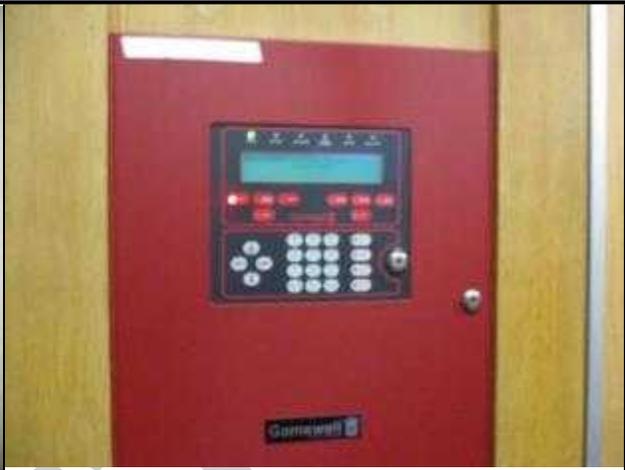
<p>199. Decommissioned <i>FPE</i> equipment in Building 9 basement</p>	<p>200. Fire alarm control panel with no known inspection information in Building 9</p>

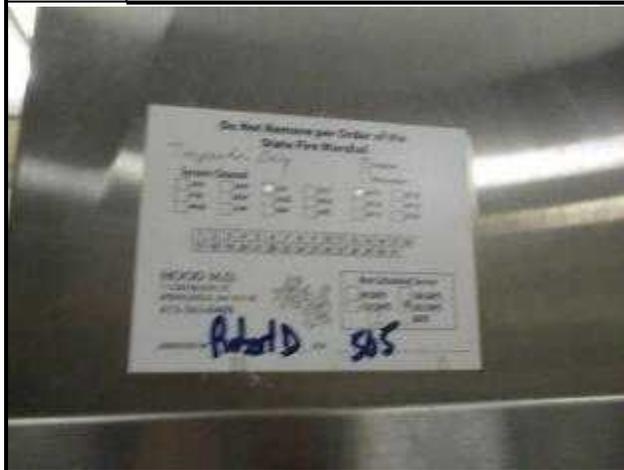
<p>201. Expired inspection tag on kitchen hood in Building 9</p>	<p>202. Entrance at Building 10</p>

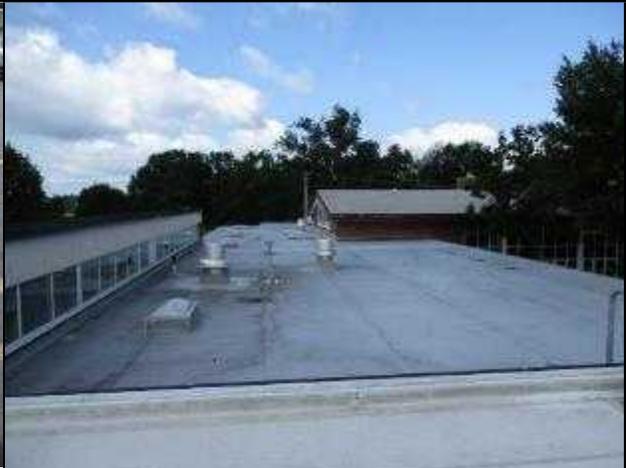
206. Representative roof at Building 10
