CAPITAL NEEDS ASSESSMENT

Town of Wilbraham Portfolio

**Various Addresses
(17 Scattered Properties)
Wilbraham MA 01095**

EBI Project No. 1321000388

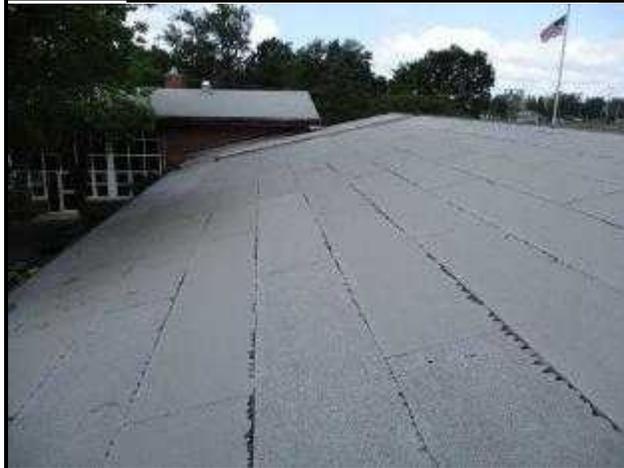
207. Representative modified built up roof at Building 10

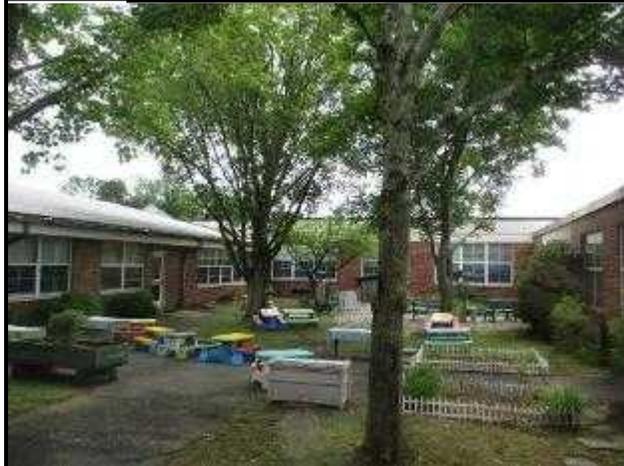
209. Courtyard façade at Building 10

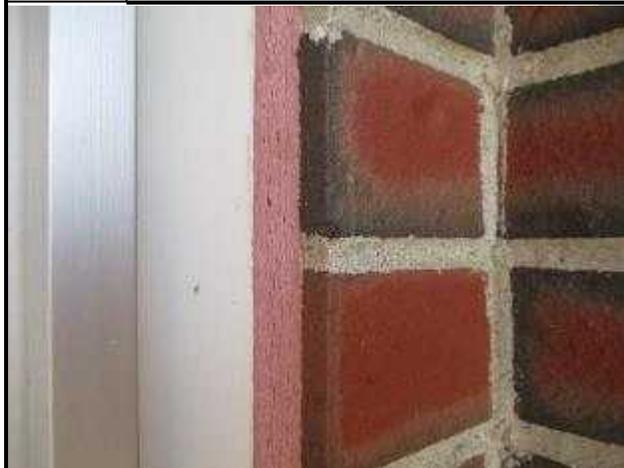
213. Building 11 front entry door jamb detail

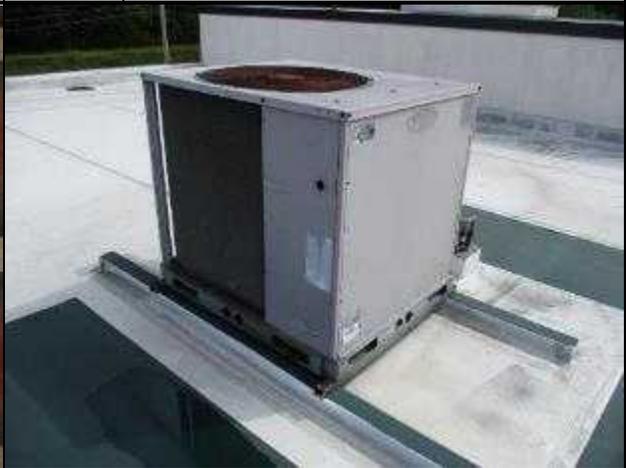
214. Condenser that utilizes R-22 refrigerant

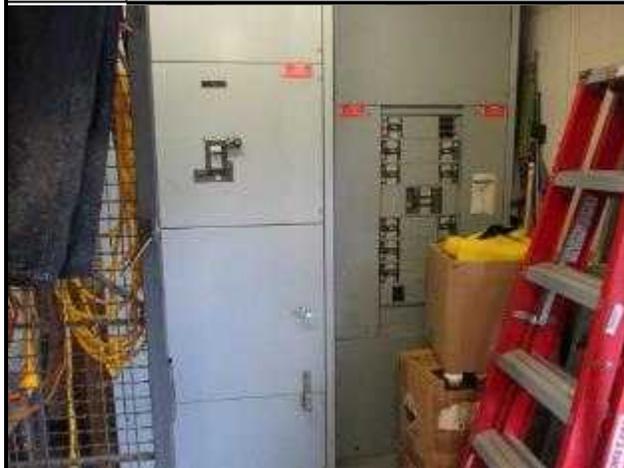
215. Stored equipment within 36" of and blocking electrical equipment

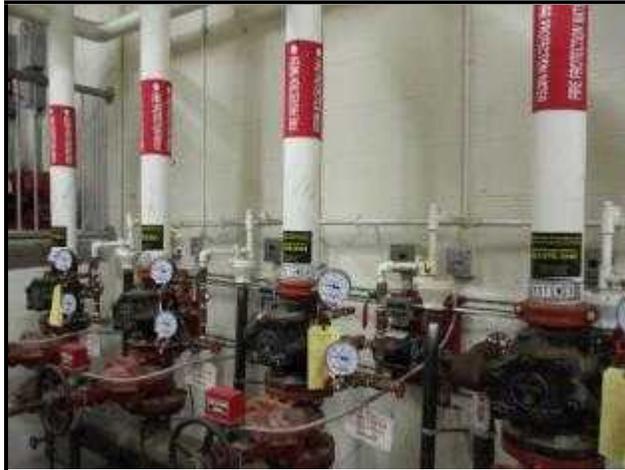
<p>217. Sprinkler risers with no data plate information in Building 10</p>	<p>218. Front entrance and façade of Building 11</p>

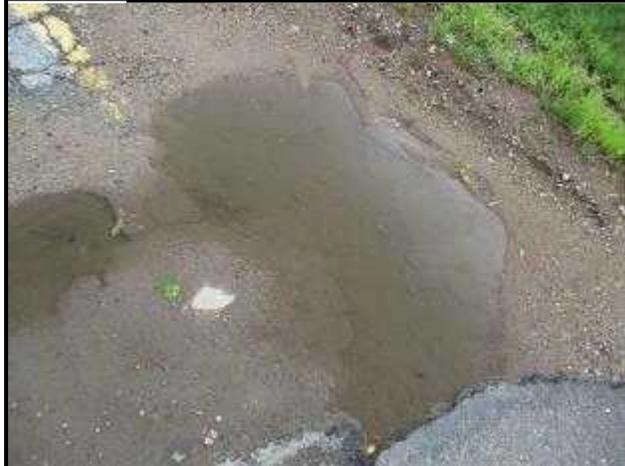
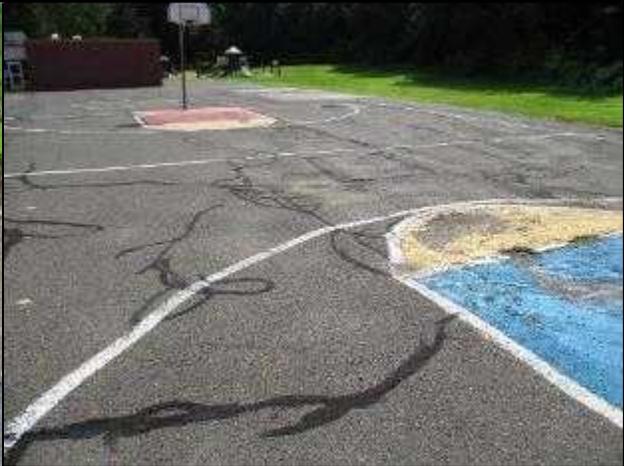
<p>221. Representative cracking and settlement in parking lot of Building 11</p>	<p>222. Representative cracking and settlement at Building 11 sport court</p>

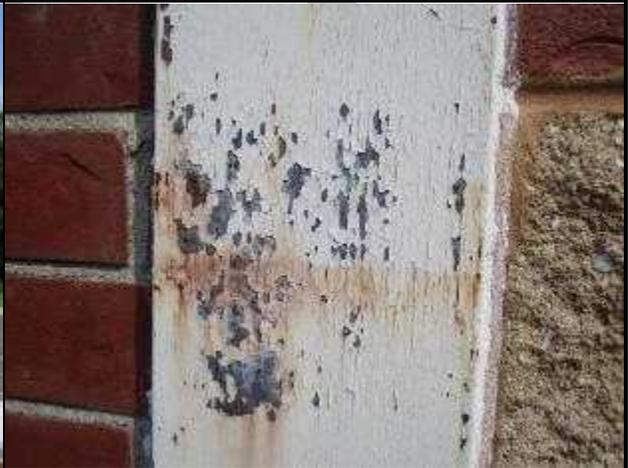
226. Representative paint peeling at Building 11 façade

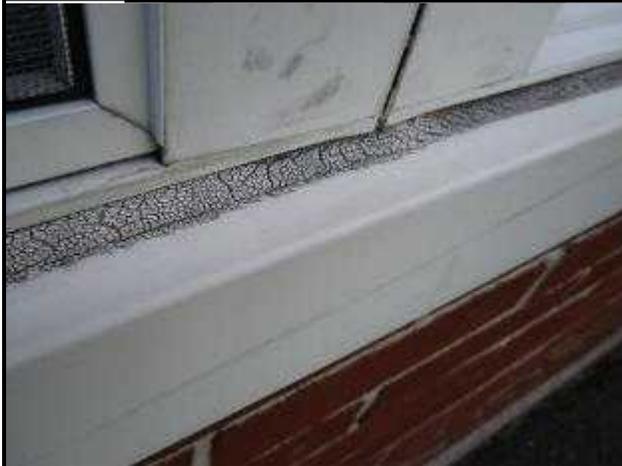
227. Worn and cracked sealant at Building 11 windows

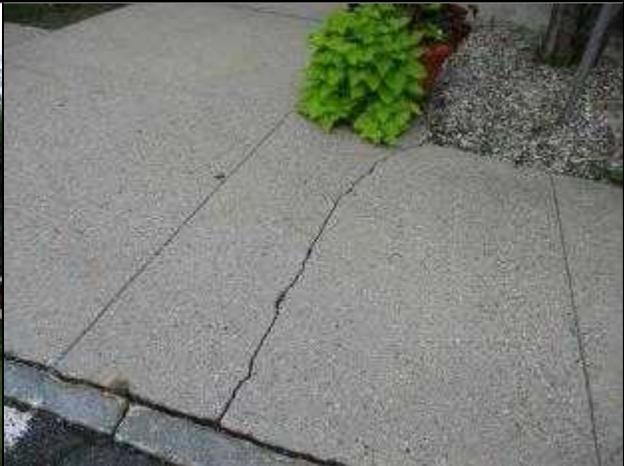
<p>233. Façade and landscaping at Building 12</p>	<p>234. Representative sidewalk cracking at Building 12</p>

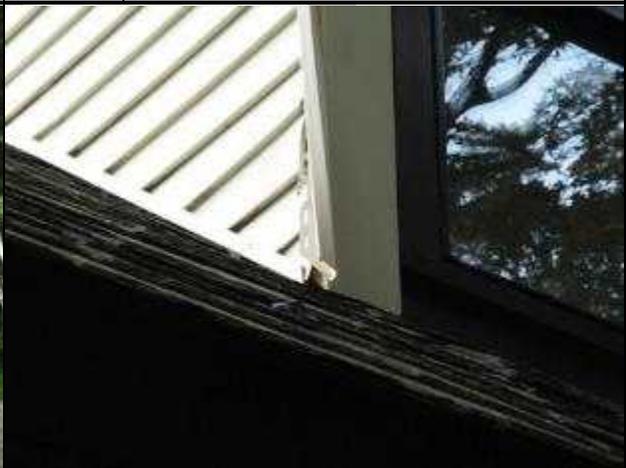
238. Representative dislodged trim piece at Building 12 dormer

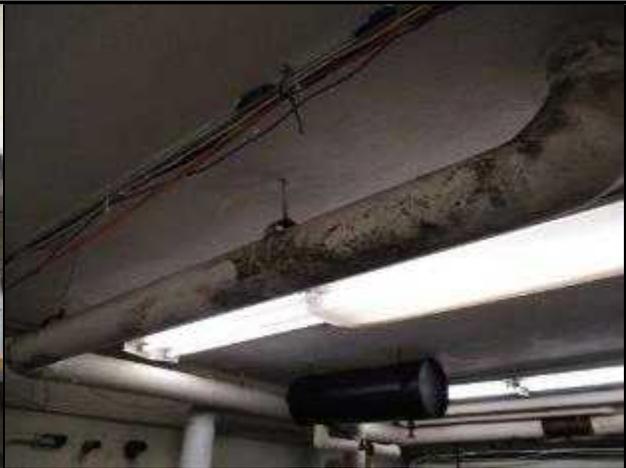
242. Suspect mold-like substance on basement piping in Building 12

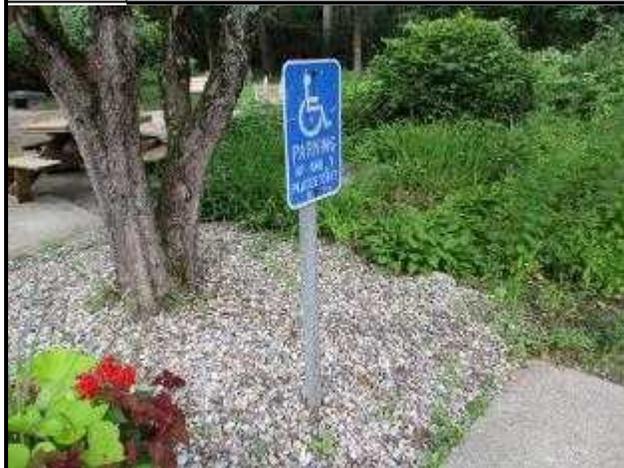
245. Non-compliant accessibility signage is too low at Building 12

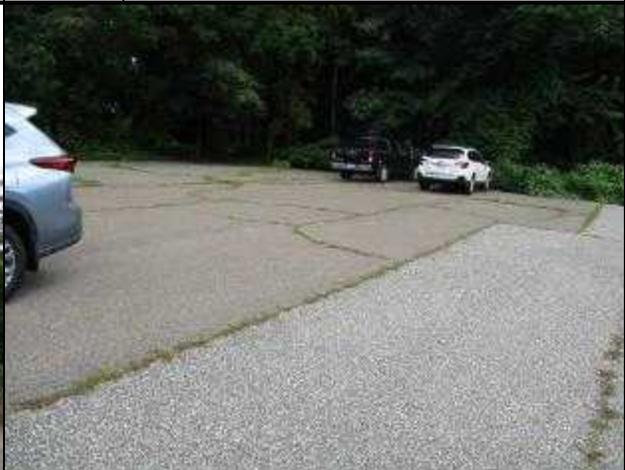
<p>249. Front view of Building 13</p>	<p>250. Representative parking lot with cracking and overgrowth at Building 13</p>

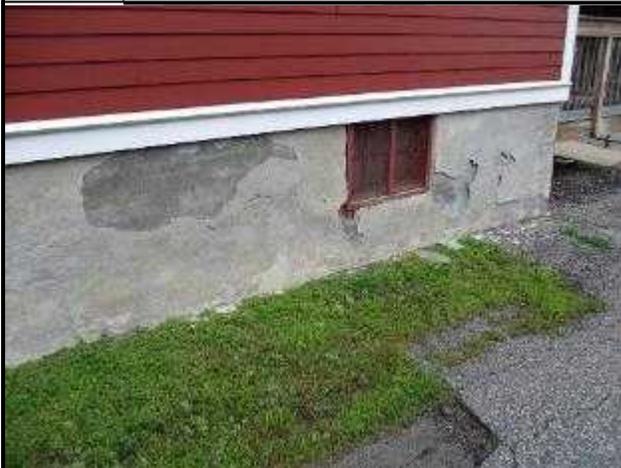
<p>251. Spalling at basement foundation at Building 13</p>	<p>252. Spalling and delamination of wall at Building 13 foundation</p>

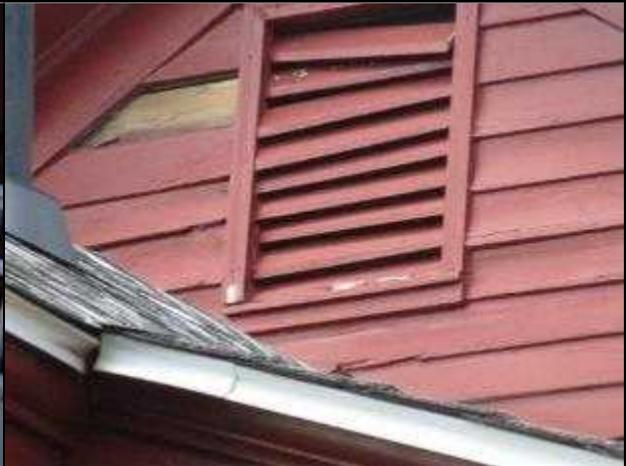
276. Dislodged siding at Building 15

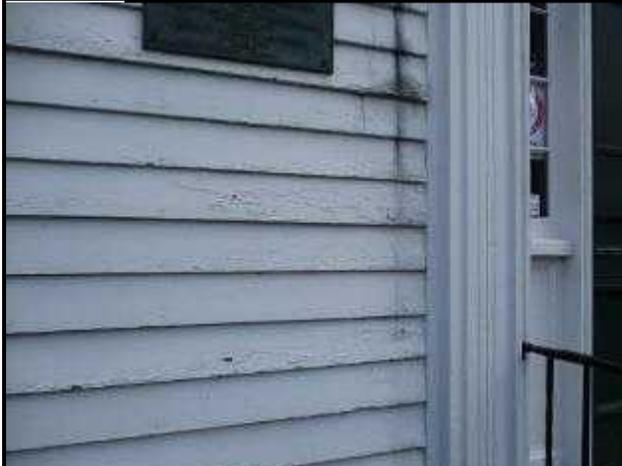
287. Worn and peeling paint at Building 16

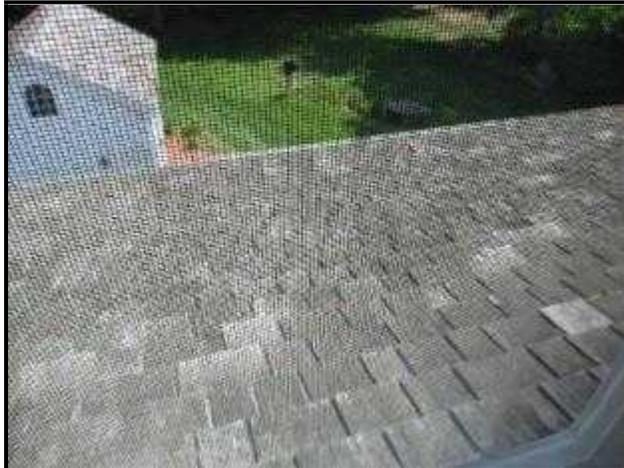
289. Representative cedar shakes at Building 16

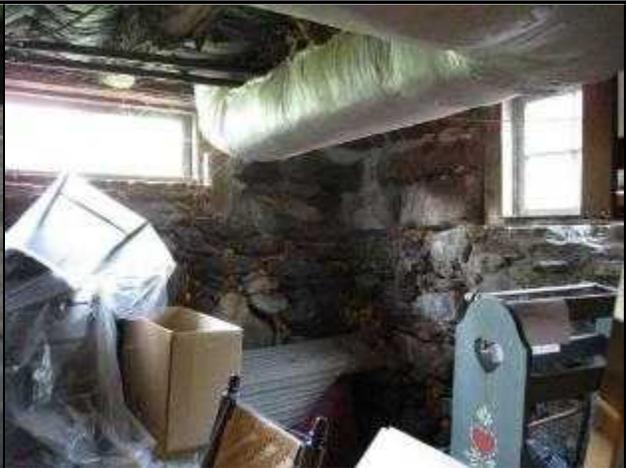
290. Representative fieldstone basement at Building 16

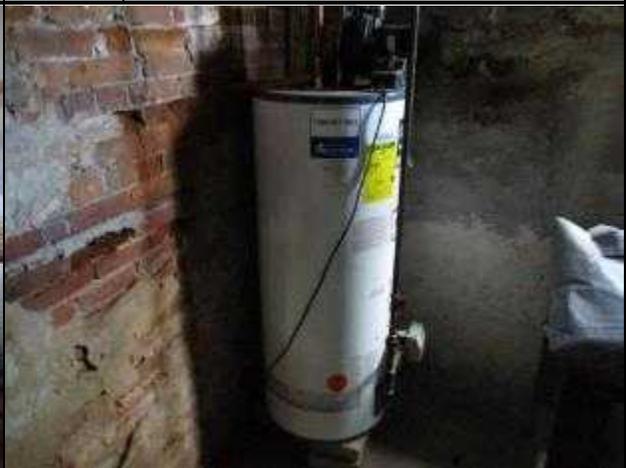
292. Water heater in Building 16

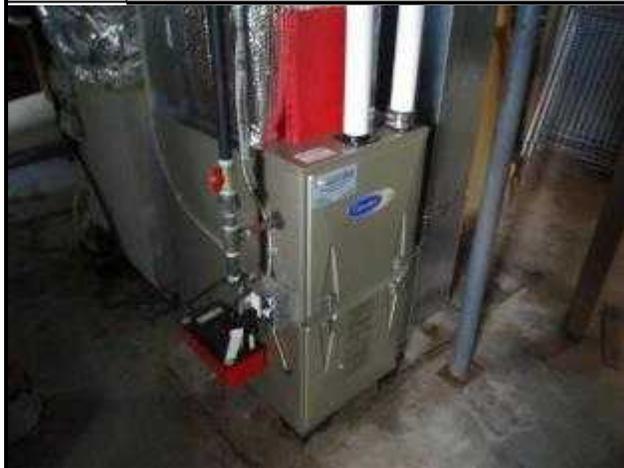
293. Furnace in Building 16
